US Army Corps
of Engineers
St. Paul District

Photo A.1: Weaver Bottoms Constructed 1986 Swan & Mallard Island, Whitewater River

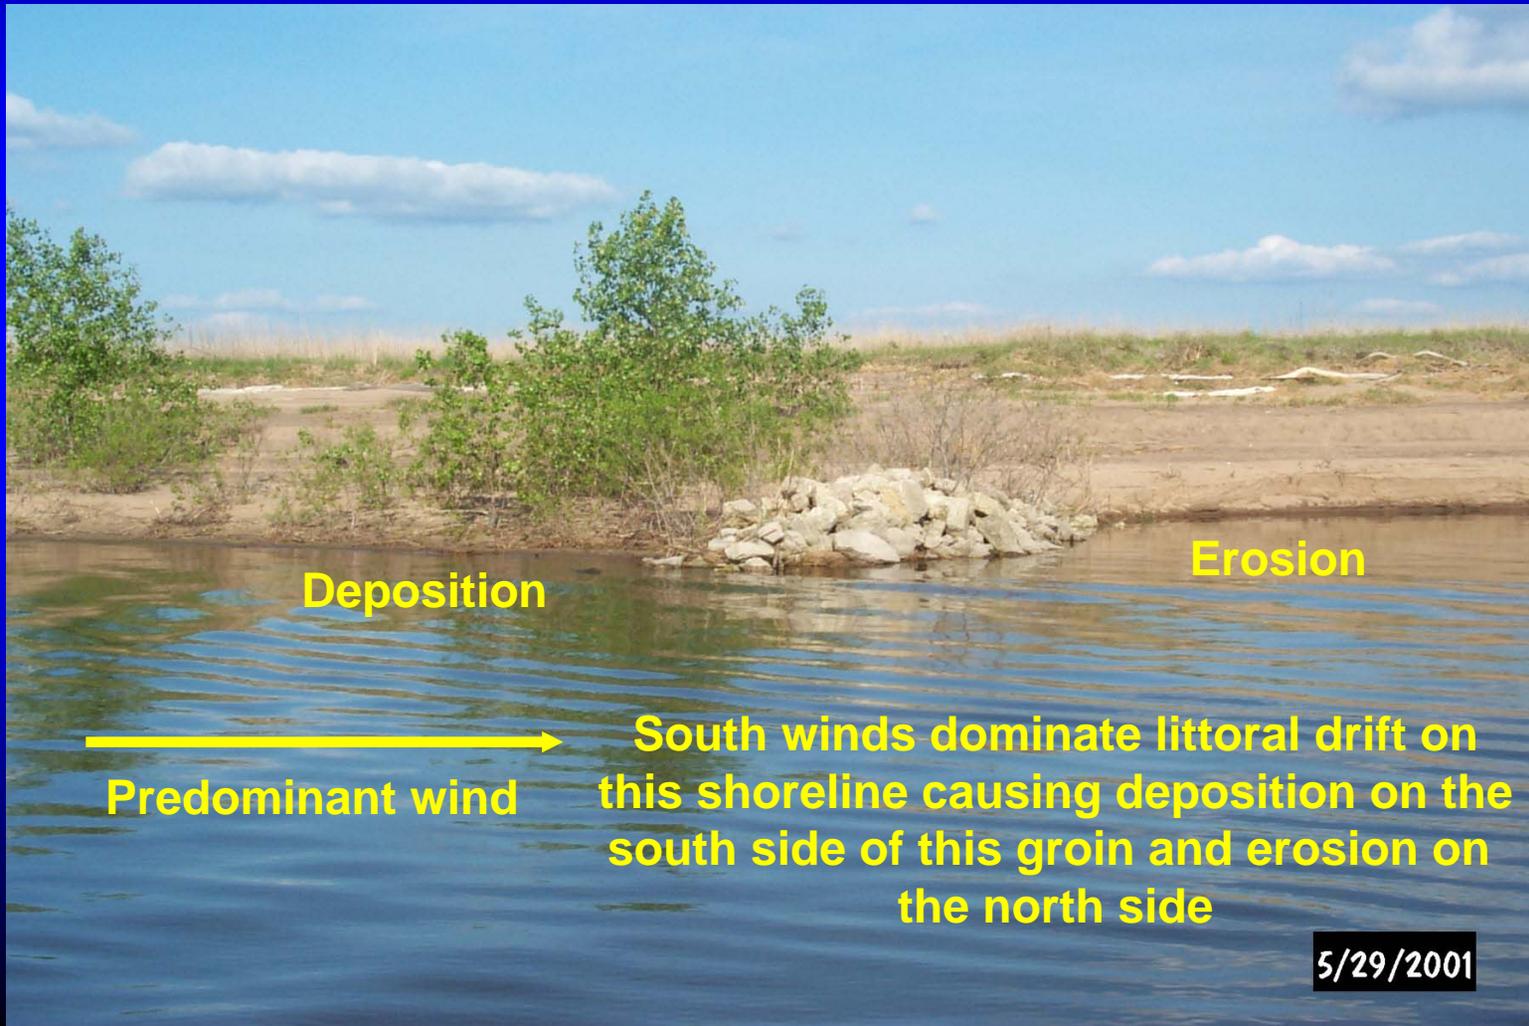
Photo A.7: Weaver Bottoms Swan Island Groin

South winds dominate littoral drift on this shoreline causing deposition on the south side of this groin and erosion on the north side

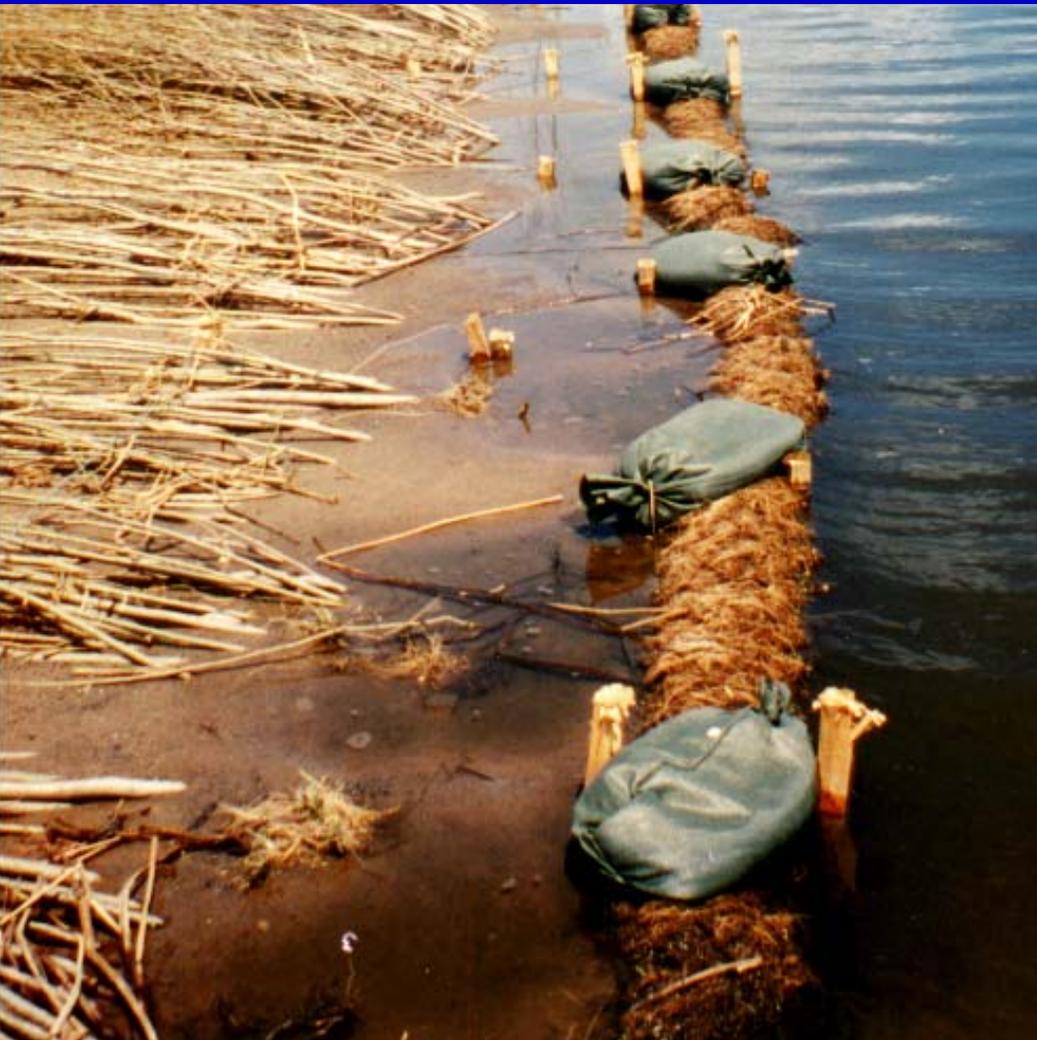
Photo A.8: Weaver Bottoms Swan Island biotechnical stabilization

Wooden stakes with wire strung between them were initially used to anchor the fiber rolls, however wave action soon loosened many of the stakes. The USFWS came up with a simple and effective way to hold the fiber rolls down.
Sandbags.

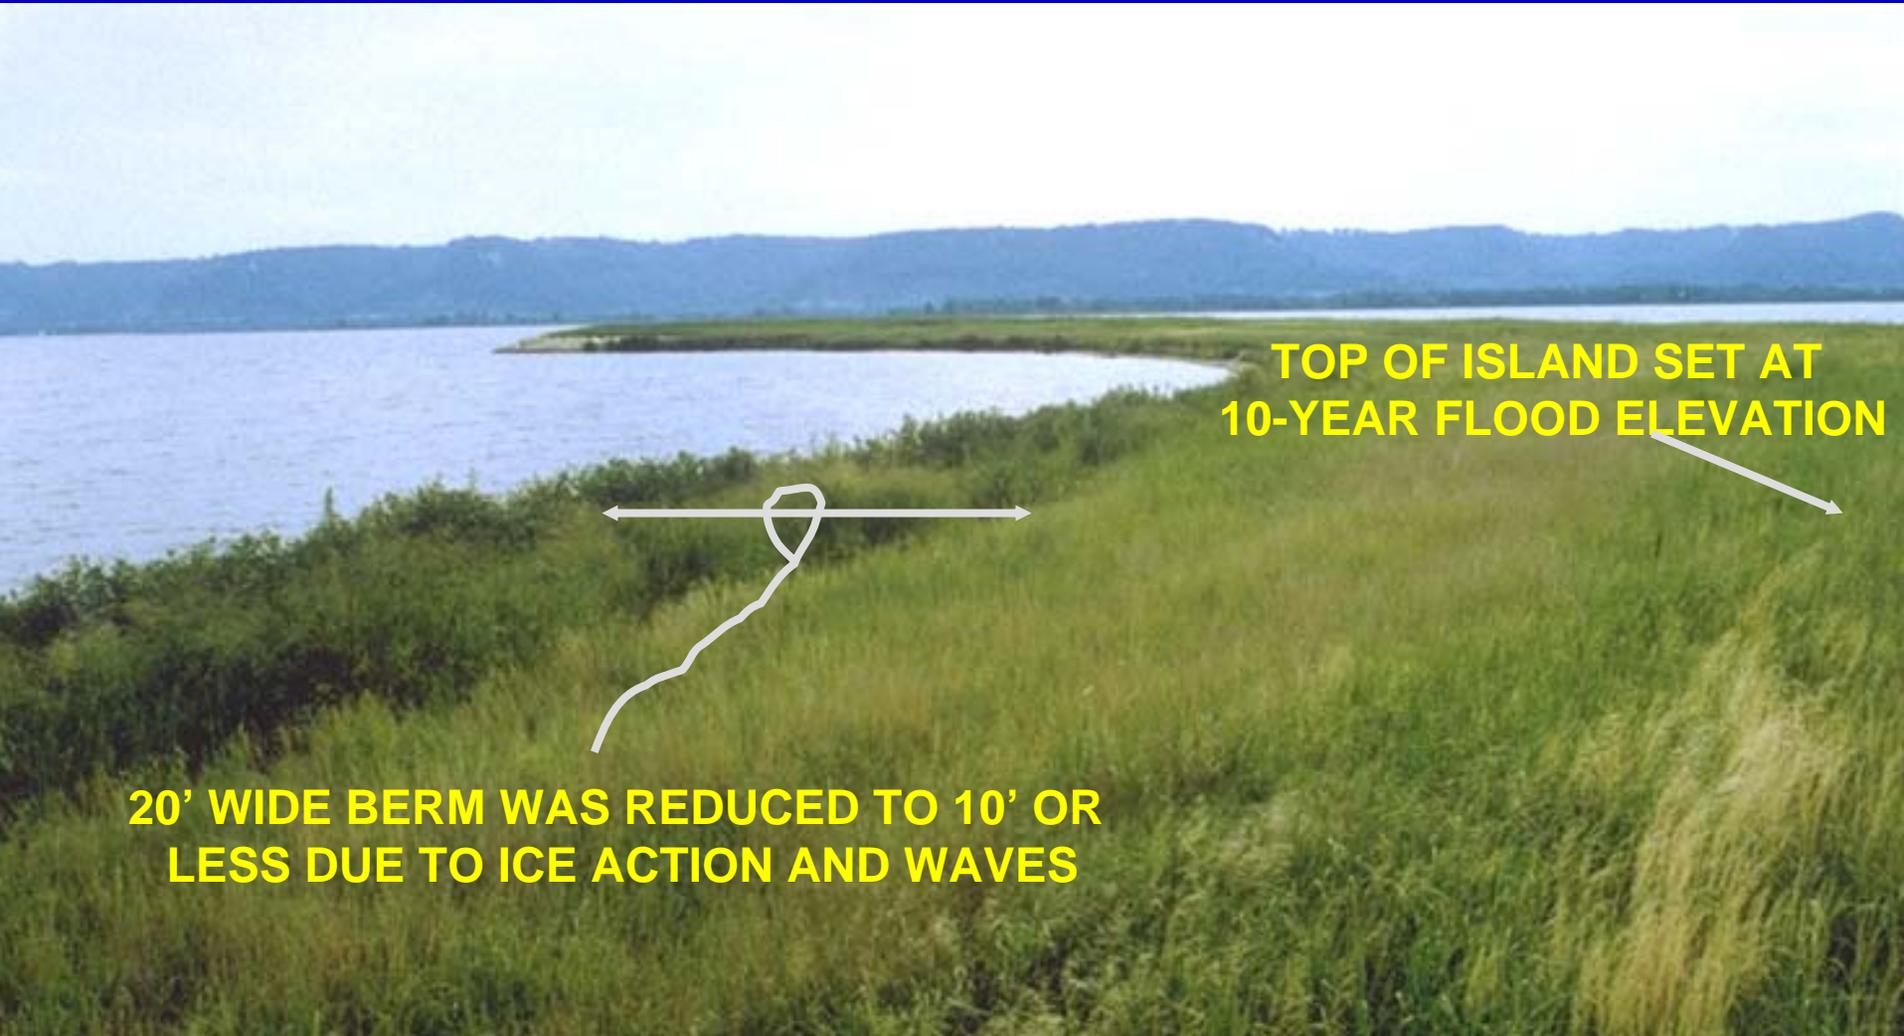
Photo B.4: Lake Onalaska Broken Gun Island 1989

TOP OF ISLAND SET AT
10-YEAR FLOOD ELEVATION

20' WIDE BERM WAS REDUCED TO 10' OR
LESS DUE TO ICE ACTION AND WAVES

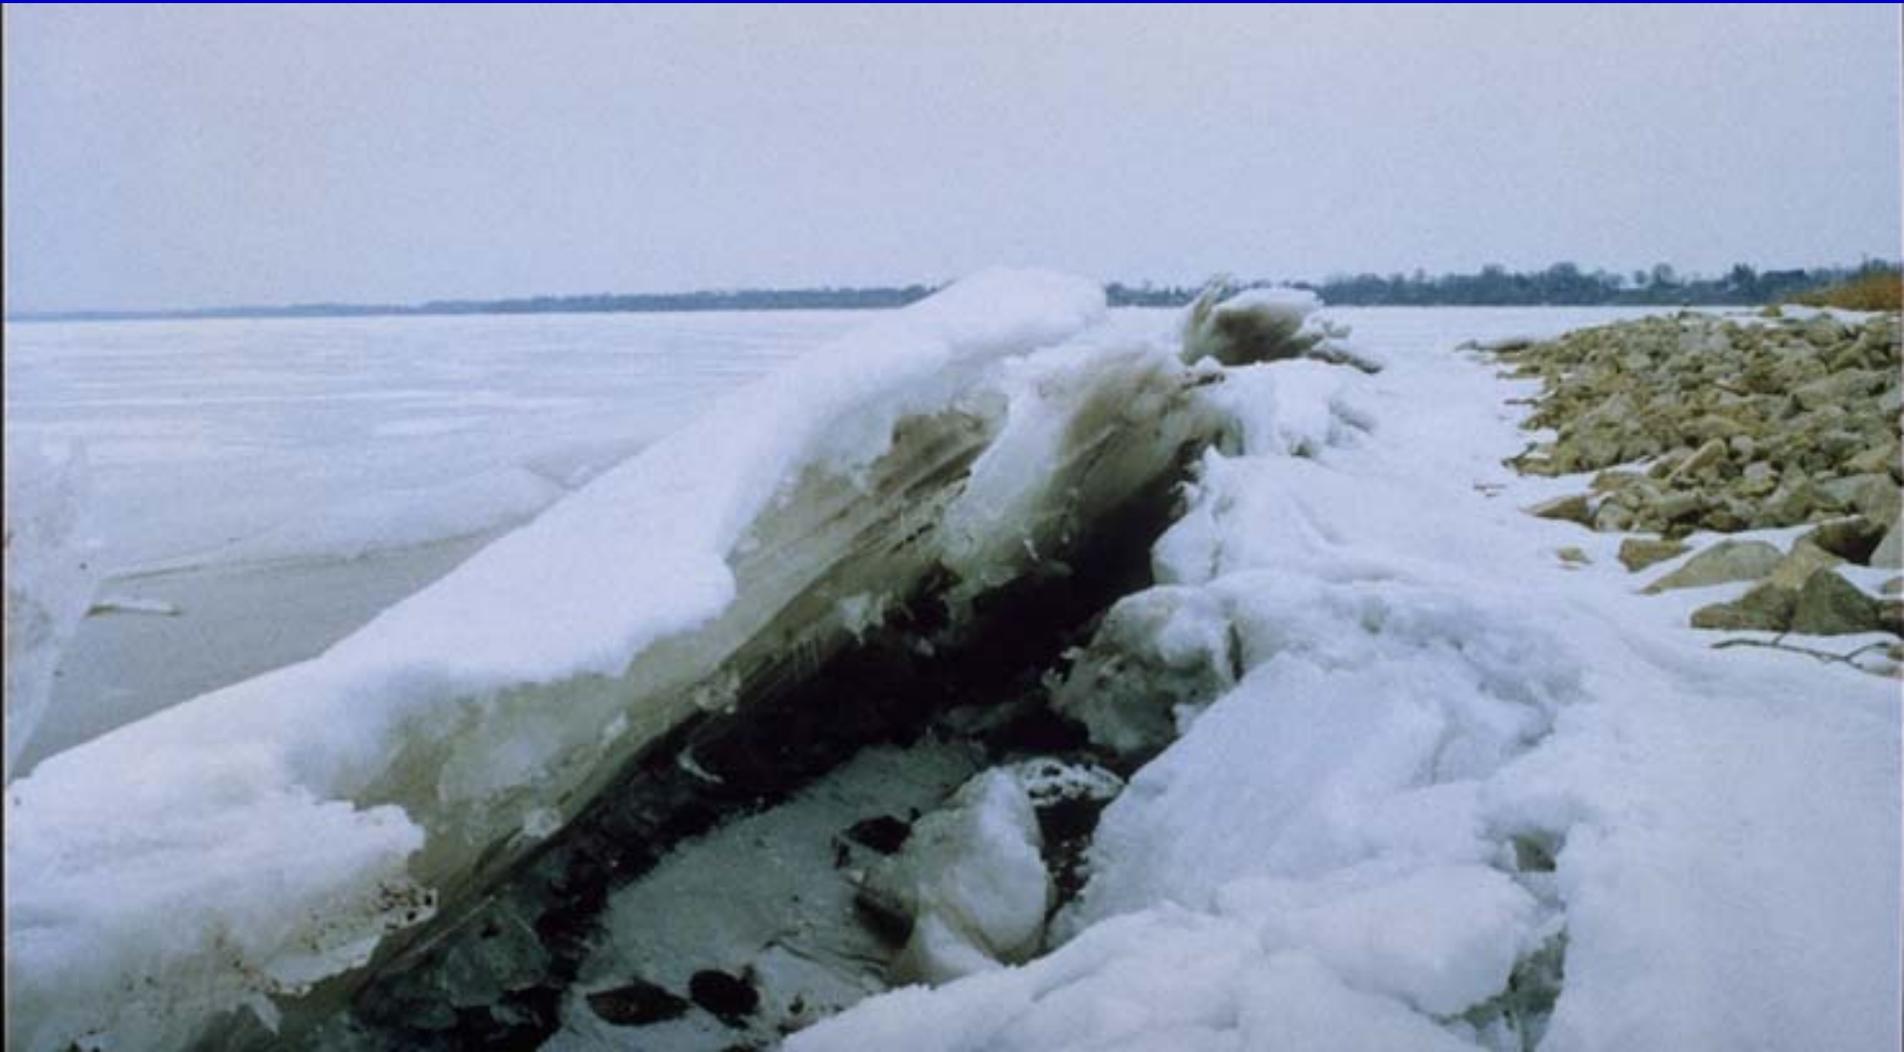
Photo B.6: Lake Onalaska Ice action at Broken Gun Island

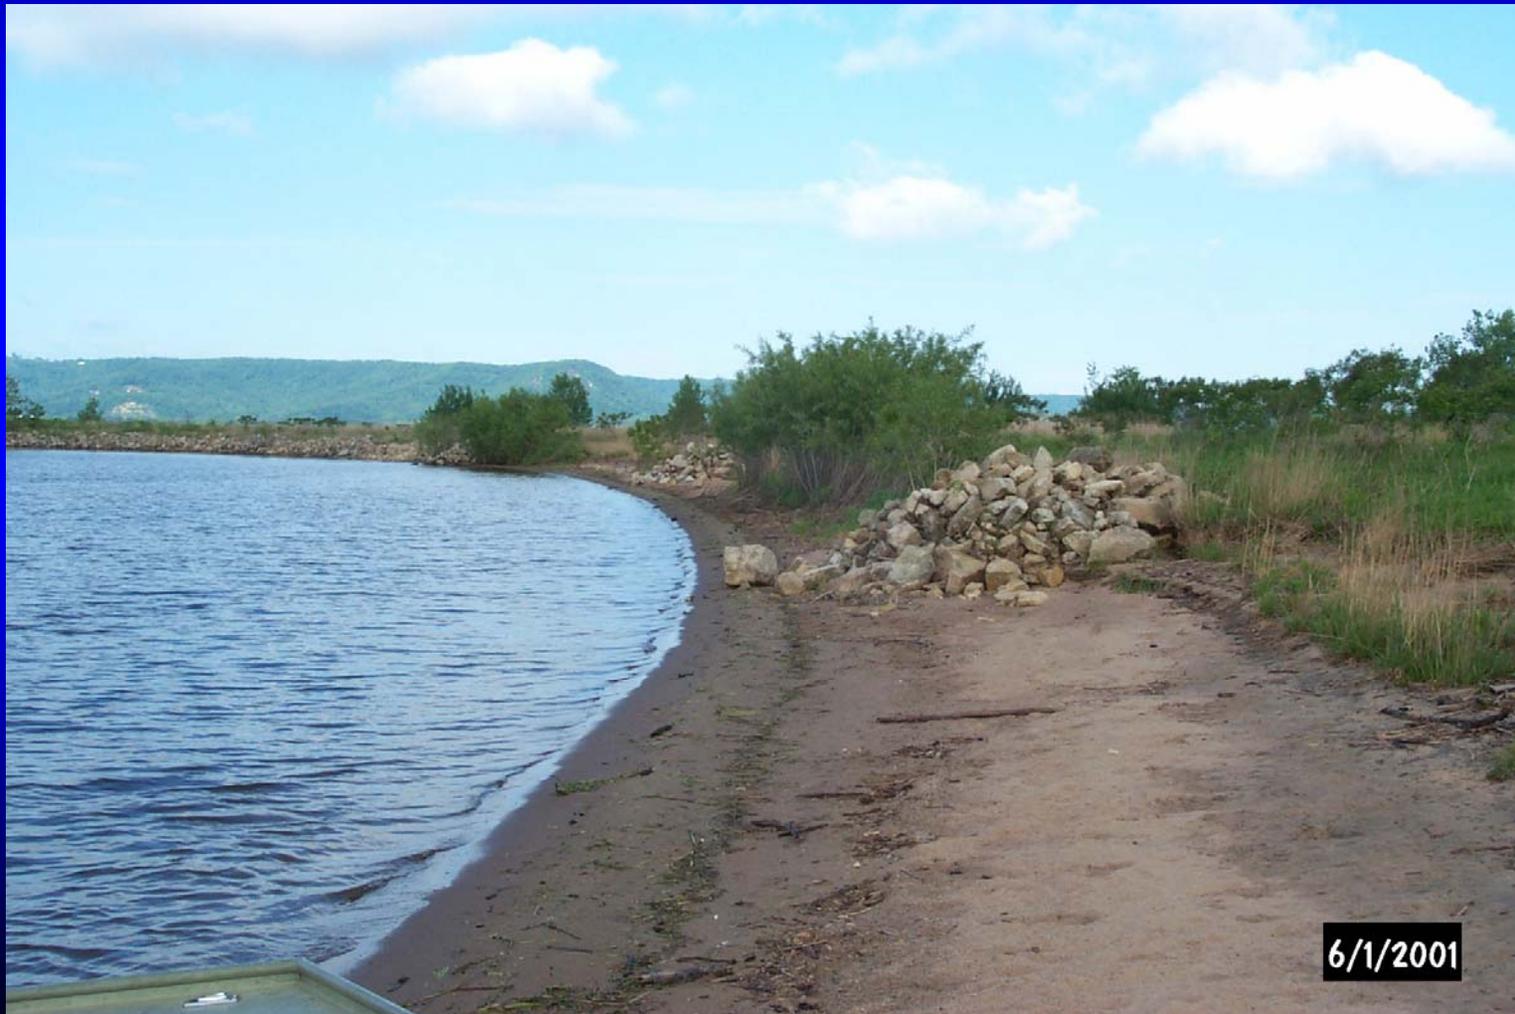
Photo B.7: Lake Onalaska Ice damaged groins

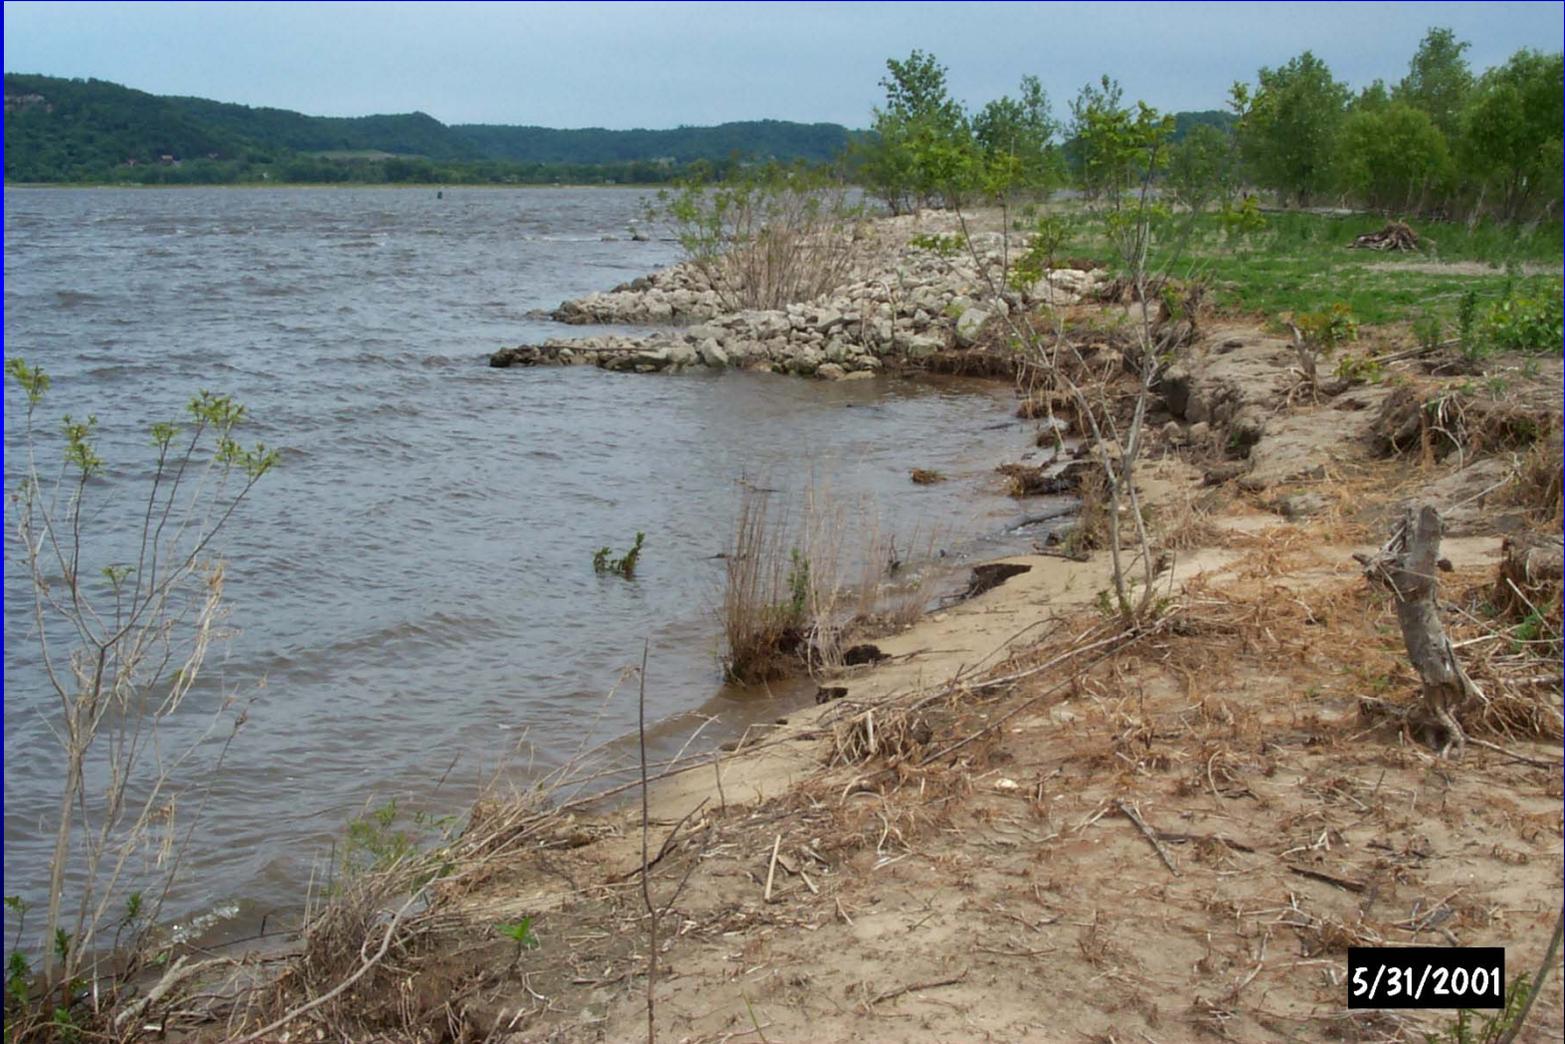
Photo D.7: Pool 8, Phase I, Stage II Erosion at Boomerang Corner

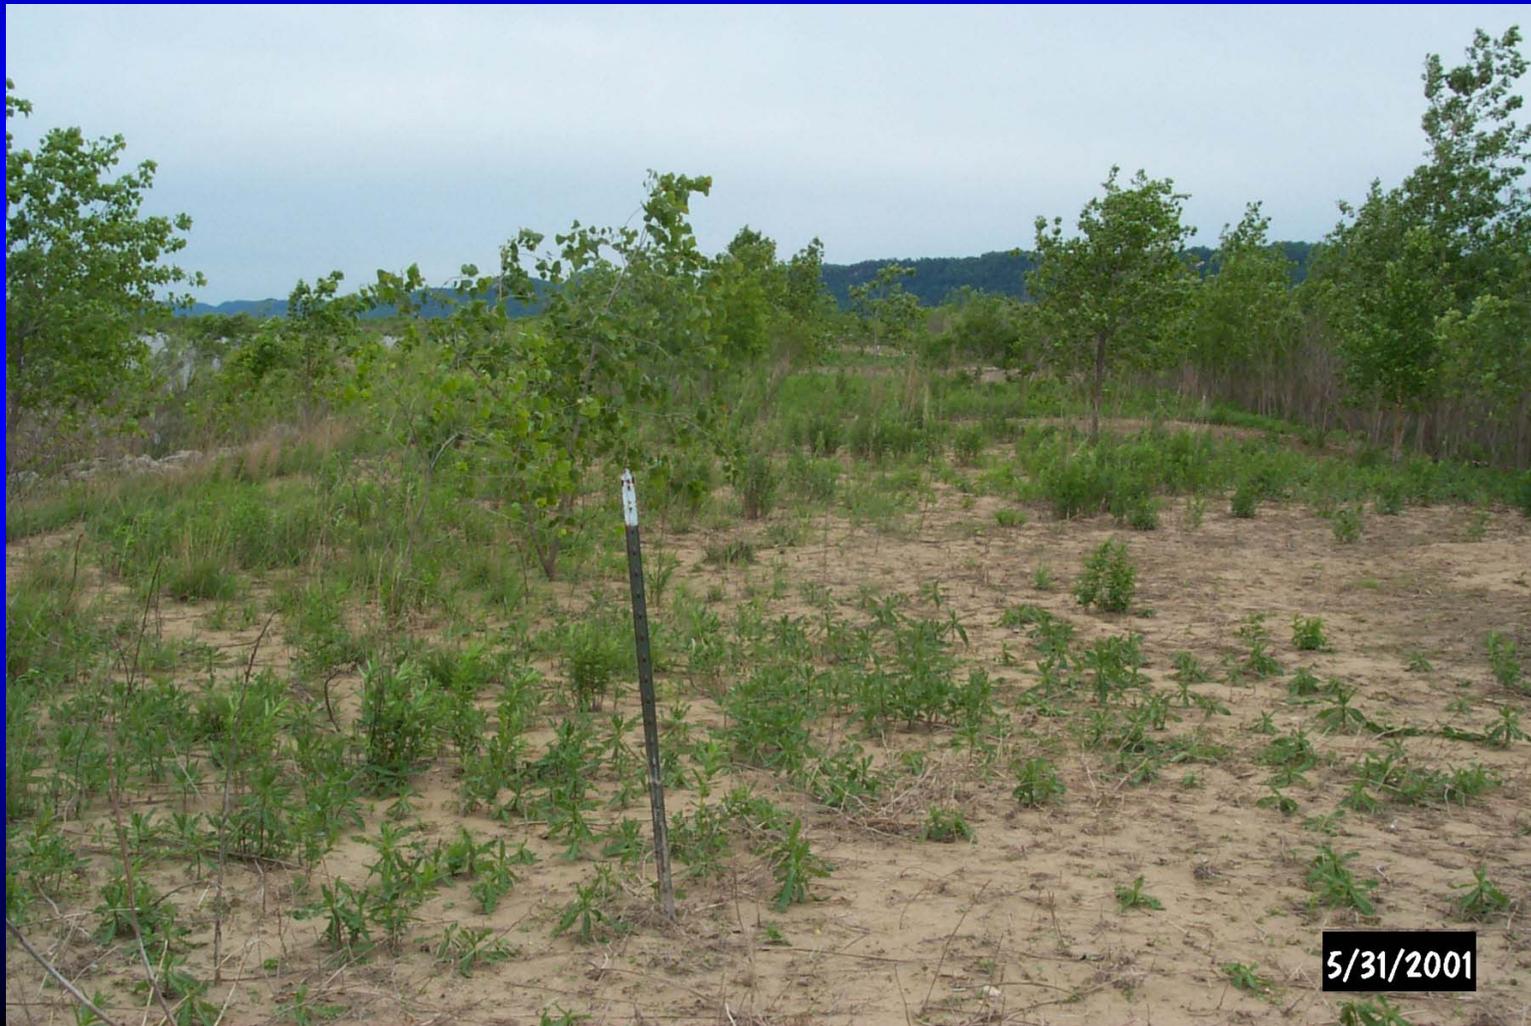
Photo D.8: Pool 8, Phase I, Stage II Sparse ground cover after 2001 flood Boomerang Corner

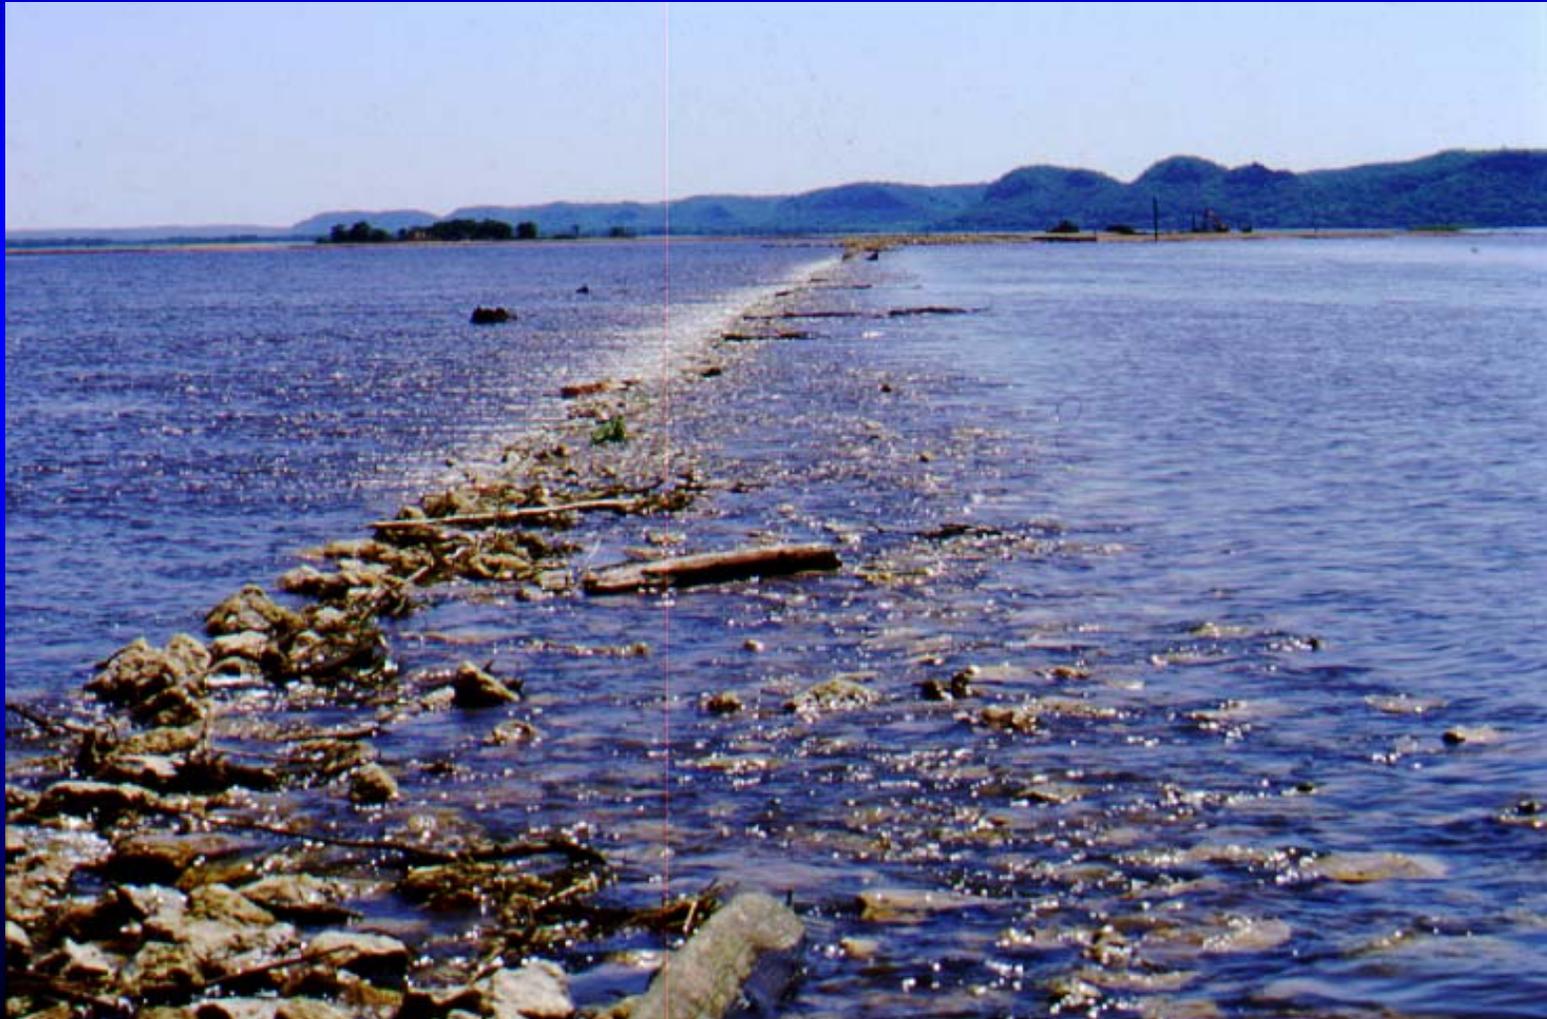
Photo H.6: Rock Sill B overtopped

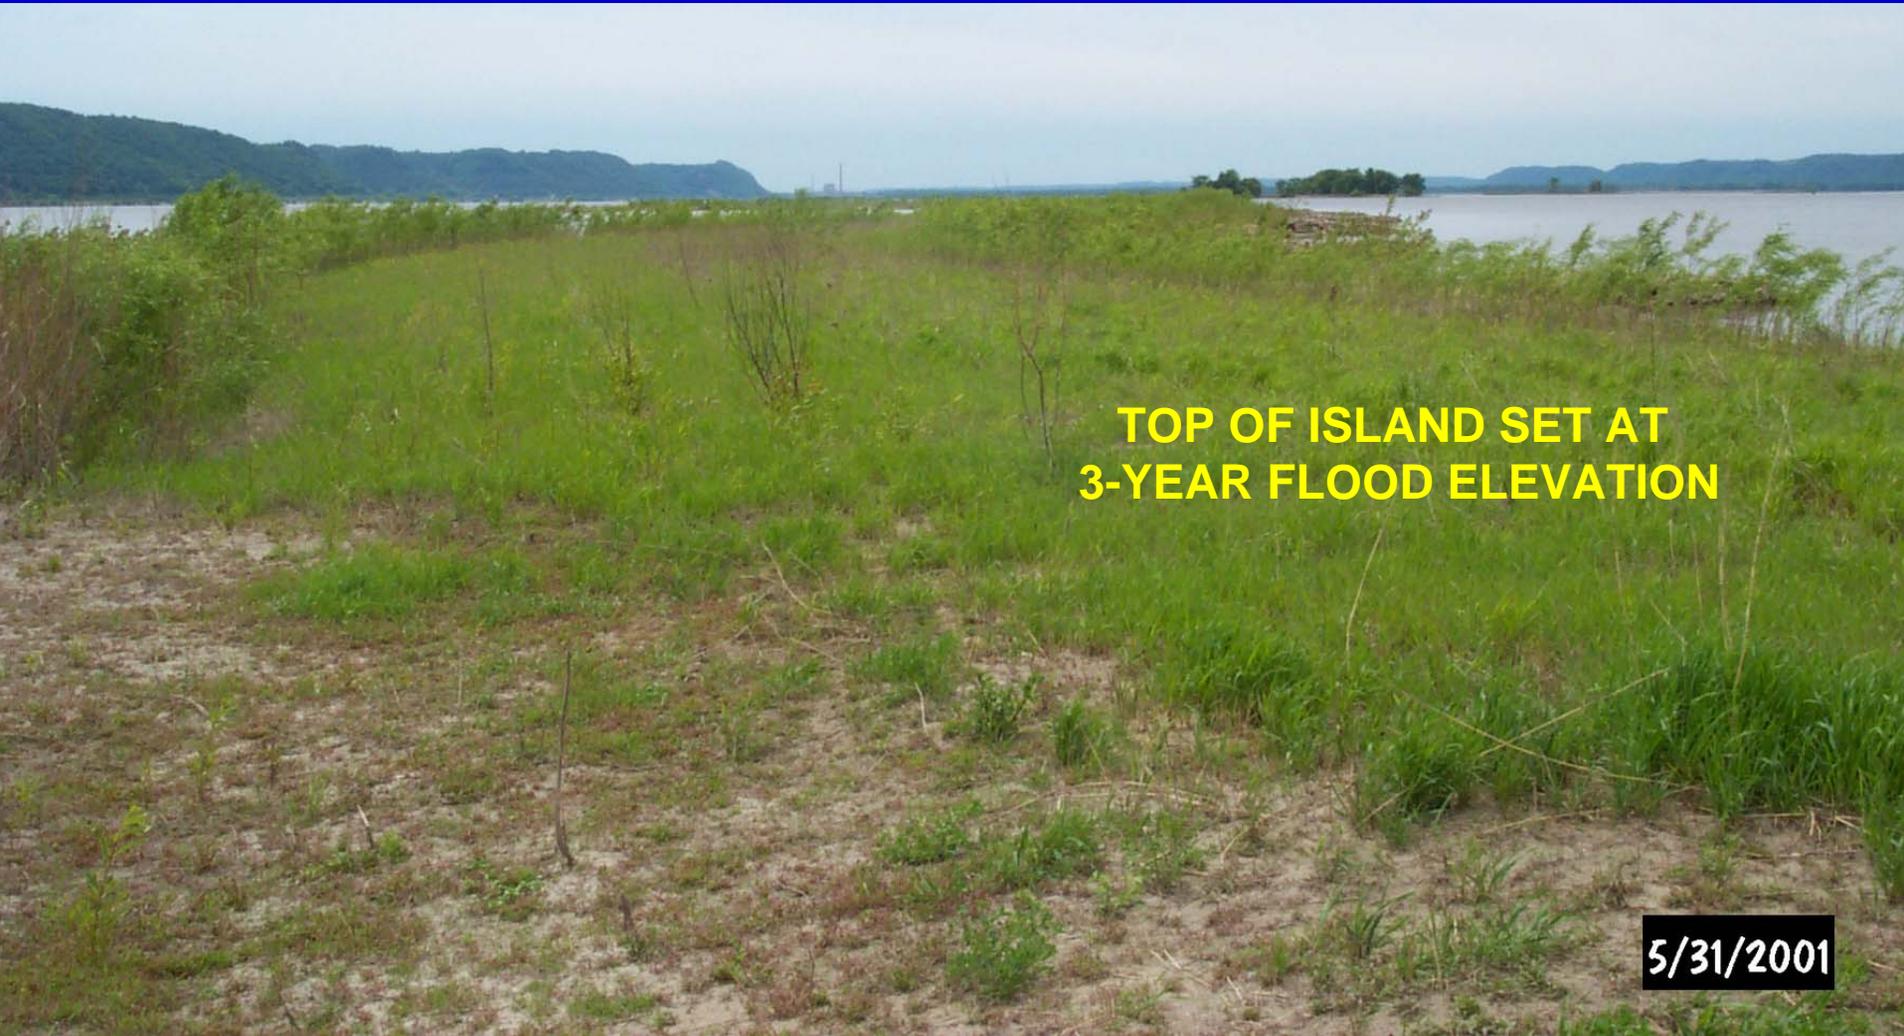
Photo H.9: Slingshot Island stable after 2001 flood

**TOP OF ISLAND SET AT
3-YEAR FLOOD ELEVATION**

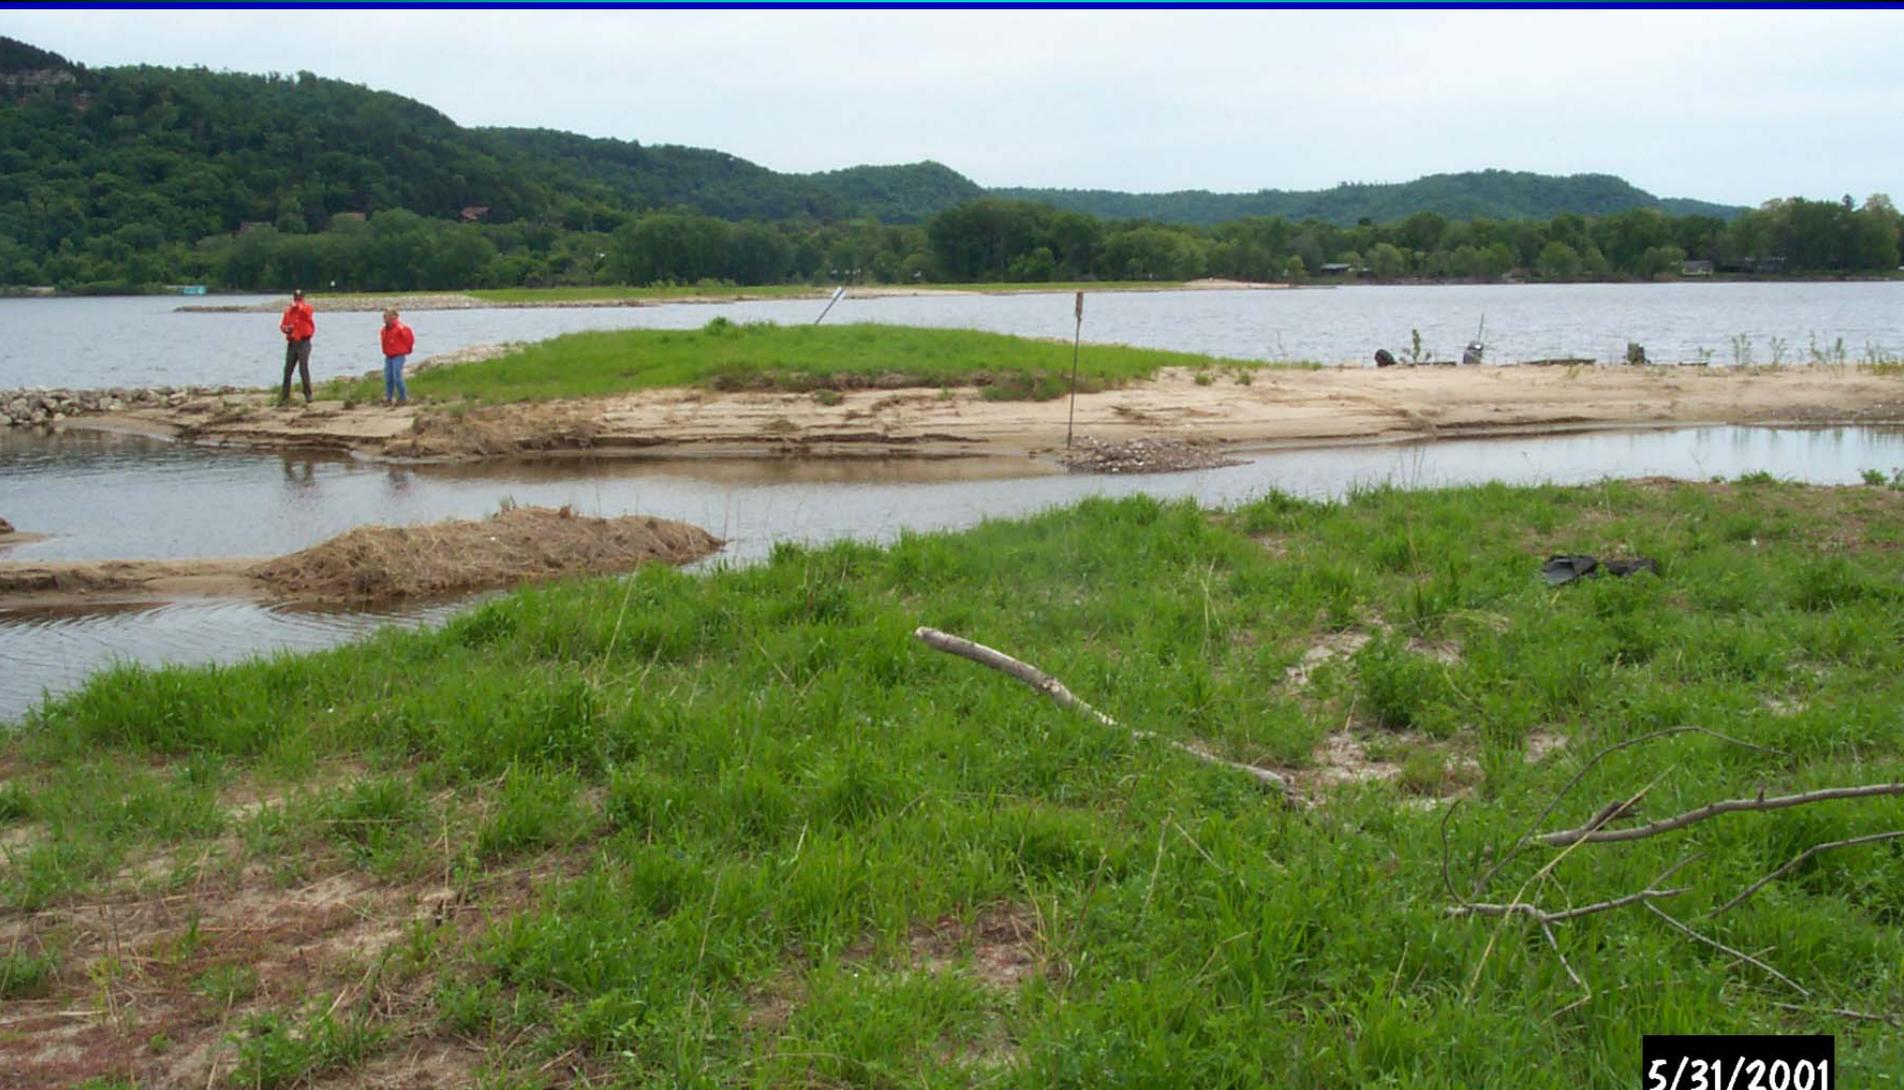
Photo H.10: Erosion of turtle nesting mound on Slingshot Island occurred during the 2001 flood

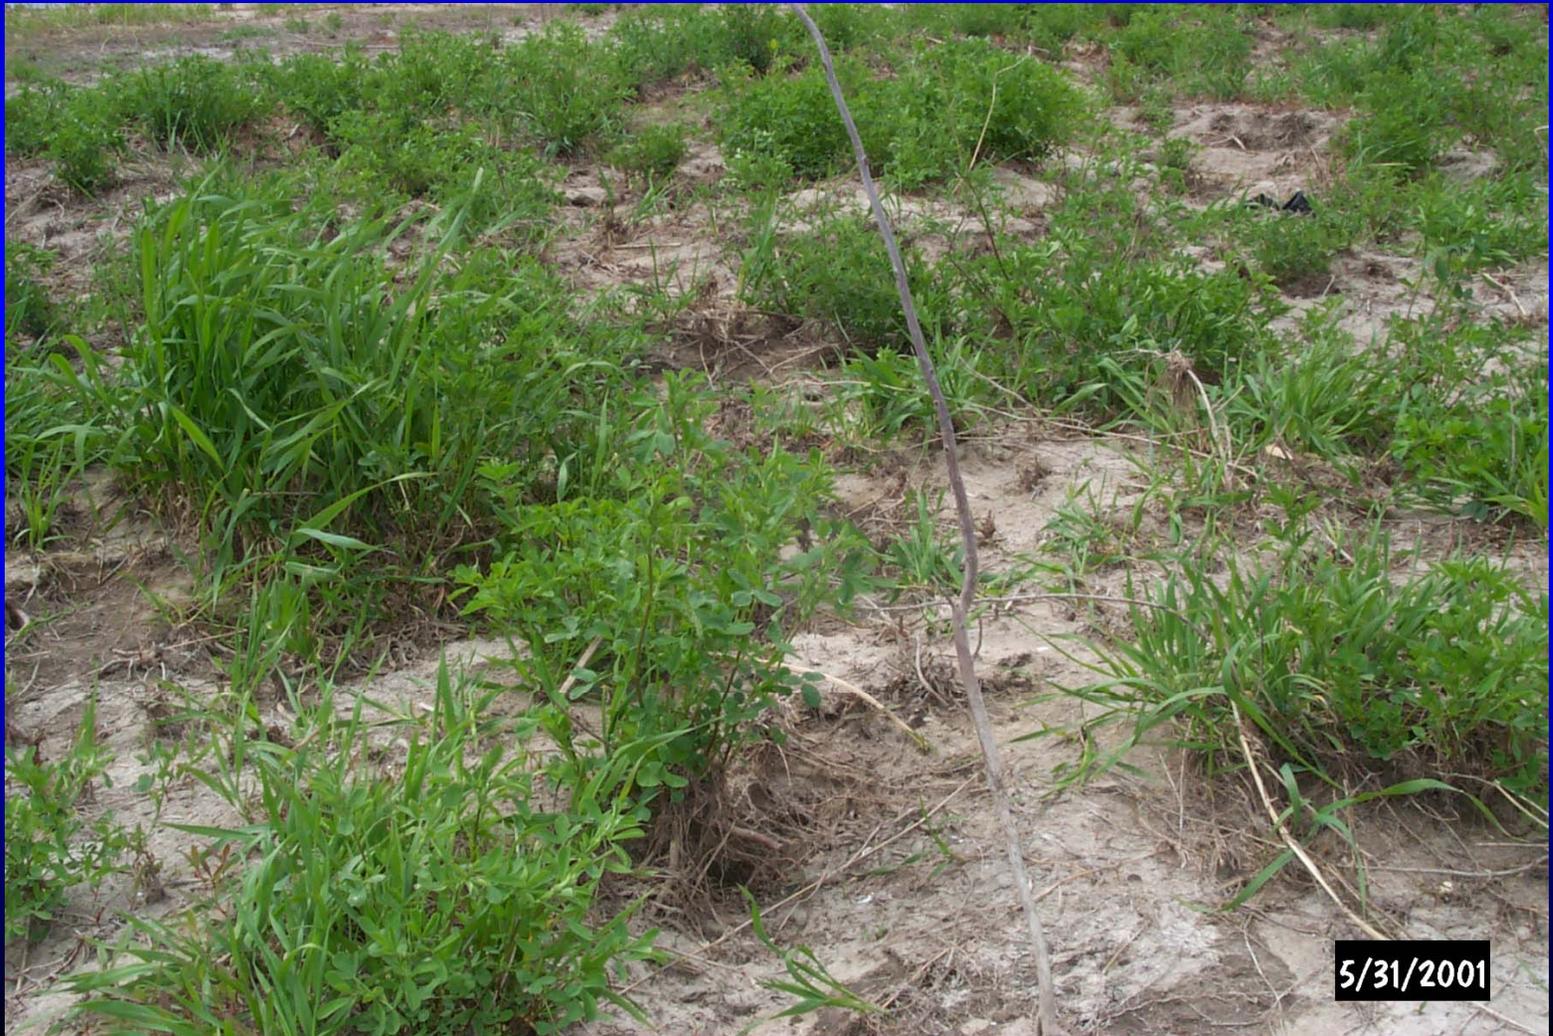
Photo H.12: Topsoil Erosion, Slingshot Island

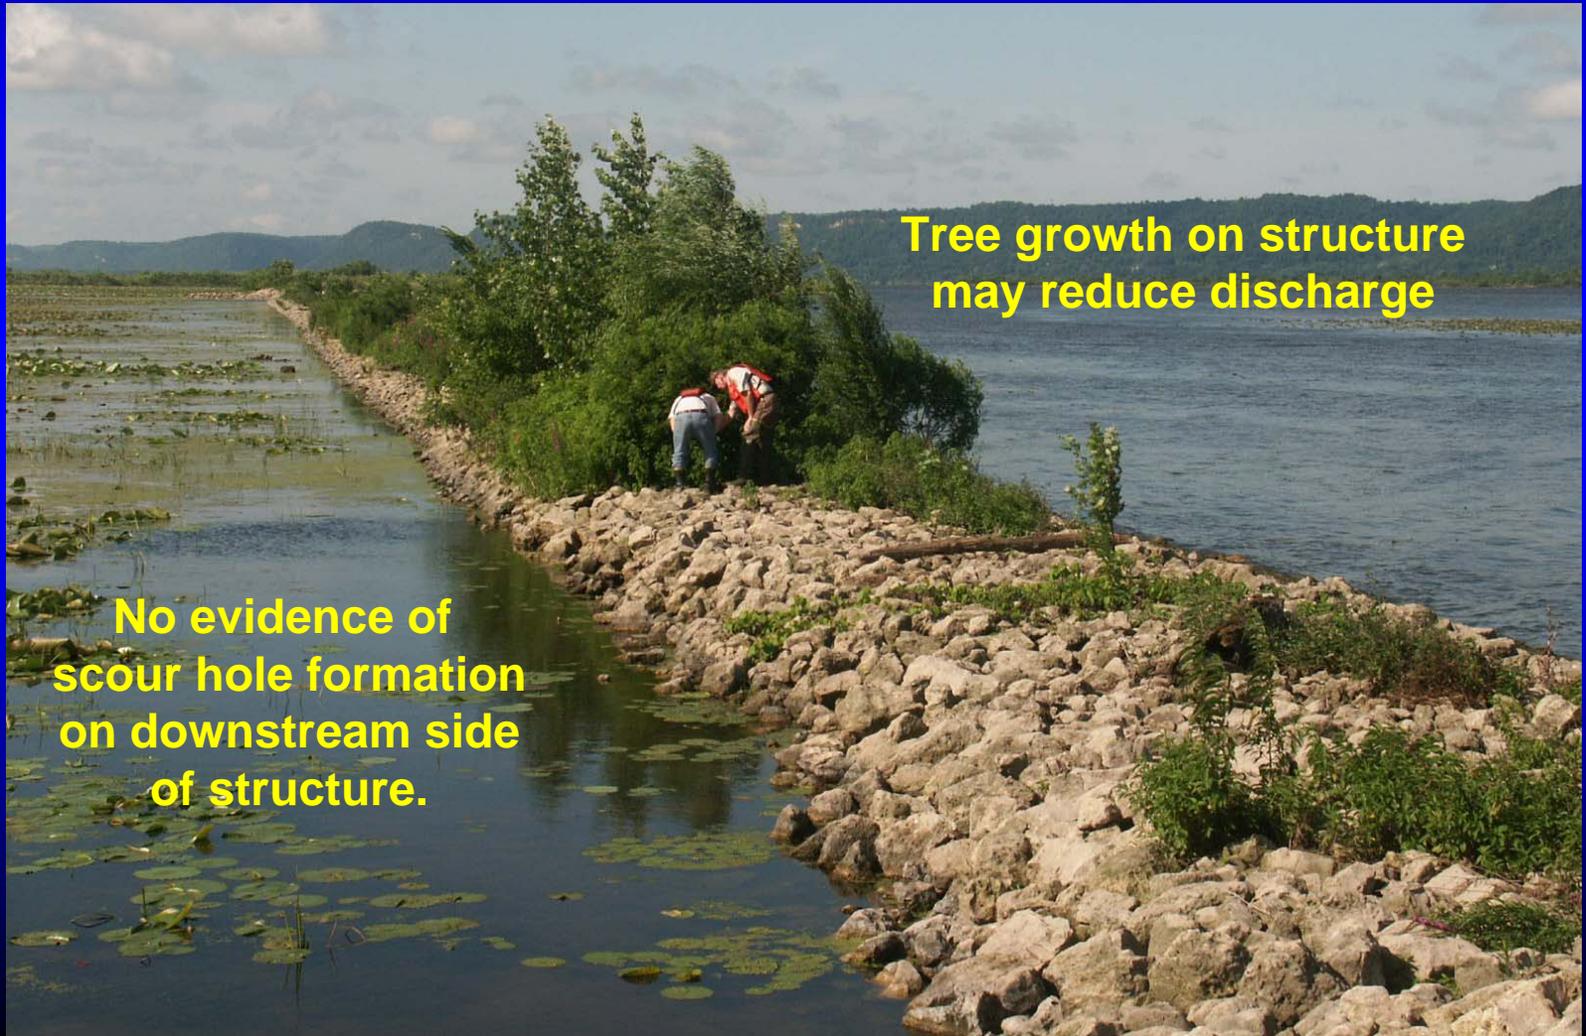
Photo H.15: Rock Sill B

Tree growth on structure
may reduce discharge

No evidence of
scour hole formation
on downstream side
of structure.

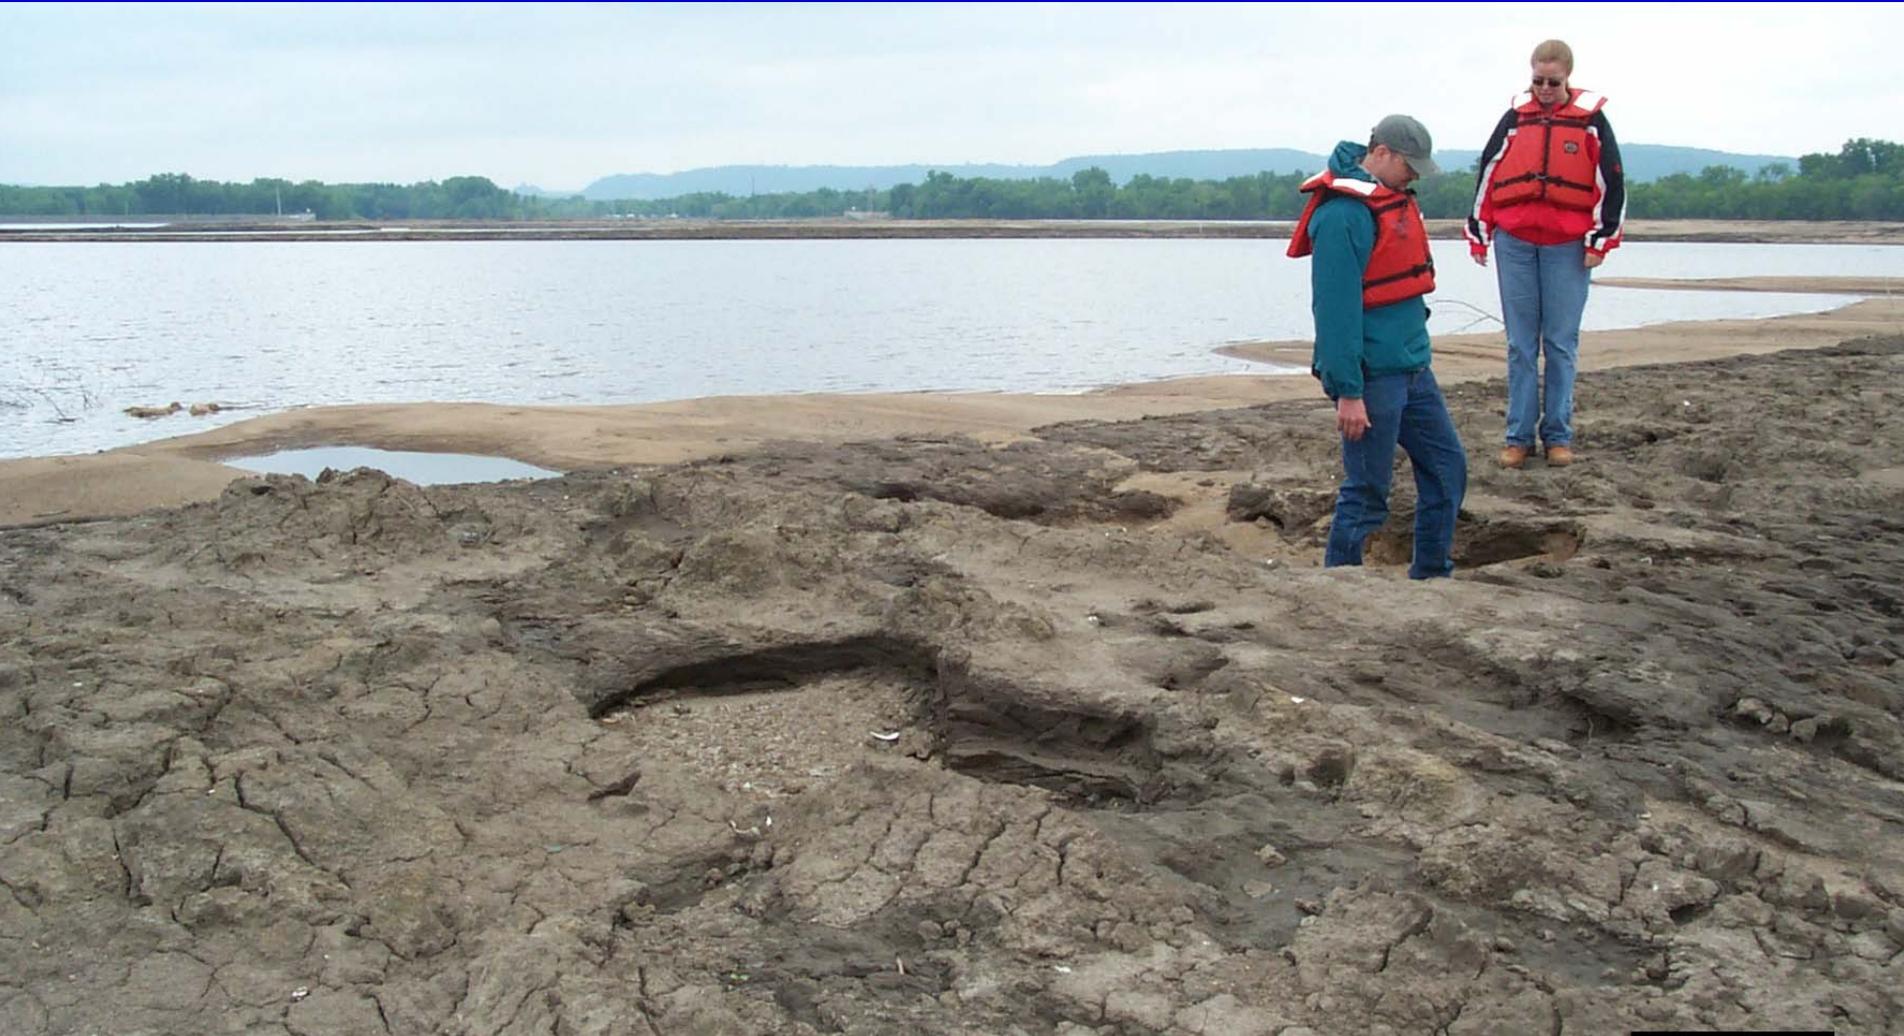
Photo I.4: Erosion of top of island due to 2001 flood
