US Army Corps
of Engineers
St. Paul District

Photo A.1: Weaver Bottoms Constructed 1986 Swan & Mallard Island, Whitewater River

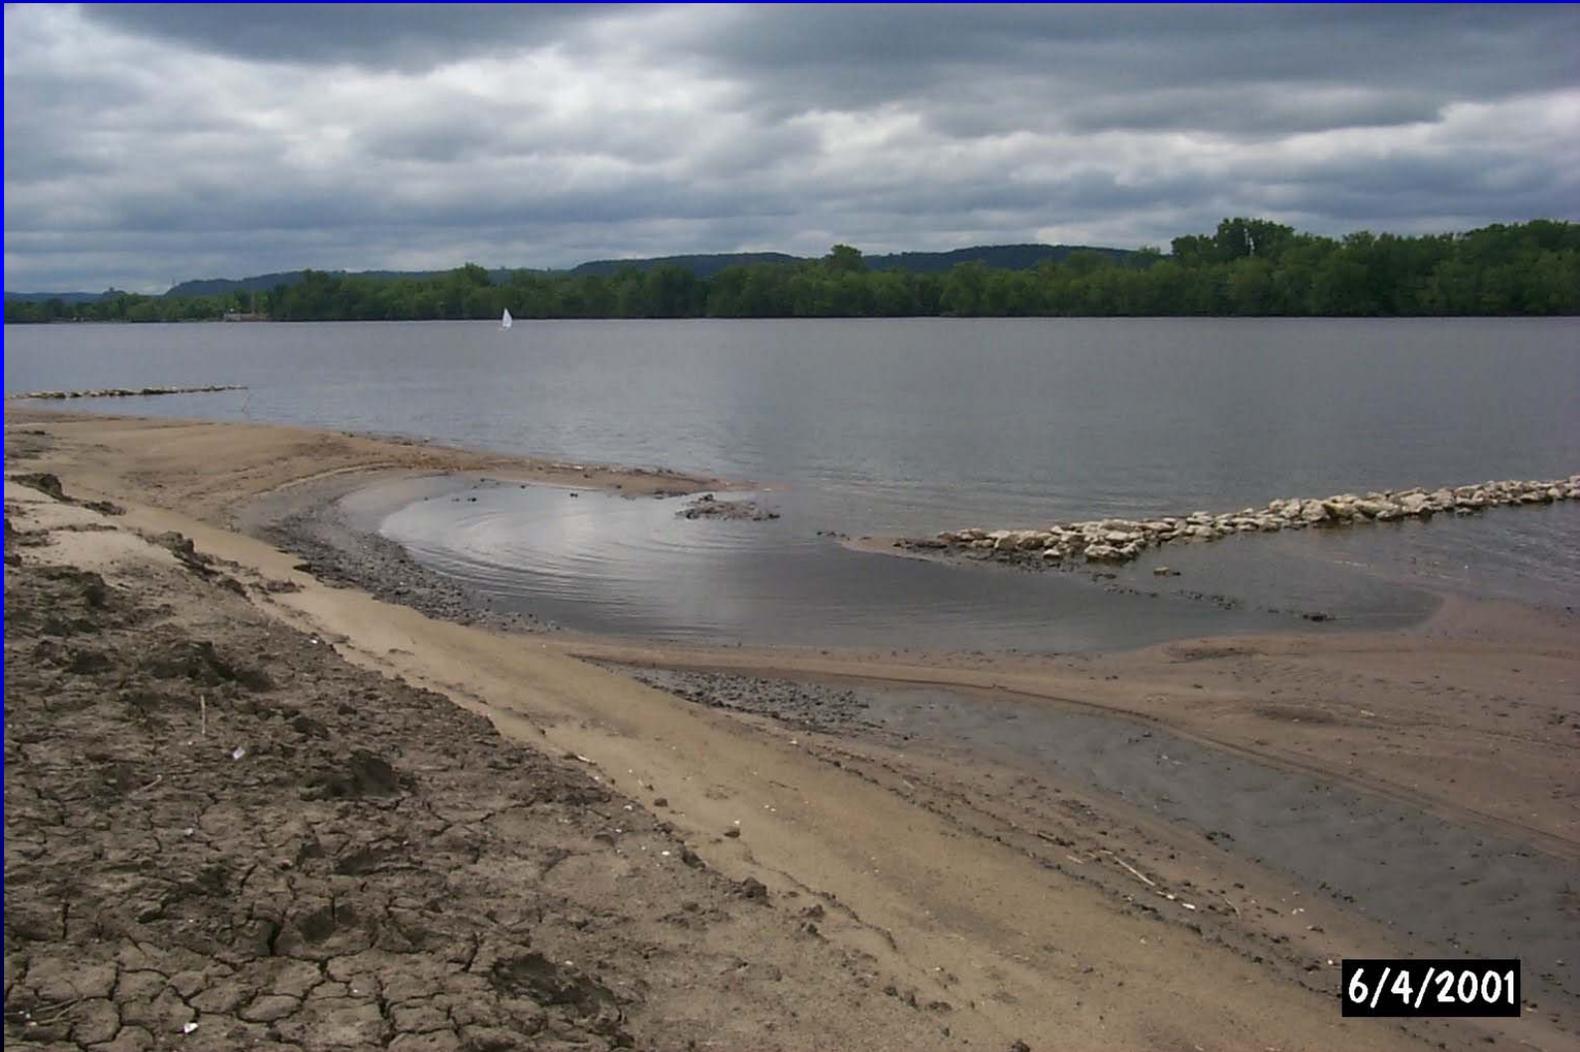
Photo I.5: Scalloping around groin occurred during the 2001 flood

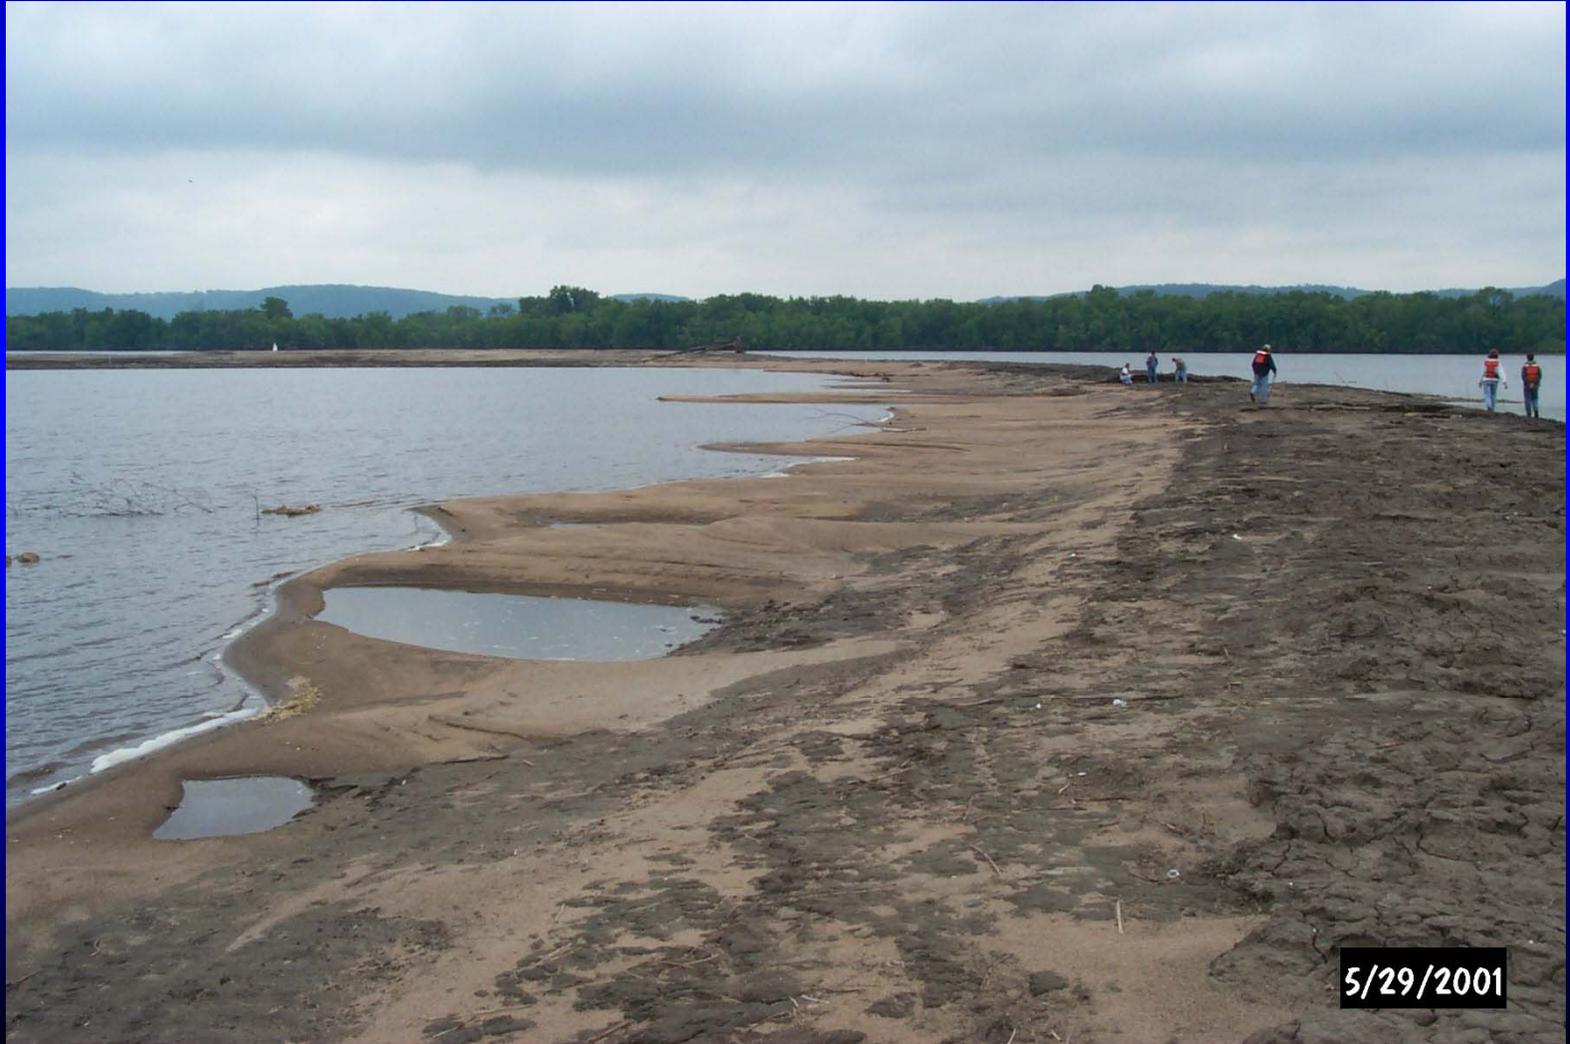
Photo I.6: Erosion of sand and fines occurred during the 2001 flood

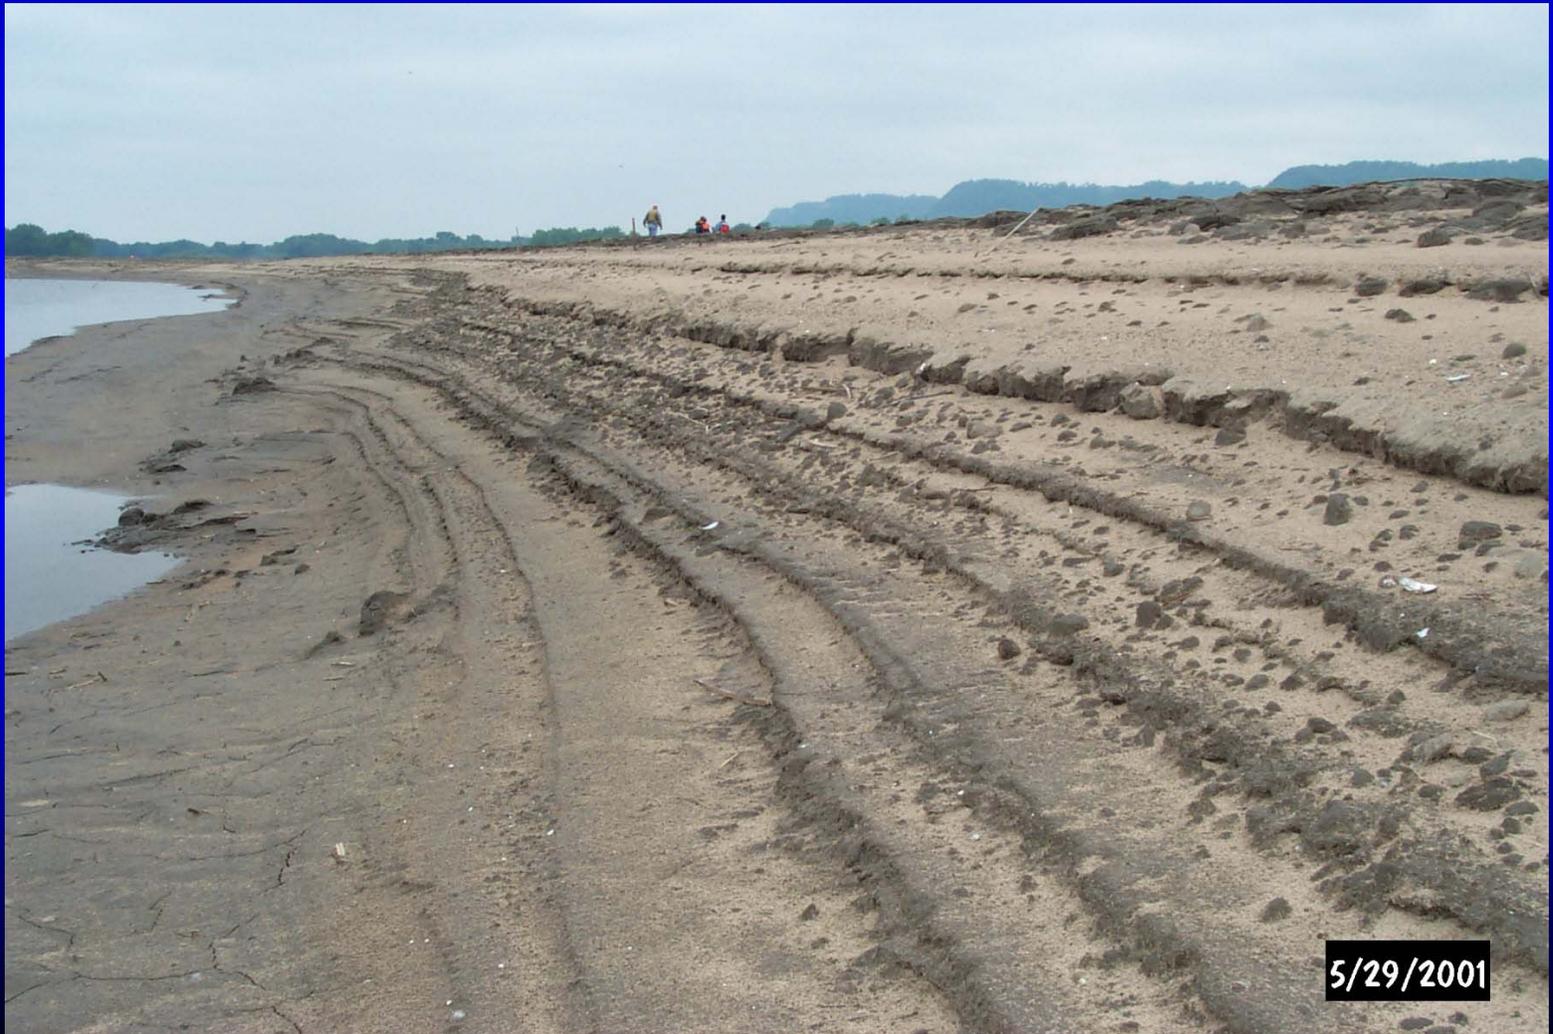
Photo I.7: Benching due to wave action during the 2001 flood

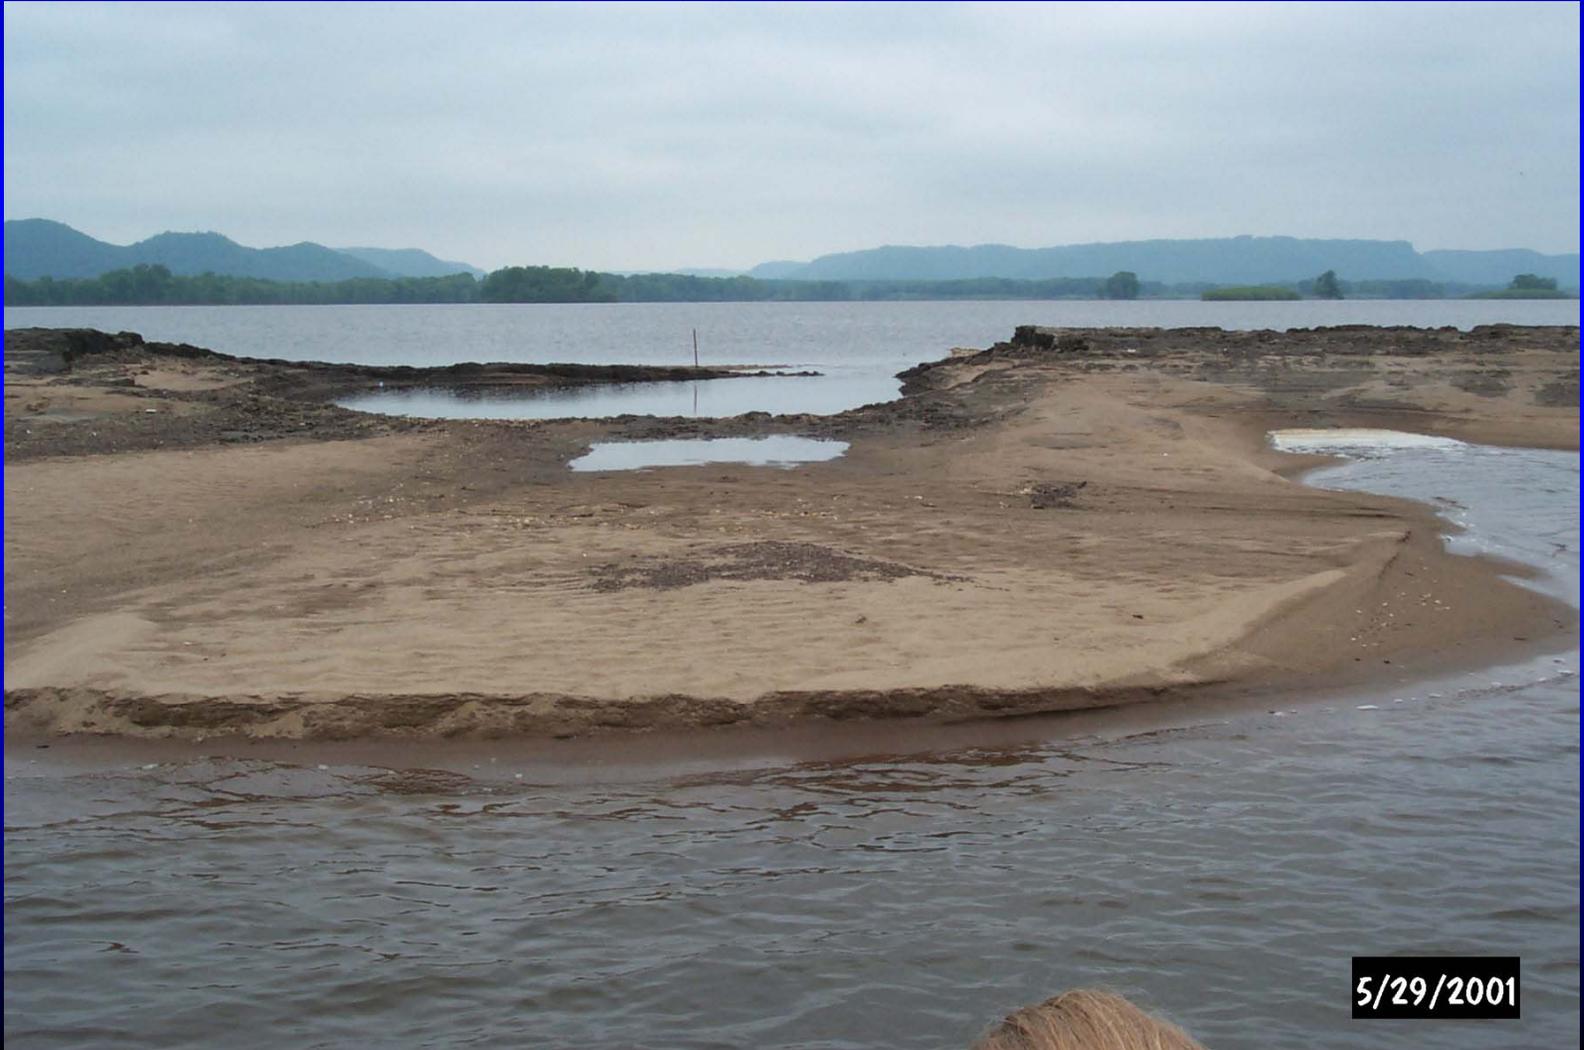
Photo I.8: A breach formed due to overtopping during the 2001 flood.
