**UPPER MISSISSIPPI RIVER SYSTEM
ENVIRONMENTAL MANAGEMENT PROGRAM
POST-CONSTRUCTION PERFORMANCE EVALUATION REPORT (PER4F)**

ANDALUSIA REFUGE REHABILITATION AND ENHANCEMENT

**POOL 16, MISSISSIPPI RIVER MILES 462-463
ROCK ISLAND COUNTY, ILLINOIS**

AUGUST 1997

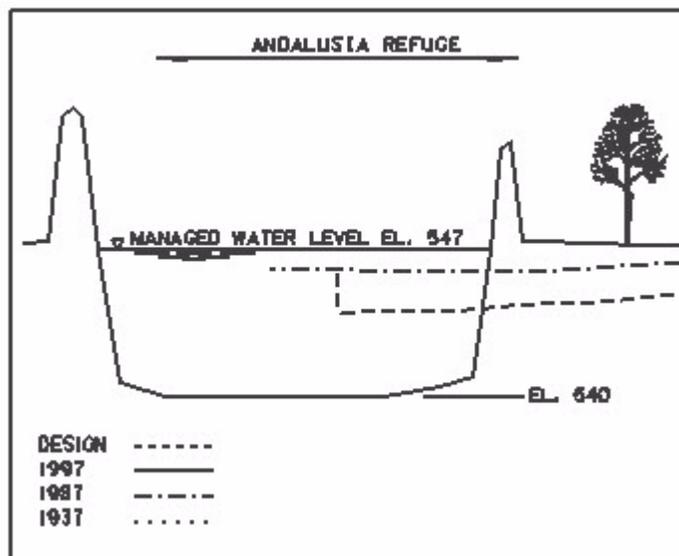
Transects within the MSMU were surveyed in January 1997 with the MSMU at increased water levels in order to determine the reliable resting and feeding water area. As illustrated in Figure 5-3 below, the tree symbol indicates the tree line, which will be used to monitor vegetative encroachment.

FIGURE 5-3. Typical transect in refuge area with water surface at December-April management level.

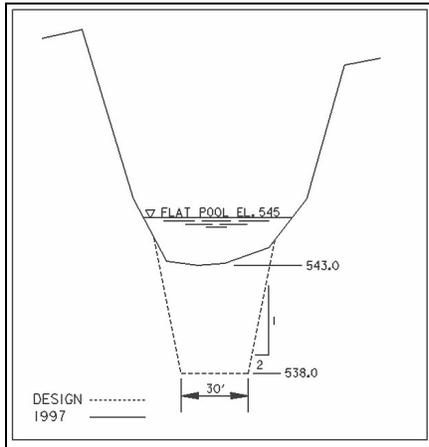
(1) Monitoring Results. As shown above and in Appendix A, Table A-1, the year 50 target with alternative is restoration of 180 square feet of lentic-lotic habitat access. In January 1997, the average cross-sectional area of the lentic-lotic habitat access channel was approximately 178 SF. The 1993 Flood Damage Assessment Report noted the lentic-lotic access channel had silted in considerably, from initial elevations of 536 -541 to 544 in some places. The channel was re-excavated to elevation 538 in March 1994 by Corps labor forces. As shown below in Figures 6-4 and 6-5 and on plate 5, the channel elevation near the mouth of the lentic-lotic access channel was approximately 2 feet below flat pool (elevation 545 feet MSL).

FIGURE 6-4. Transect D1
Near mouth of lentic-lotic access channel
Cross-sectional area = 104.8 SF
Depth = 2'

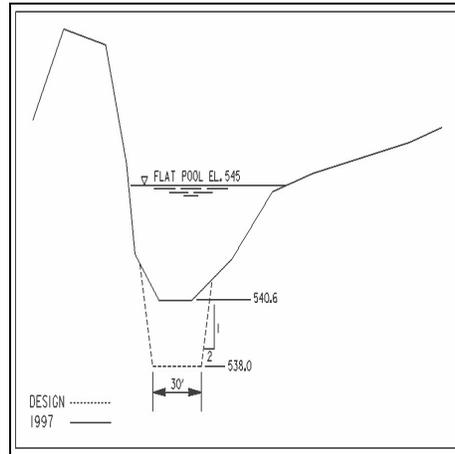
FIGURE 6-5. Transect D2
Upstream end lentic-lotic access channel
Cross-sectional area = 250.2 SF
Depth = 4.4'

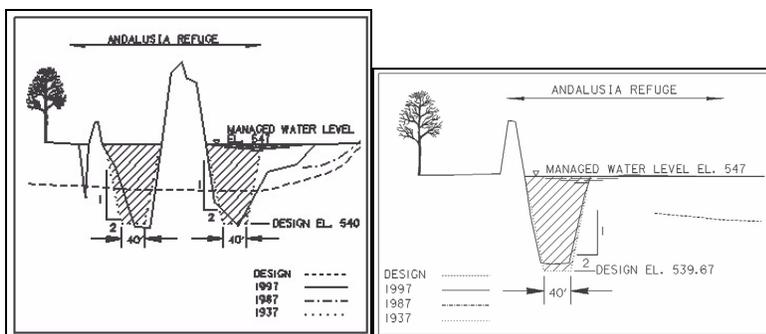
The sedimentation transects of the refuge area were obtained in January 1997. As shown below in Figures 6-6 through 6-8, sedimentation in the refuge area is noticeably less than Dead Slough or the lentic-lotic access channel.

FIGURE 6-6. Transect C.

FIGURE 6-7. Transect E.
