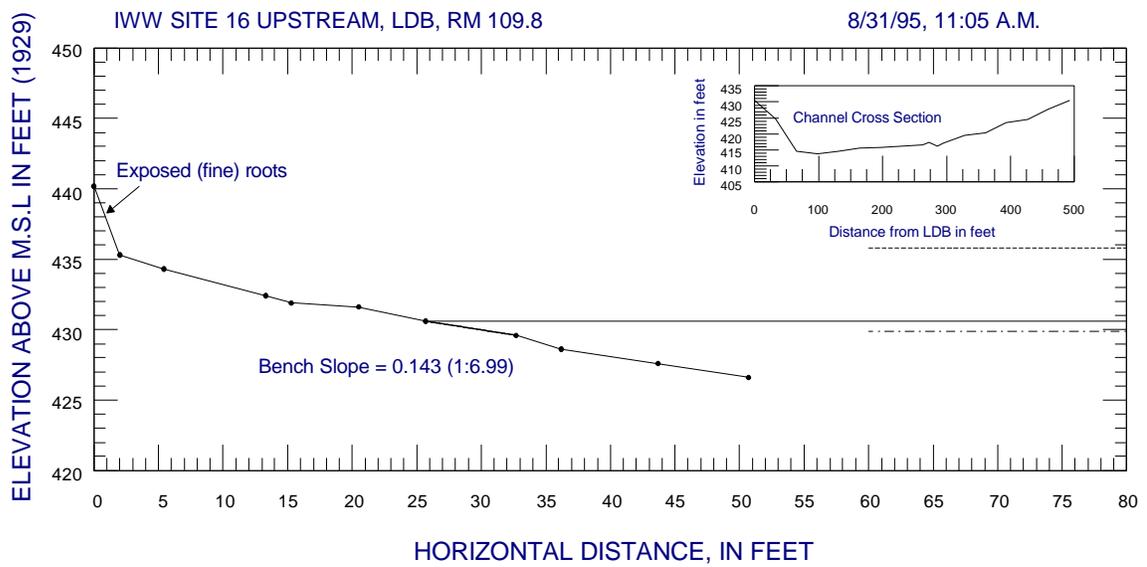
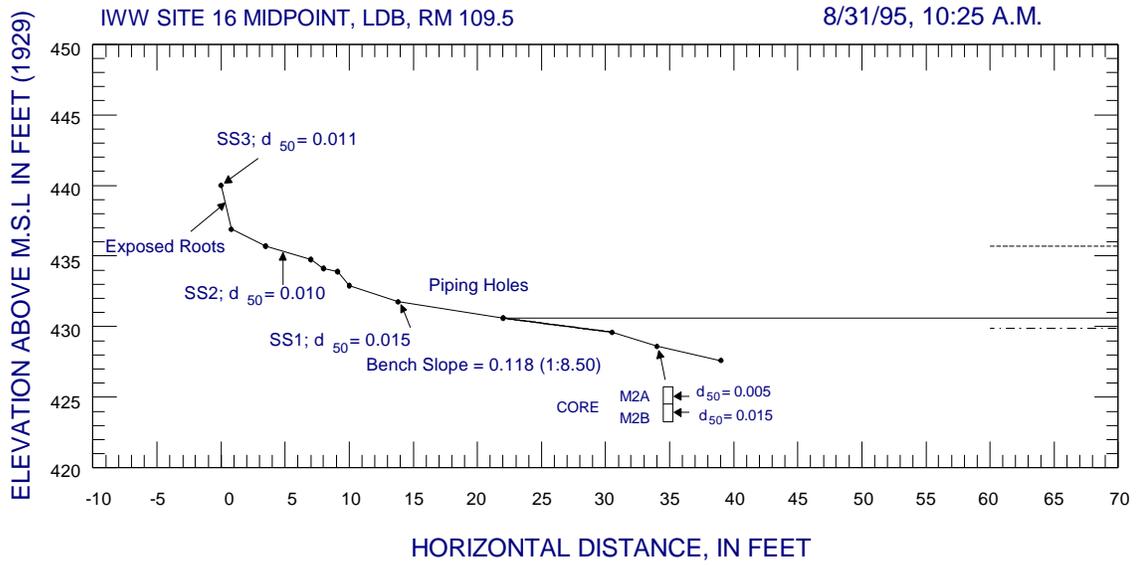
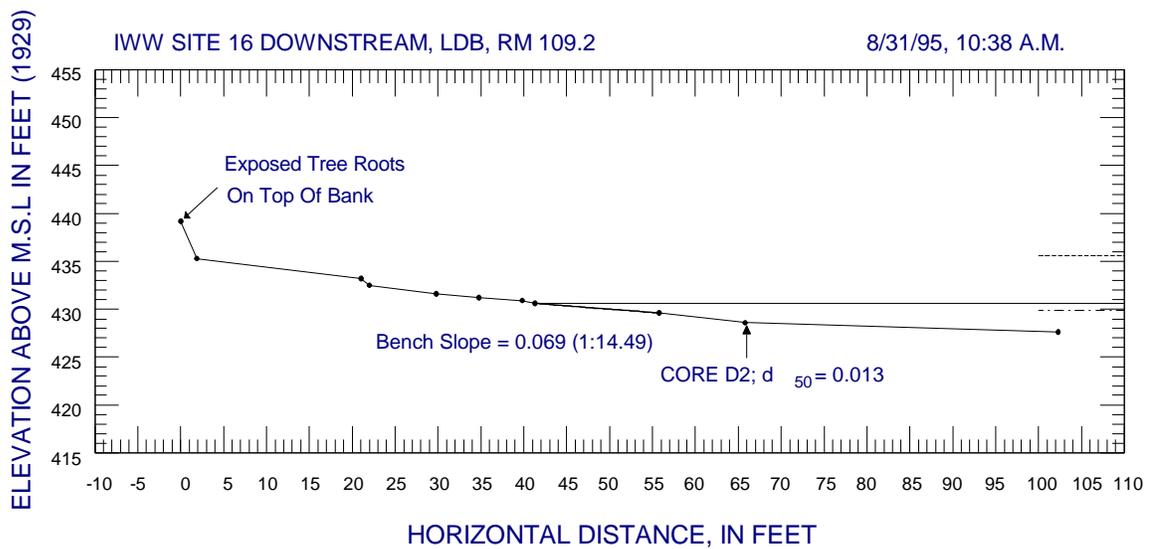
Figure 6-89. Bank sections at site 16

At the midsection, the d_{50} varied from 0.011 mm at the top surface of the bank to 0.005 mm at the upper portion of a core sample at a water depth of about 2 feet. The d_{50} of the lower portion of this core sample, 0.015 mm, is similar to that of other materials found on the bank. Gradation plots of bank soils and nearshore sediment are presented in appendix F. The detailed cross section and coordinates are shown in appendix G.

Bench slopes varied rapidly from 1V:7.0H at the upstream section to 1V:14.5H at the downstream section. The upstream section and midsections are classified as type 2, and the downstream section is classified as type 3 (figures 6-19, 6-20, and table 6-4). Rework and transport of bench materials occur at stages within the normal range of pool-level fluctuations. Erosion of in-place soils occurs at stage above OHW. Seepage and piping affect the extent of failure during recession periods when the river stages can drain.

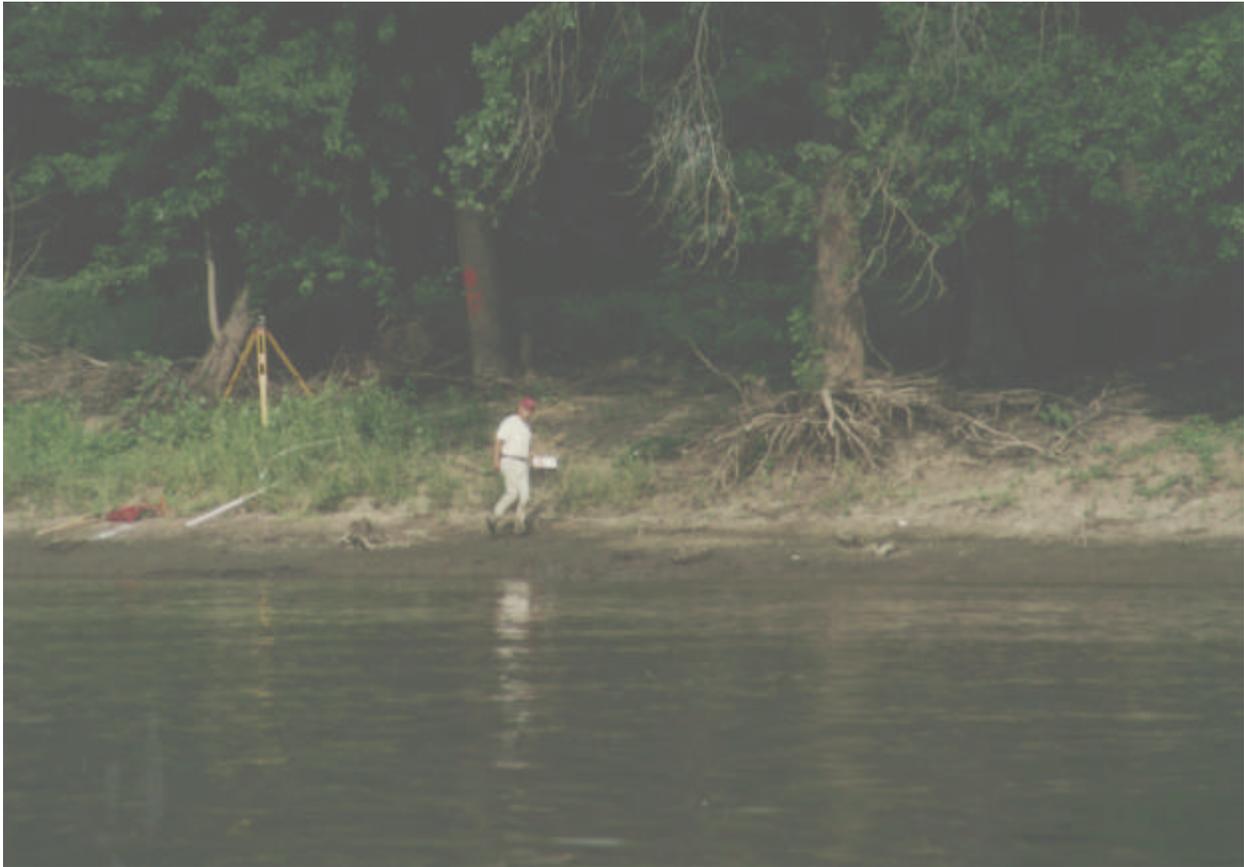
Figure 6-90. Site 17 on the Illinois Waterway

The site is about 280 feet from the sailing line. This site was described as severely eroded by Hagerty (1988). According to Corps personnel, this was formerly a dredged material placement site, containing about 8 feet of dredged materials. However, floods apparently have removed all the dredged materials. Seepage flows containing oxidized iron (brownish color) were observed along the bank. Seepage may be attributed to the presence of adjacent Anderson Lake behind this site.

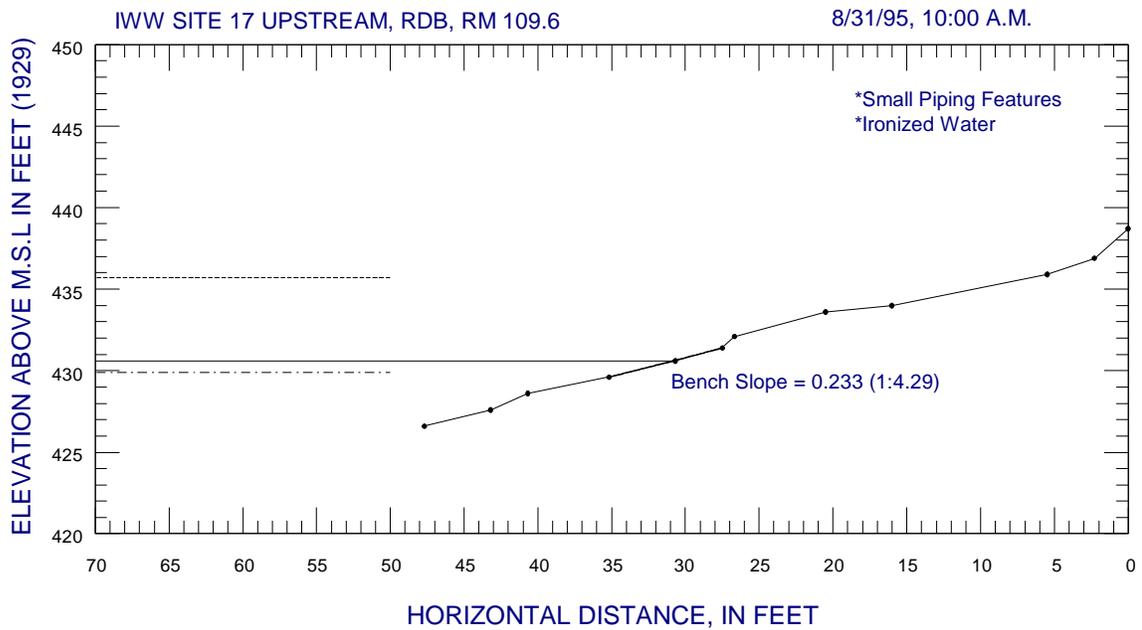
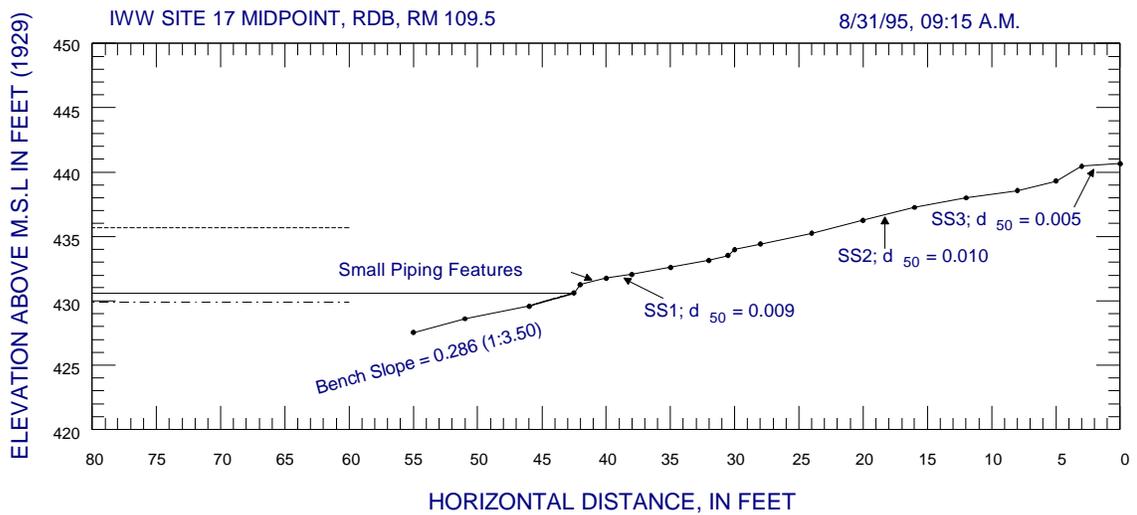
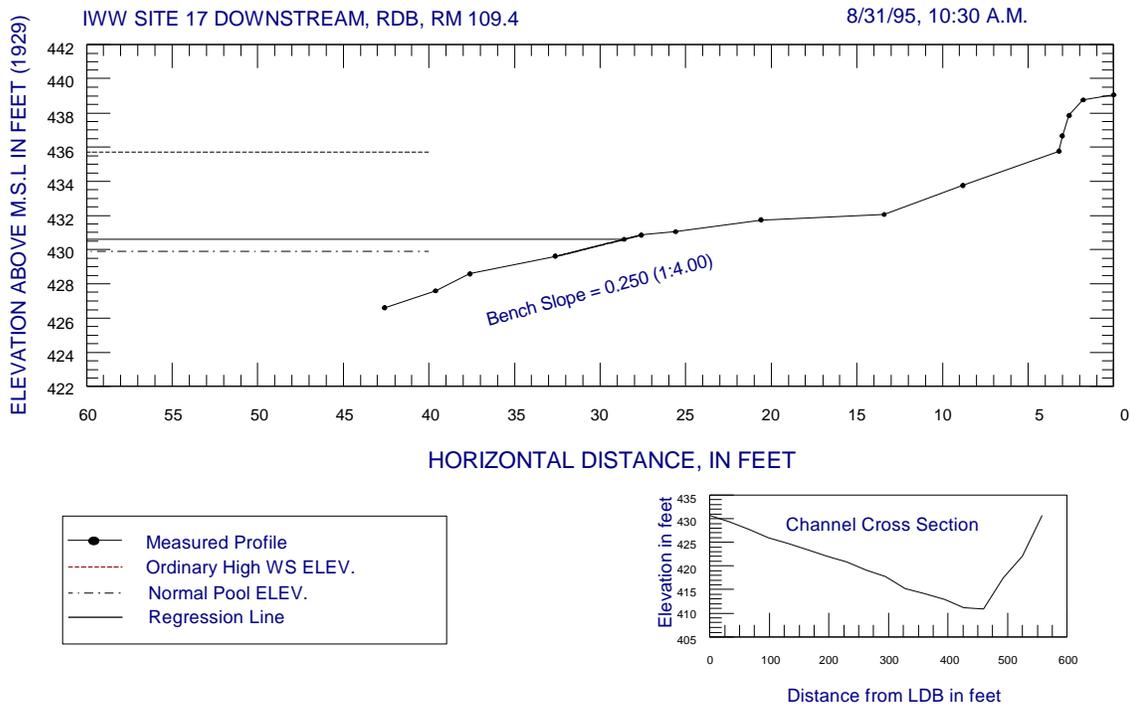
Figure 6-91. Bank sections at site 17

Figure 6-91 shows the three measured bank sections and two reduced cross sections. The OHW is 435.7 feet and NP is 429.9 feet above msl. There is a scarp near the water's edge and downslope from areas of seepage flows; the OHW elevation is above a zone of seasonal grasses. The OHW elevation corresponds well to the base of a scarp on the upper portion of the bank. Other stages and corresponding features are given in table 6-27.

At the midsection, the d_{50} varied from 0.005 mm at the top surface of the bank to 0.009 mm near the water's edge. Bank materials are similar. Gradation plots of bank soils and nearshore sediment are presented in appendix F. The detailed cross section and coordinates are shown in appendix G.

Bench slopes varied around 1V:4.0H. Both the upstream section and midsection are classified as type 5, and the downstream section is classified as type 4 (figures 6-21, 6-22, and table 6-4). Seepage at NP stages could weaken the bench materials and wave wash could create scarps on the bench. As at site 16, the subaerial bench was moist. Waves and currents at stages within the normal range of pool fluctuations cause erosion on bench and berm. These forces move failed soil or recent sediment away from the bank sections also.

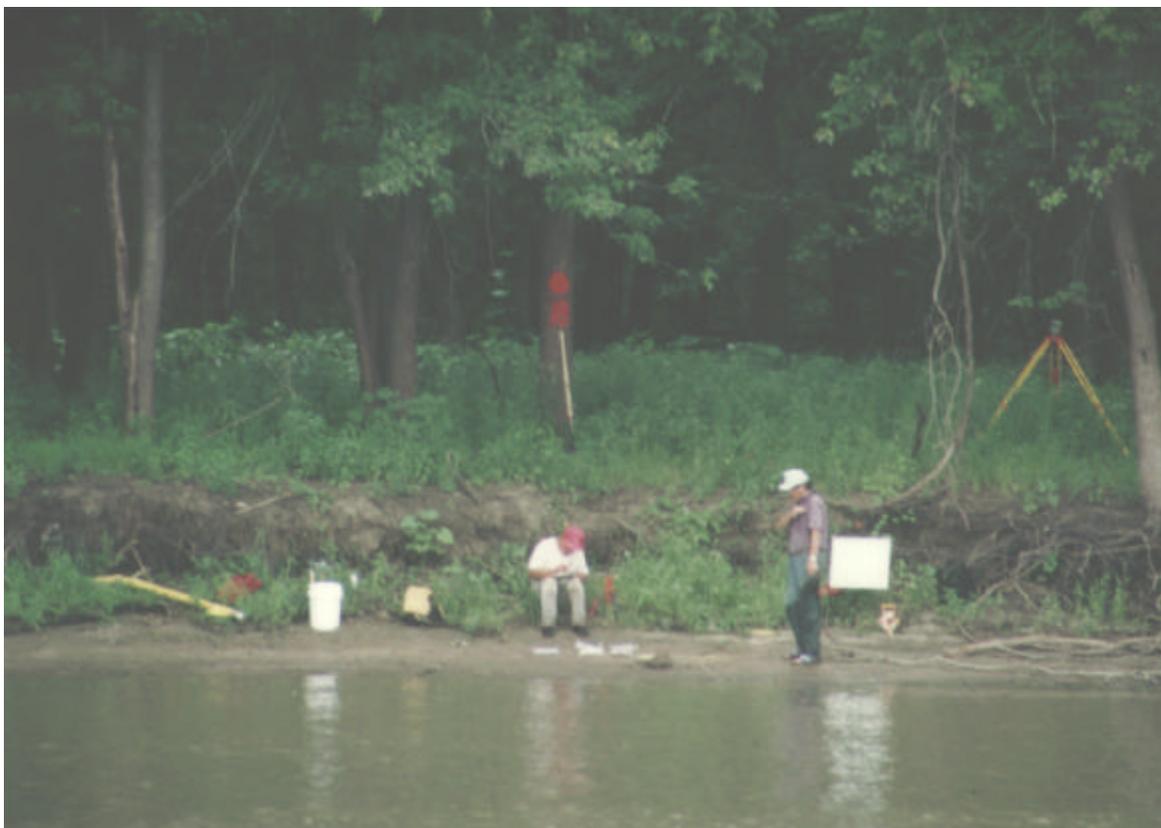
Figure 6-93. Site 18 on the Illinois Waterway

The site is about 250 feet from the sailing line. Both Bhowmik and Schicht (1980) and Hagerty (1988) observed erosion immediately upstream and downstream from the mouth of Sugar Creek, but did not indicate erosion at the current site. However, scarps and displaced trees were found on the bank in this trip. The bank had a thick cover of sand over exposed clay in several places. Dredged material was placed here in the 1960s, according to Corps personnel. In this 1995 trip, the previously eroded section was covered with sand, with shells and gravel at the water's edge. For comparison purposes, the upstream section was taken from that previously eroded section.

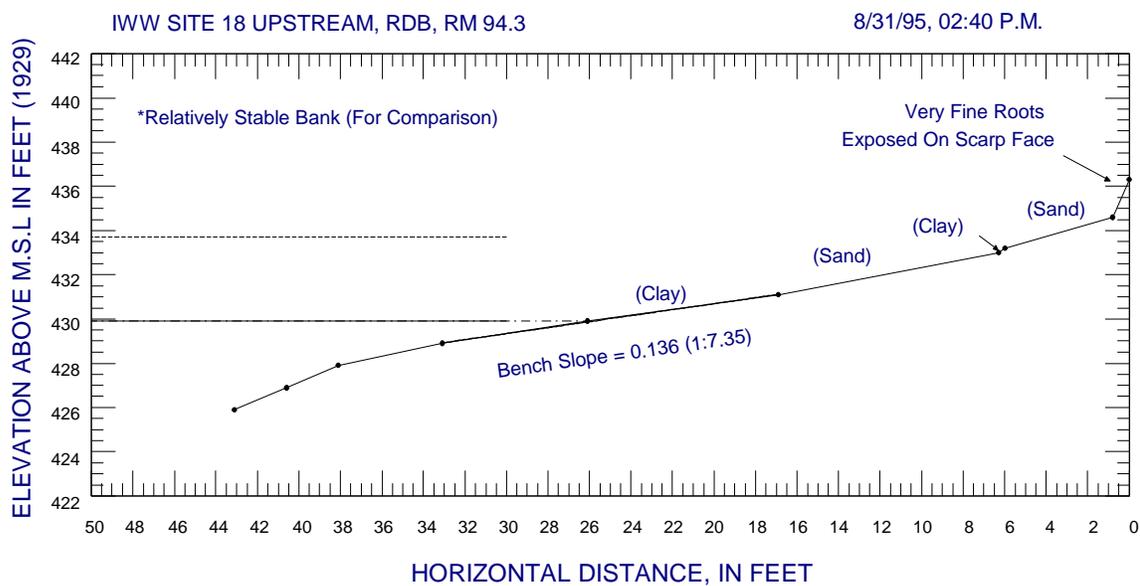
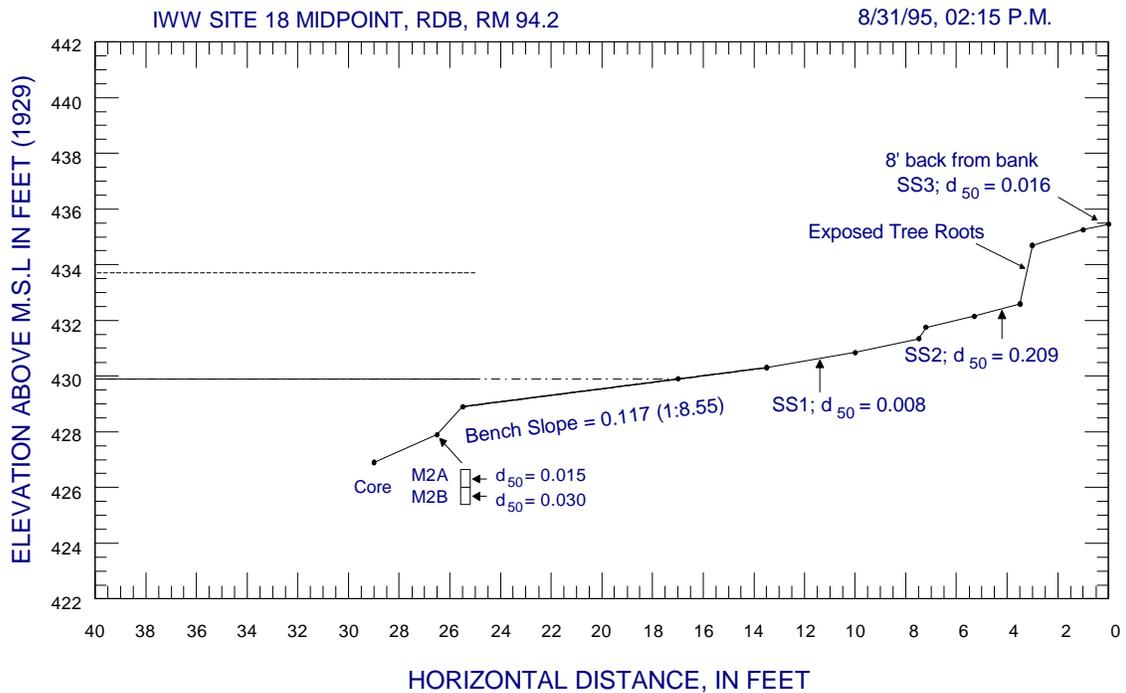
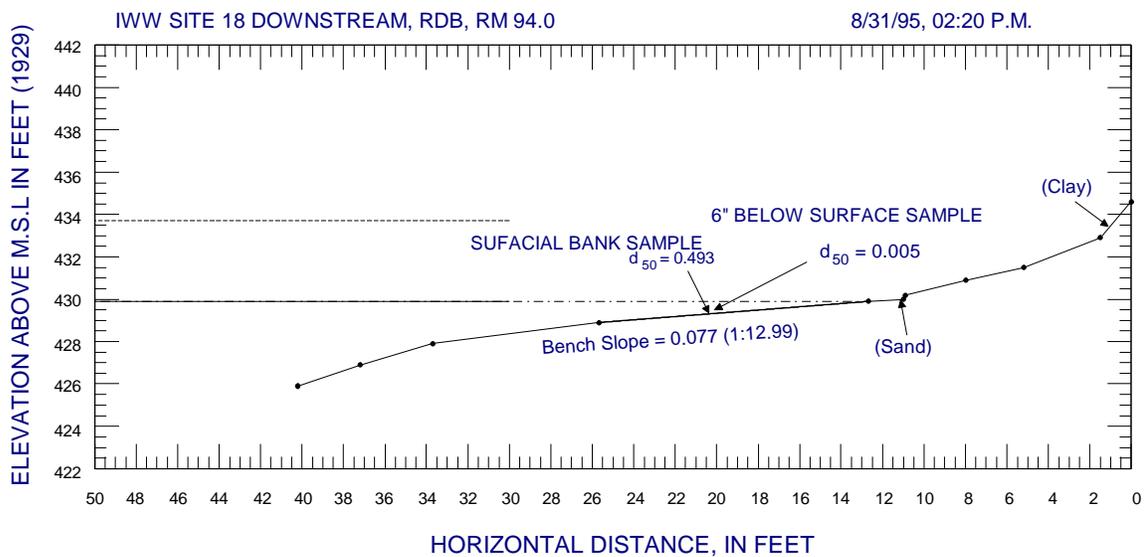
Figure 6-94. Bank sections at site 18

Figure 6-94 shows the three measured bank sections and a reduced cross section. All three sections were cut by a scarp, but scarp elevations were different. At this site, the OHW is 433.7 feet and the NP is 429.9 feet above msl. The scarp was above the OHW elevation at the upstream section, but the scarp elevations were lower for the midsection and downstream sections. The midsection and downstream section had small scarps in the stage range between the OHW and NP, but the upstream section did not have such scarps. Table 6-28 contains the stages with corresponding recurrence frequencies at this site.

At the midsection, the d_{50} varied from 0.016 mm at the top surface of the bank to 0.015 mm at the upper part of a core sample at a water depth of about 2 feet. Gradation plots of bank soils and nearshore sediment are presented in appendix F. The detailed river cross section and coordinates are shown in appendix G.

The bench slopes varied from 1V:7.4H at the upstream section to 1V:13.0 at the downstream sections. The subaqueous bench dropped off quickly at the midsection at this site. Both the upstream and downstream sections are classified as type 4, but the midsection is classified as a combination of types 2 and 4 (figures 6-19, 6-21, and table 6-4). The bank crest was covered by dense vegetation, and roots from that vegetation provided additional bonds to bank materials. The bank showed vertical cracks, which apparently were caused by basal scour. Sandy materials underneath the scarp seeped out after rapid stage recession. Waves and currents can rework and transport failed soils or recent sediments at stages within the normal range of pool-level fluctuations.

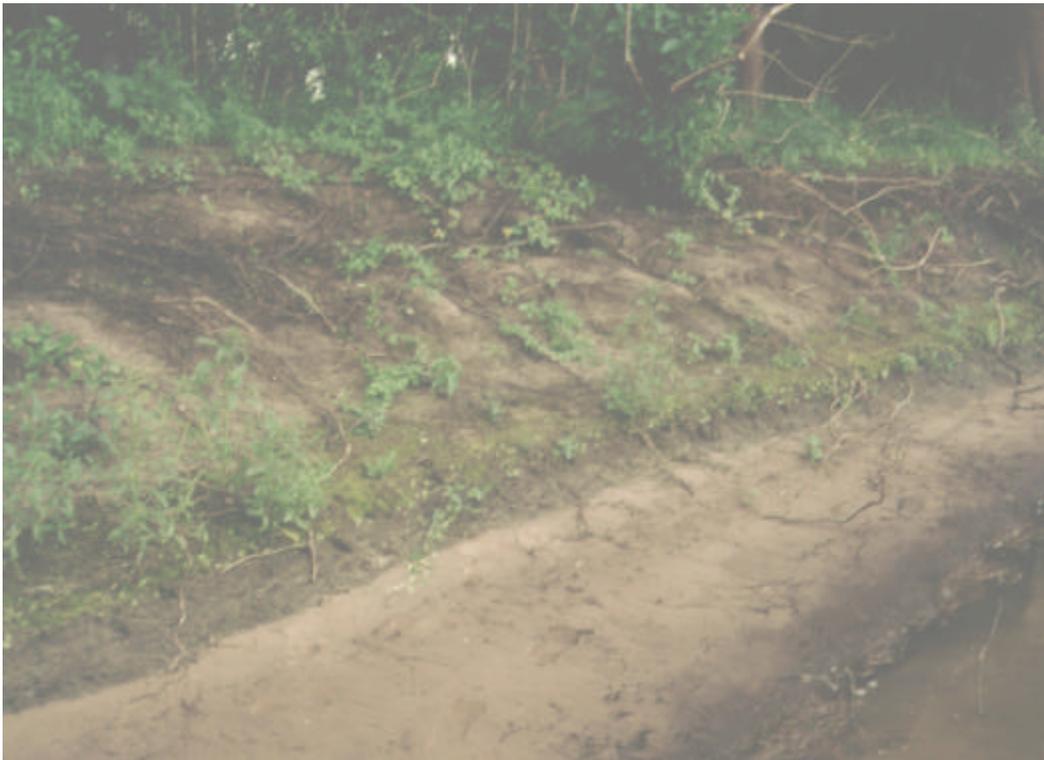
Figure 6-96. Site 19 on the Illinois Waterway

The site is about 310 feet from the sailing line. A Chicago Burlington & Quincy railroad line is located just behind the site. Hagerty (1988) marked this site as an erosion site, but it appeared to be stable when Bhowmik and Schicht (1980) surveyed. A depression between the bank and the railroad embankment will retain floodwater or rainwater, and cause seepage to the bank. The depression was a borrow pit for the construction of the railroad embankment. Some large dead trees and exposed roots were observed. Velocities were relatively high at a close distance from the shore.

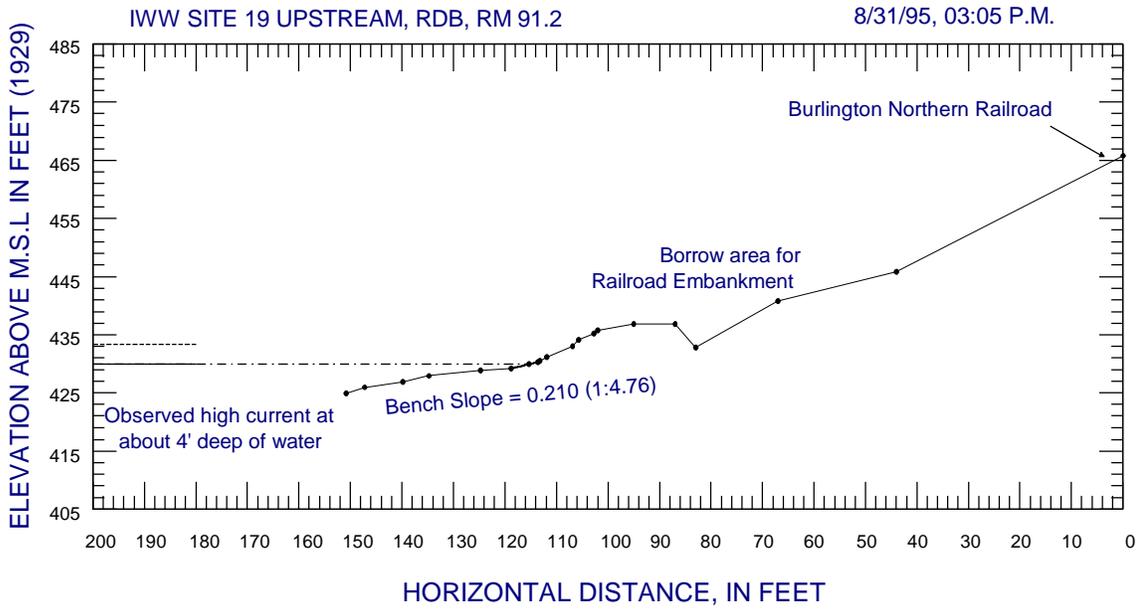
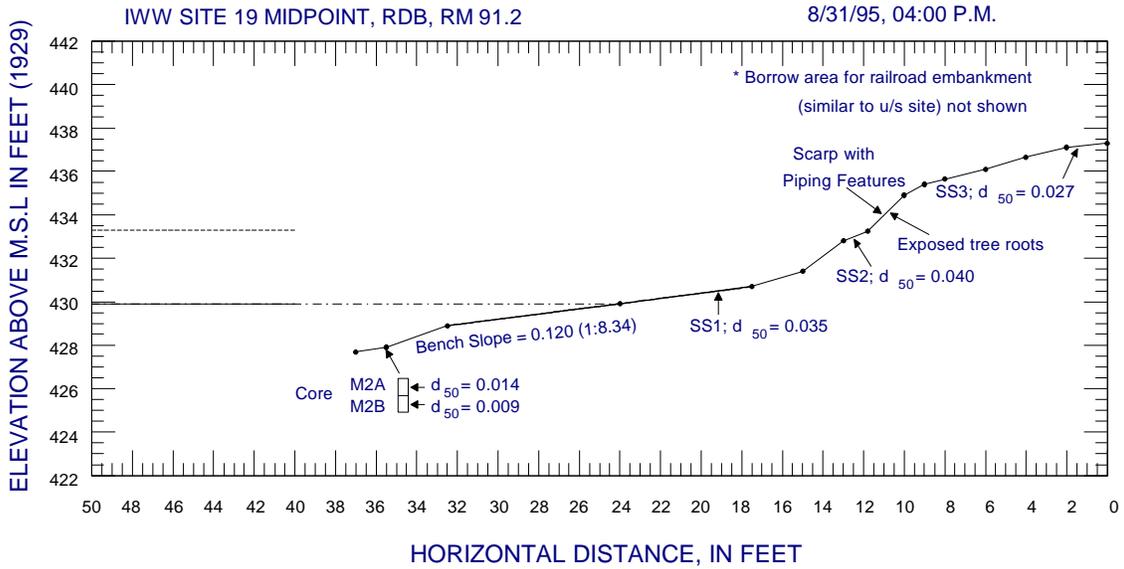
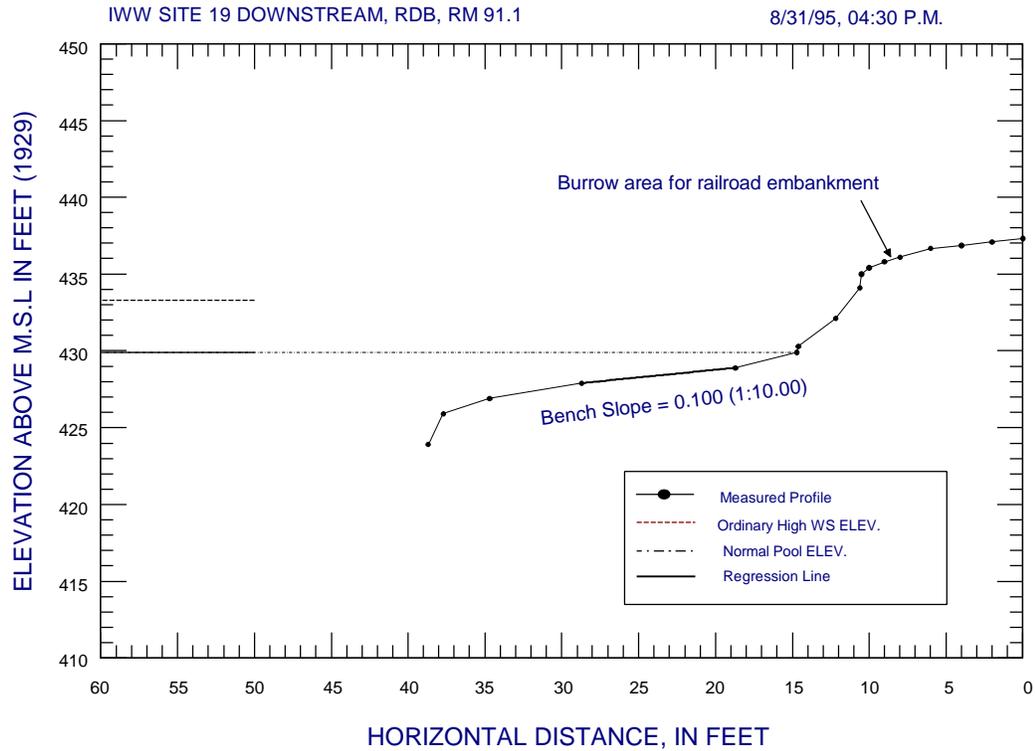
Figure 6-97. Bank sections at site 19

A scarp approximately 4 to 6 feet high was present. The lower bank and berm area contained several scarps and a moist soil layer at the toe. Some sand deposition was found on the narrow bench area. Figure 6-97 shows the three measured bank sections and a reduced cross section. The upstream bank section was extended approximately 160 feet to include the top of the embankment for the Chicago Burlington & Quincy Railroad. The OHW is 433.3 feet and NP is 429.9 feet above msl. The OHW elevation is at the base of the large scarp. The stage at the time of the field visit was at NP level.

At the midsection, the d_{50} varied from 0.027 mm at the top surface of the bank to 0.014 mm at the upper part of a core sample at a water depth of about 2 feet. Gradation plots of bank soils and nearshore sediment are presented in appendix F. The detailed river cross section and coordinates are shown in appendix G.

Bench slopes varied from 1V:4.8H at the upstream section to 1V:10H at the downstream section. This site is classified as a combination of types 2 and 4 (figures 6-19, 6-21, and table 6-4). Seepage initiated bank failure, rework and transport of failed soils occurred at stages within the normal pool-level fluctuations. Traffic-induced disturbances should be considered because the closeness to the barge terminal. Rapid drop of depth at mid- and downstream sections may reflect such a factor.

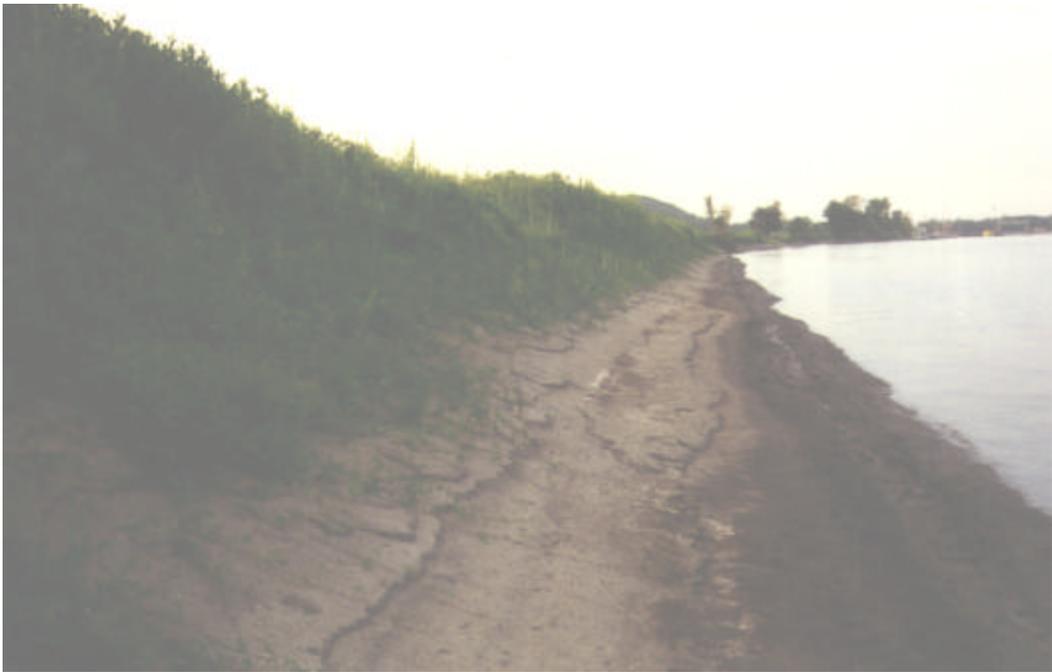
Figure 6-99. Site 20 on the Illinois Waterway

The navigation channel is fairly close to site 20; the bank is about 230 feet from the sailing line. No major tributary enters the IWW at this location. The opposite side of the river is used as a mooring area as barges wait for lockage. Bhowmik and Schicht (1980) noted erosion on both sides of the river downstream from the L&D. Hagerty (1988) selected this site for further survey and also indicated scarps about 12-14 feet high. In 1995, the face of the bank was bare, and the upper bank covered with short grasses. A fairly clear wet/dry line was present at the lower portion of the bank. The subaqueous bench dropped very quickly toward the channel. The land use on the top of the bank is agriculture (corn).

At the midsection, the d_{50} varied from 0.023 mm at the top surface of the bank to 0.004 mm near the water's edge. Seepage water quickly filled a trench dug on the bank (figure 6-99) even though the bank material was hard and cohesive. Gradation plots of bank soils and nearshore sediment are presented in appendix F. The detailed river cross section and coordinates are shown in appendix G.

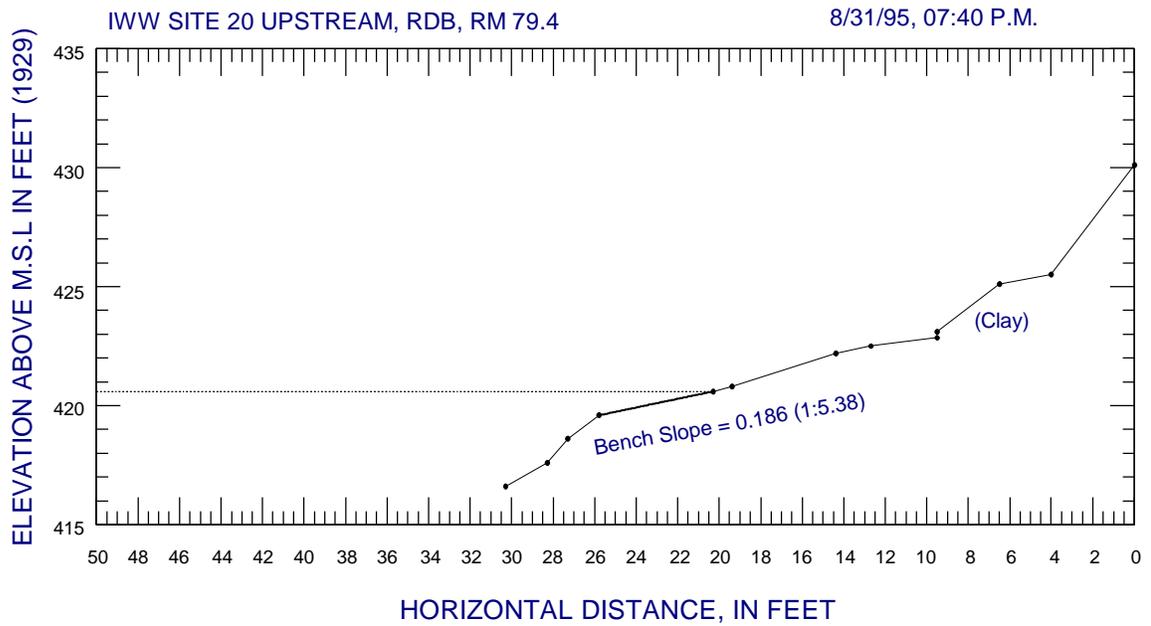
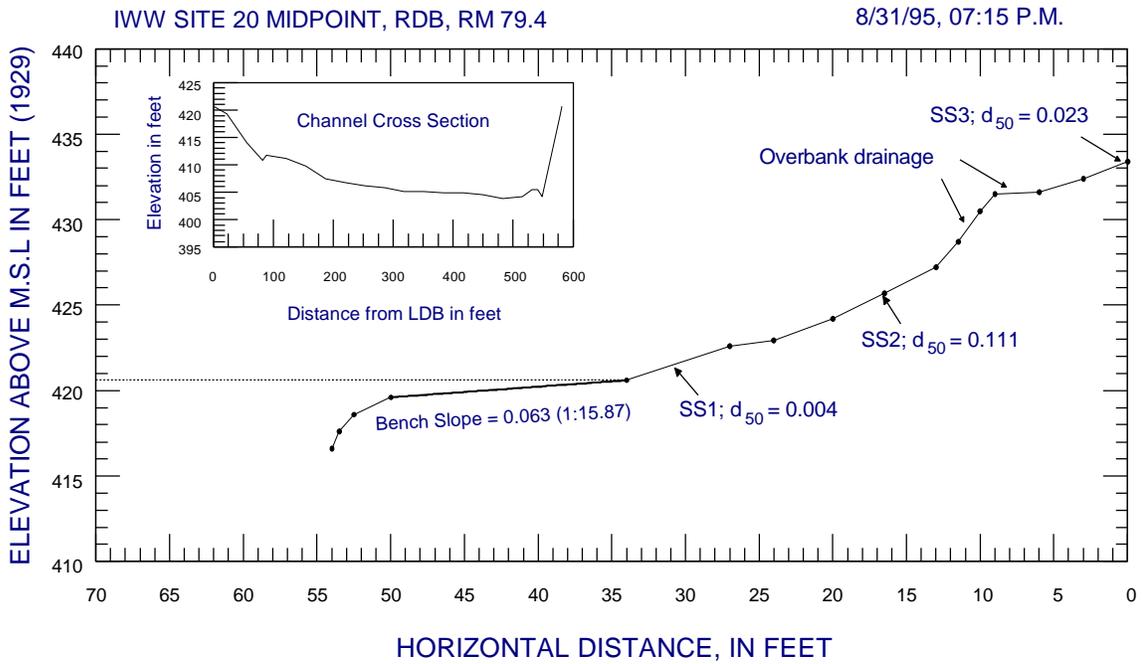
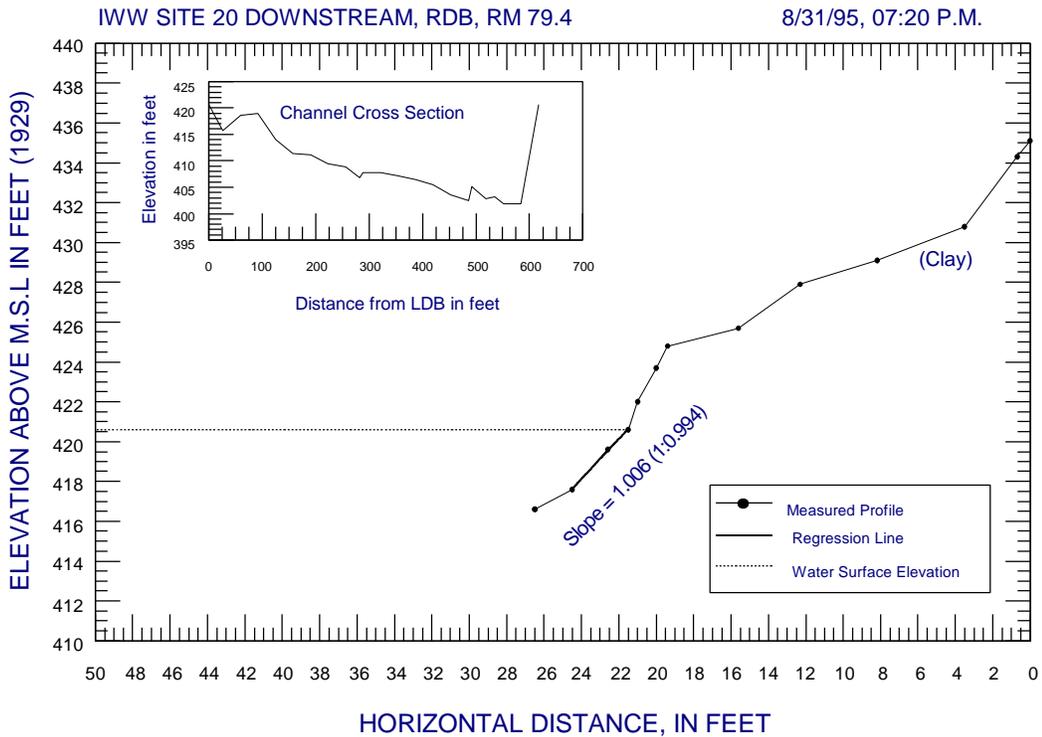
Figure 6-100. Bank sections at site 20

Figure 6-100 shows the three measured bank sections and two reduced cross sections. The bench narrowed at the downstream section. The OHW and NP elevations were not available for the Alton Pool, but analysis of the historical data indicated that the river stage at the time of survey had a recurrence frequency of about 90%. As shown in table 6-30, the bare bank area lies between the NP level and the 50% recurrence frequency stage (425.7 feet above msl).

Bench slopes varied from 1V:5.4H to 1V:15.9H to 1V:0.99H from upstream to downstream sections. This site can be classified as type 2 (figure 6-19 and table 6-4). Traffic approaching the L&D gets close to this site. High velocity flows released from the lock of the La Grange L&D, and turbulence induced by navigation traffic appeared to be the major cause of erosion at this site, but seepage effects also appeared to be significant.

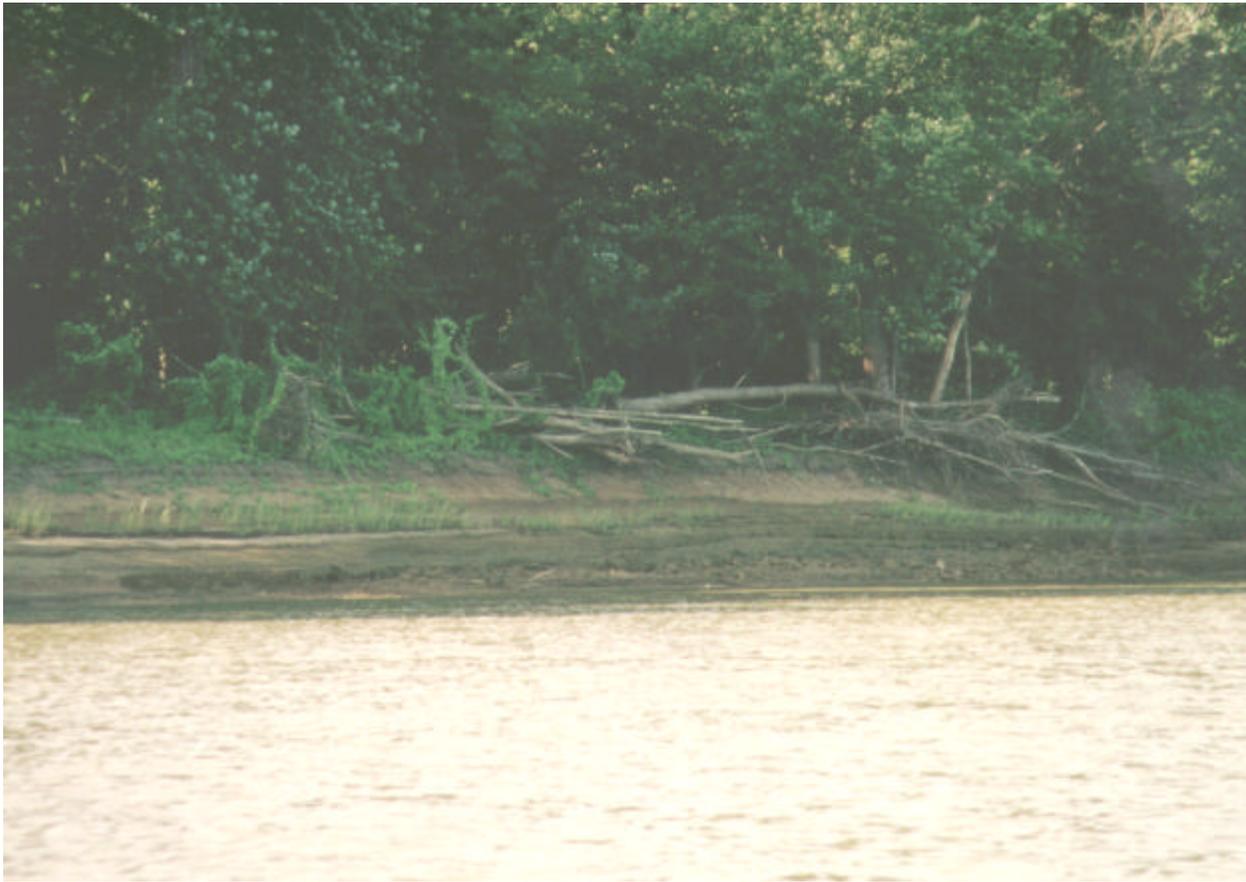
Figure 6-102. Site 21 on the Illinois Waterway

The navigation channel is close to this site; the bank is about 230 feet from the sailing line. A pumping station is located on the opposite bank, and there are several wing dams upstream in this reach. Bhowmik and Schicht (1980) did not note erosion in 1978, but Hagerty (1988) observed erosion around RM 61.9 on this bank. Silver maples are growing on the edge of the bank. Slaked blocks were mantled with grass and trees; tree roots extended out on the scarp.

Seasonal grasses were growing on the upper portion of the bank face. A bare bench with springs coming out of a clay layers extended from the failed soil blocks to the water's edge. Dead trees were present on the upper part of the bench.

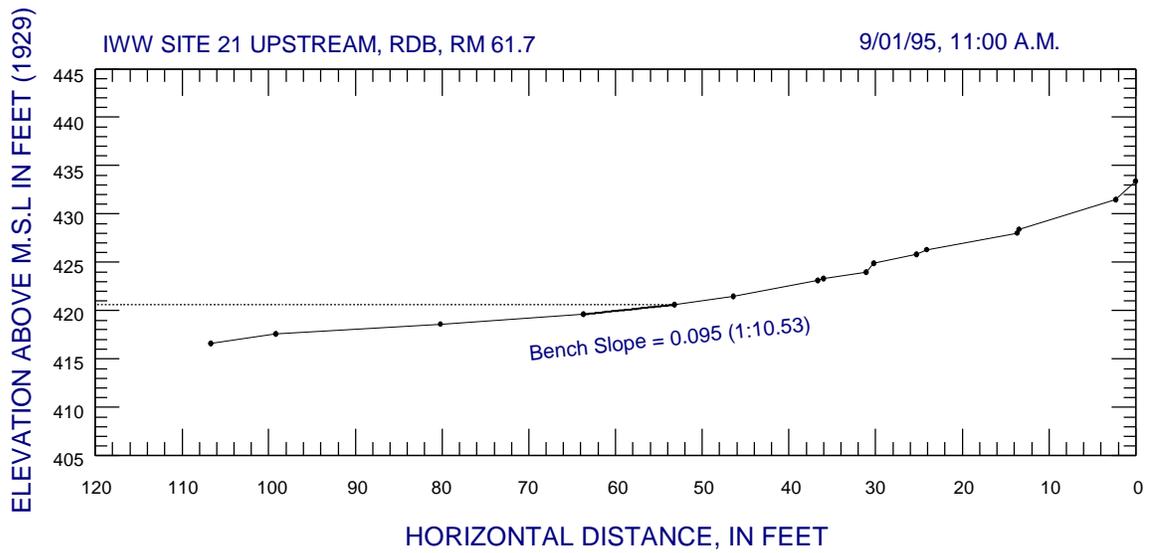
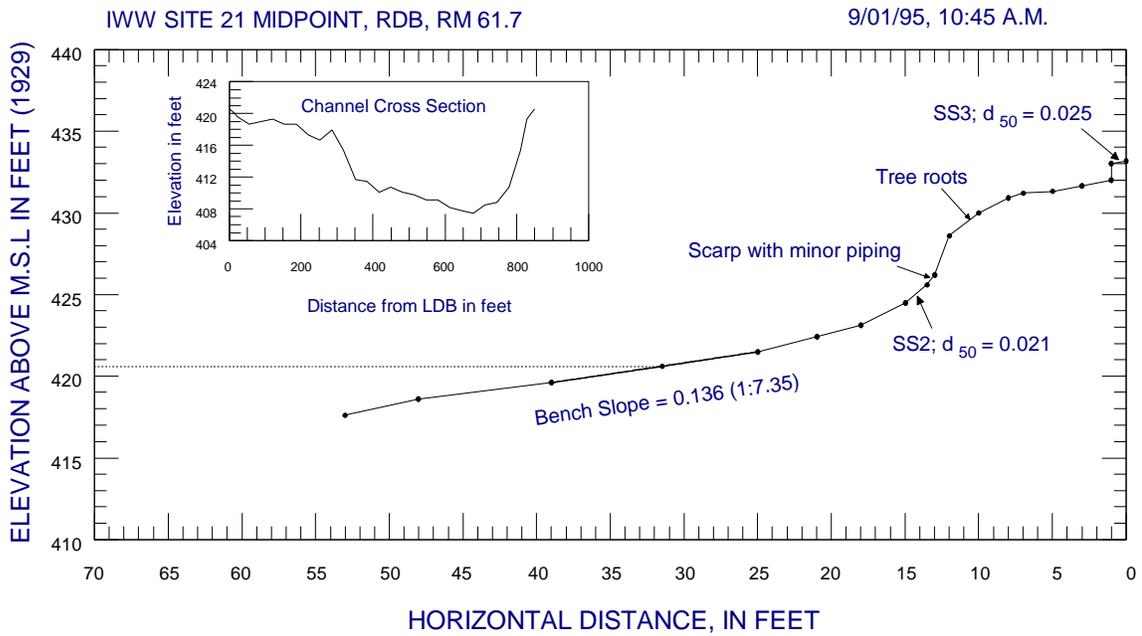
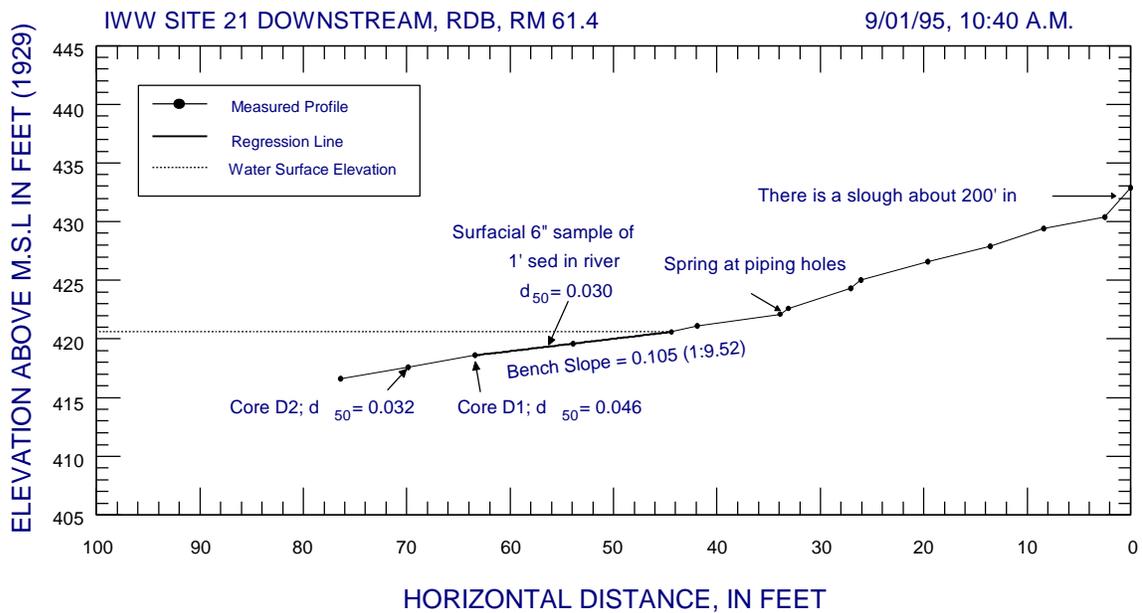
Figure 6-103. Bank sections at site 21

Figure 6-103 shows the three measured bank sections and a reduced cross section. The bank sections at the midsection differs from the up- or downstream sections. The stage at the time of survey corresponded to approximately 90% recurrence frequency. The scarps observed in the upstream and downstream sections were present in the range of stage fluctuation between 50% to 25% (424.5 and 429.1 feet, respectively, see table 6-31); this was also the range of scarp in the midsection.

At the midsection, the d_{50} was 0.025 mm at the top surface of the bank. The d_{50} from the core samples at the downstream section was 0.046 at 1 foot and 0.032 at 2 feet of water depth. Gradation plots of bank soils and nearshore sediment are presented in appendix F. The detailed river cross section and coordinates are shown in appendix G.

Bench slopes varied from 1V:10.5H to 1V:7.4H. The upstream and downstream sections are classified as type 5, and the midsection is classified as type 4 (figure 6-21 and 6-22 and table 6-4). Wave wash apparently produced some small scarps on the bench area. Springs and seepage weakened the bench soils and made them susceptible to wave erosion. Currents at high stages or during floods can erode in-place bank soils.
