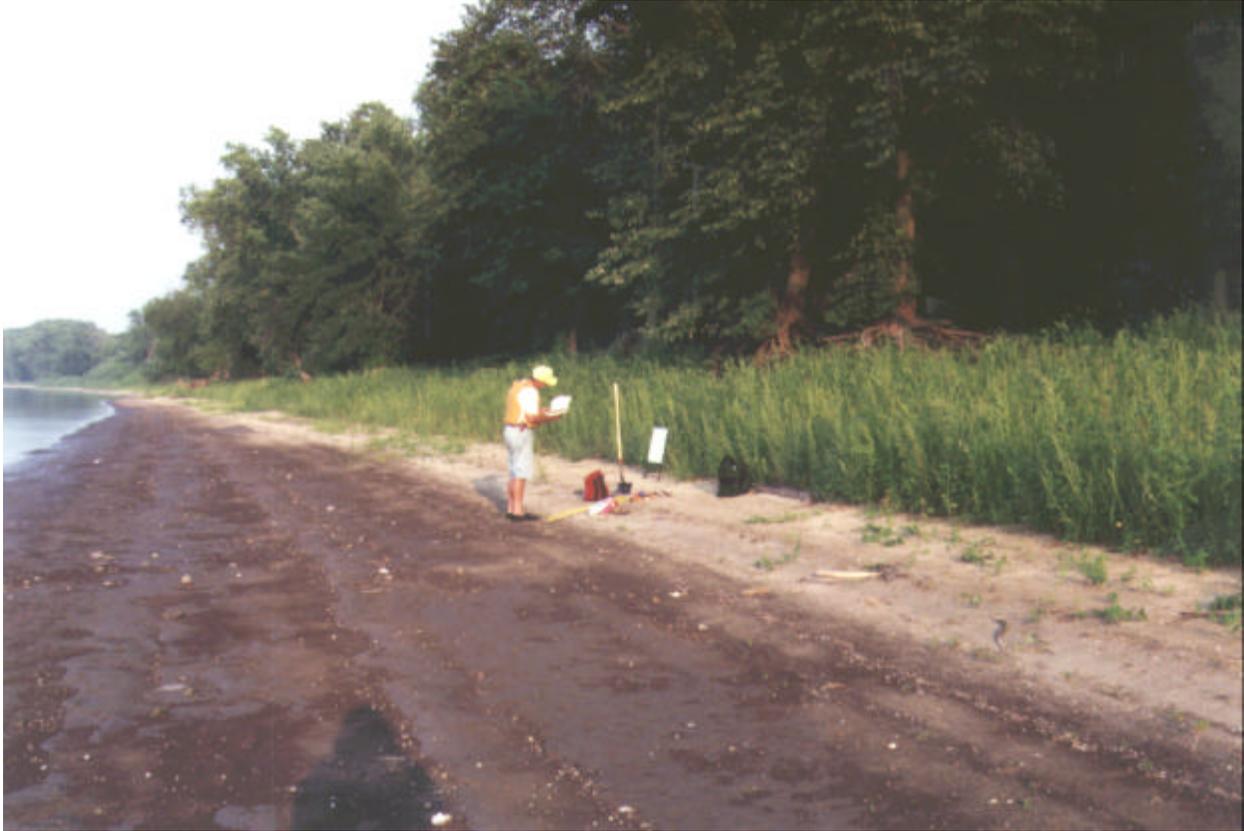
**Figure 6-55. Site 4 on the Illinois Waterway**

Bench slopes varied slightly from 1V:18.2H at the upstream section to 1V:25.6H at the downstream section. This site can be classified as type 5 (figure 6-22 and table 6-4). The bank seemed to be stable in 1995 but was an eroded site in 1978 (Bhowmik and Schicht, 1980). The elevation of the scarp was fairly high compared to NP or OHW stages where piping was noted. Erosion of bench soils or recently deposited sediments can occur during flow at stages higher than OHW.

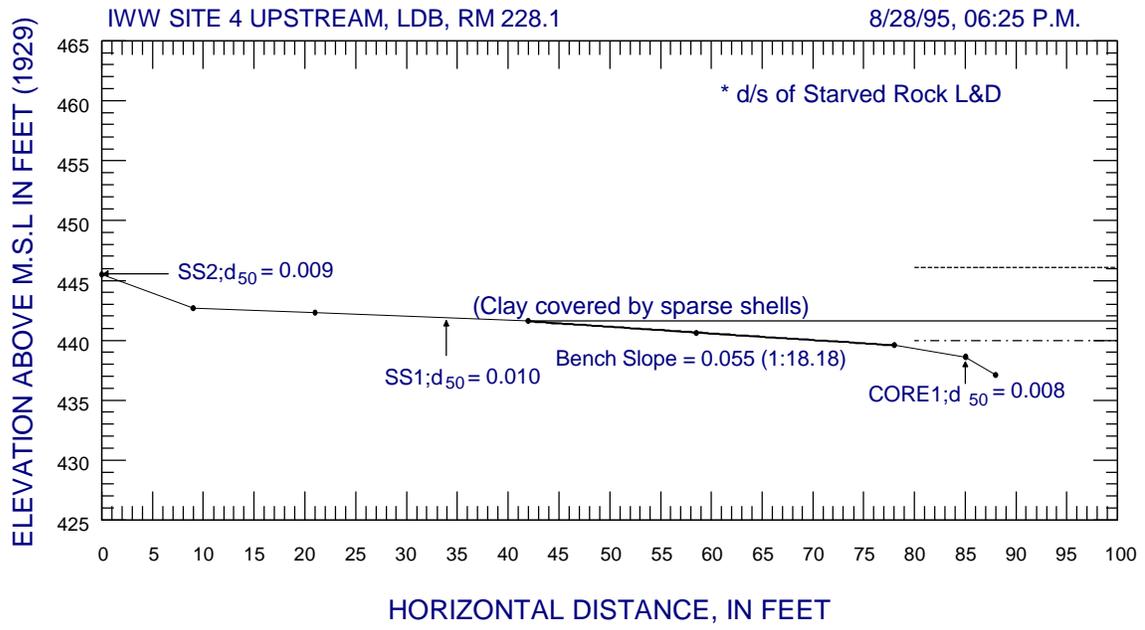
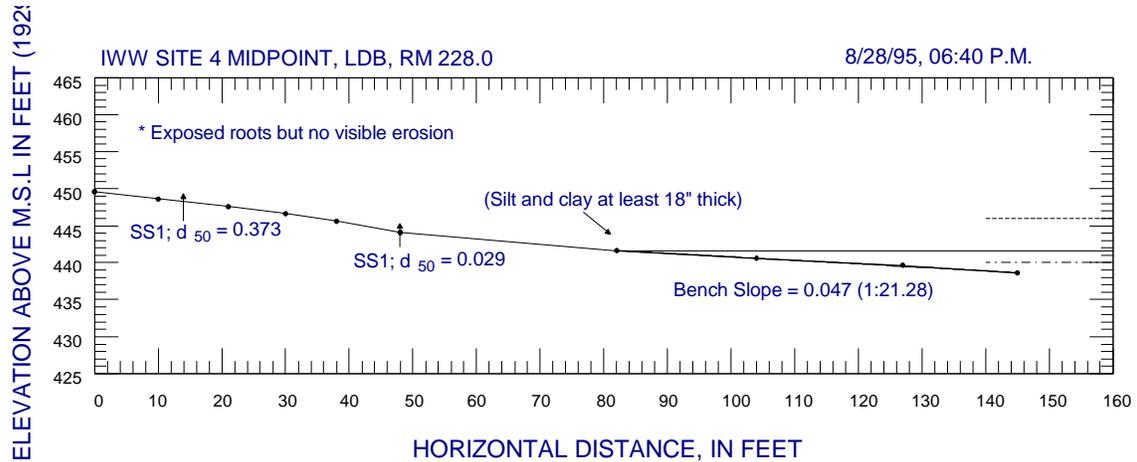
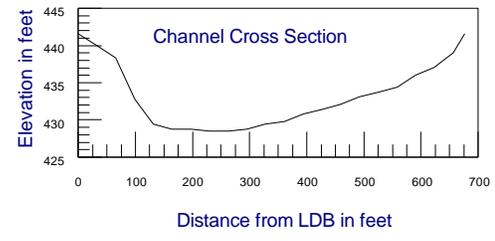
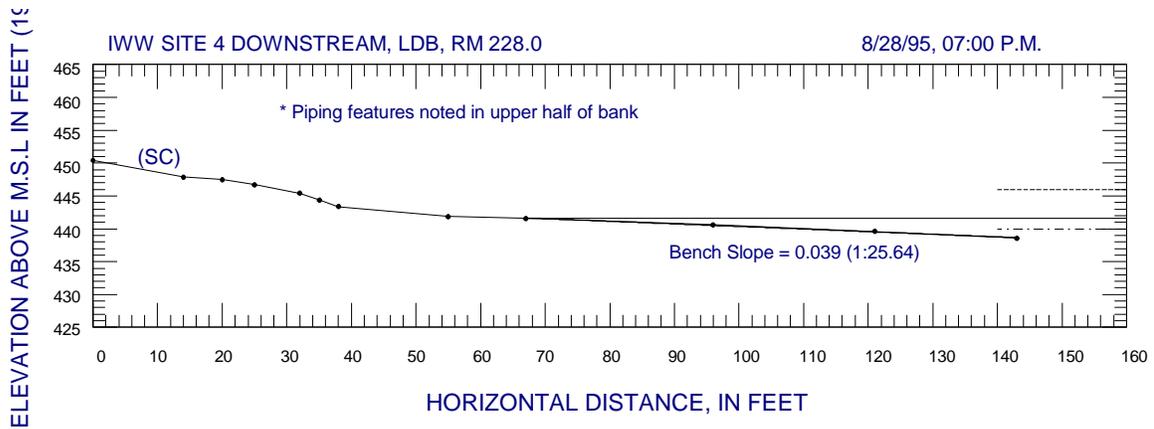
**Figure 6-56. Bank sections at site 4**

Figure 6-56 shows the three measured bank sections and a reduced cross section. Bank sections were fairly uniform at this site. The OHW is 446 feet and NP is 440 feet above msl. The range of fluctuation between the OHW and NP covers the entire bench.

At the midsection, the  $d_{50}$  varied from 0.373 mm for materials on the scarp under the exposed tree roots of a mature tree to 0.029 mm on the bench. Mean particle size at the upstream section varied from 0.009 mm at the top surface of the bank to 0.008 mm for a core sample at a water depth of about 1 foot. Gradation plots of bank soils and nearshore sediment are presented in appendix F. The detailed cross section and coordinates are shown in appendix G.

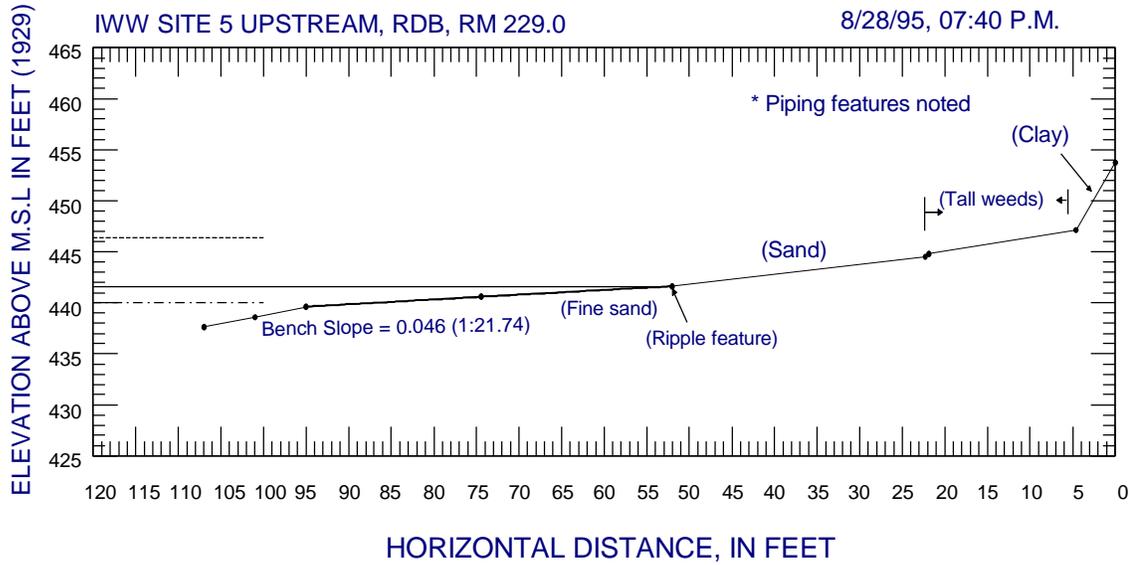
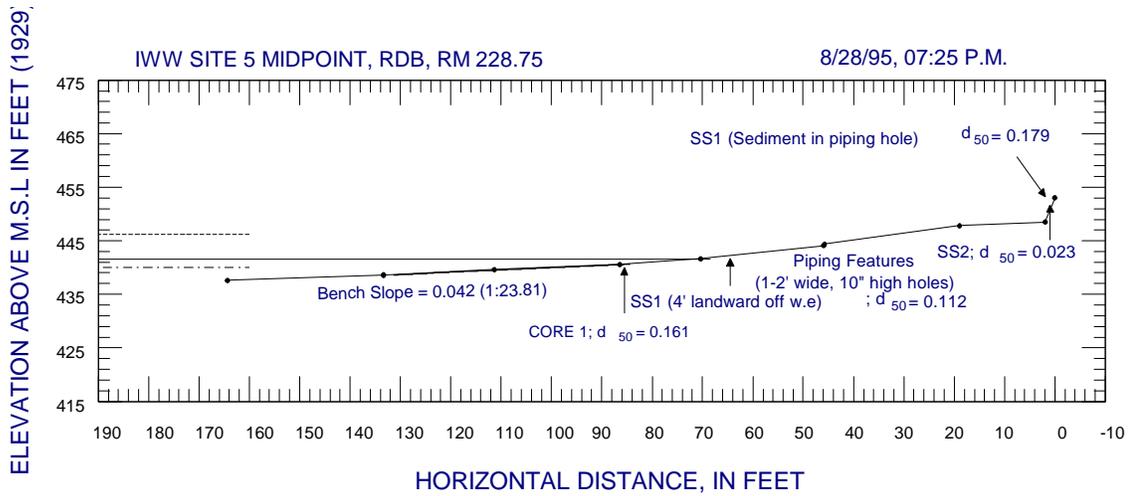
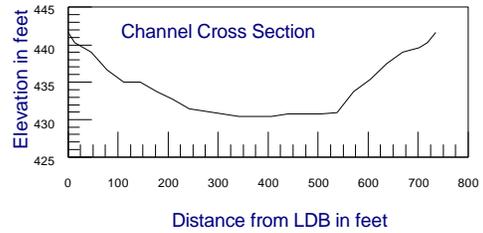
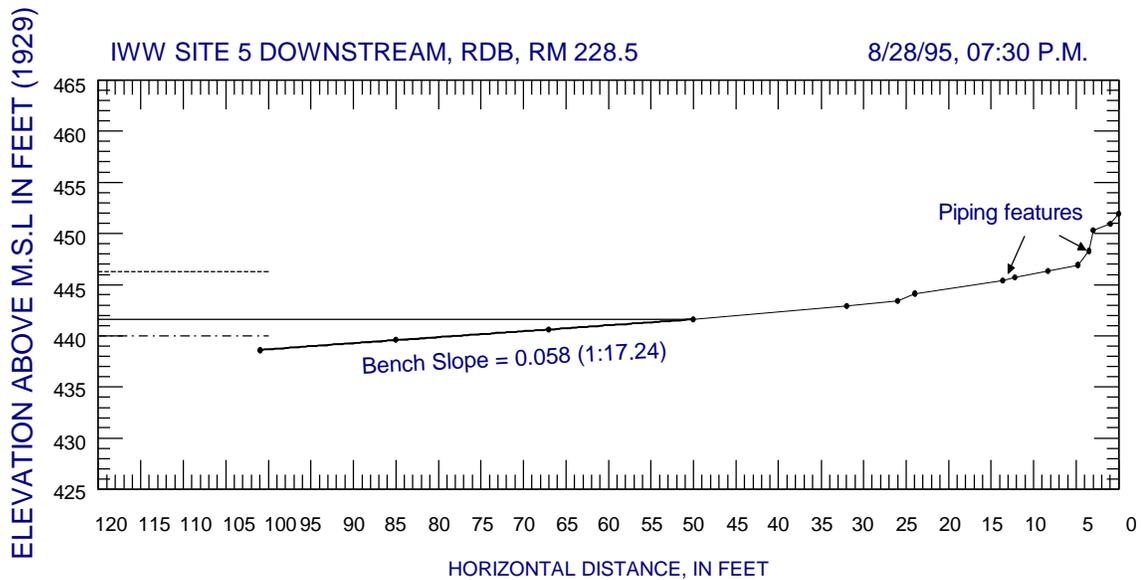
**Figure 6-57. Bank sections at site 5**

Figure 6-57 shows the three measured bank sections and a reduced cross section. The OHW is 446.2 feet and NP is 440.0 feet above msl. The OHW elevation was at the base of the scarp at all three sections, while the NP was at a break in the subaqueous slope at the upstream section. According to the stage analysis using 10-year data (see table 6-15), river stages with 25% or less occurrence frequency reach the scarp and stages with 10% or less occurrence frequency top the bank.

At the midsection, the  $d_{50}$  varied from 0.023 mm at the top surface of the bank to 0.161 mm for a core sample at a water depth of about 1 foot. Gradation plots of bank soils and nearshore sediment are presented in appendix F. The detailed cross section and coordinates are shown in appendix G.

Bench slopes varied slightly between 1V:23.8H and 1V:17.2H. With a scarp over a gentle bench slope, this site is classified as a combination of types 3 and 5 (figures 6-20 and 6-22, and table 6-4). The scarps have layered failure features and were initiated by piping and surface drainage. Waves and currents at OHW cause erosion of failed soil or recent sediments on the bench area.

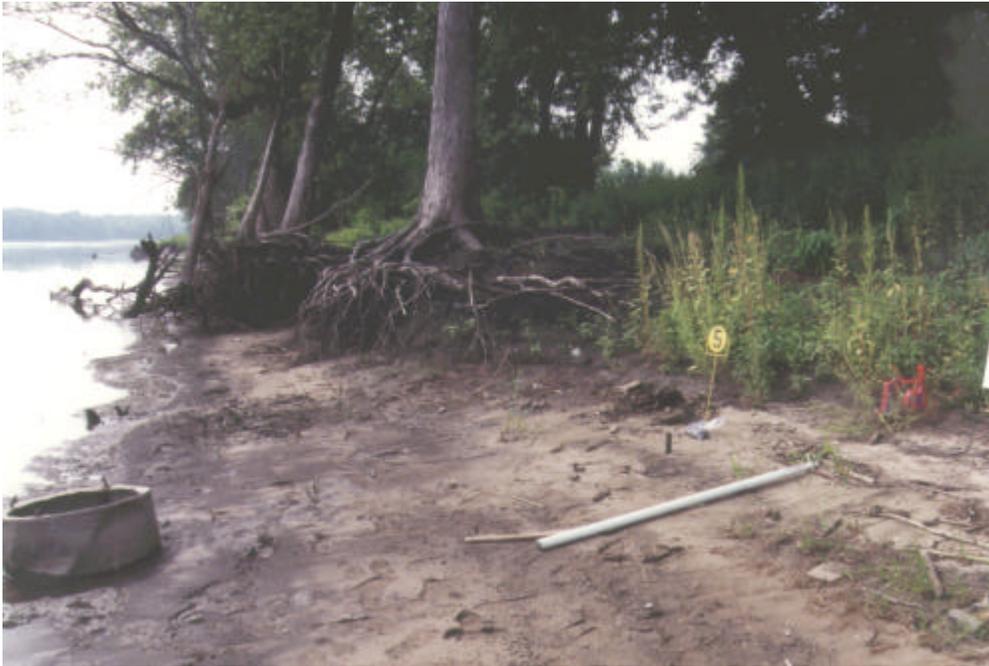
**Figure 6-59. Site 6 on the Illinois Waterway**

The site is about 310 feet from the sailing line. In plan form it is on the outer side of a bend. Bhowmik and Schicht (1980) observed erosion on both banks, while Hagerty (1988) noted erosion only on the RDB, but his site extended further upstream and downstream from the entrance of the lake. The bank contains small scarps, and the top of the bank is covered with some fine tree roots. Agriculture (corn) is the land use for the upstream section and woods cover the bank for the other two sections. At the most upstream end point of this reach (immediately downstream from the lake outlet), the subaqueous bench dropped more than 11 feet right off the water's edge, a feature not observed at the remaining sections. Judging from the plan form this truncation could be caused by tow-induced current passing through the bend. Small worm holes existed on the truncated bench face near the water's edge.

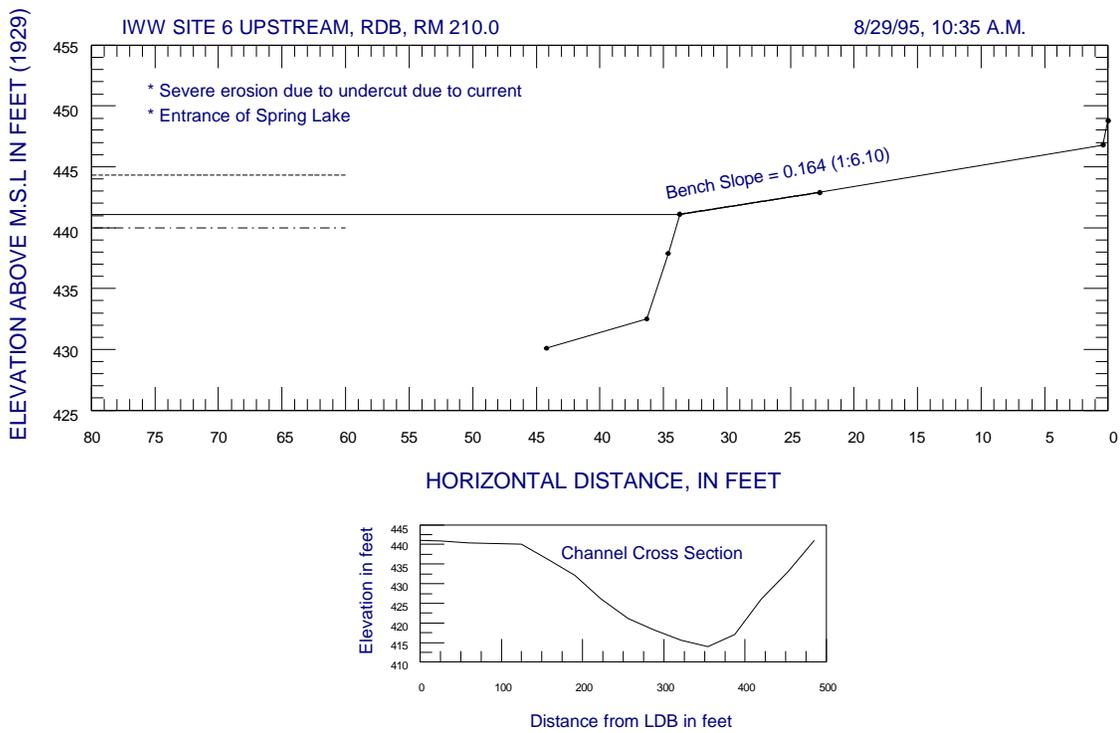
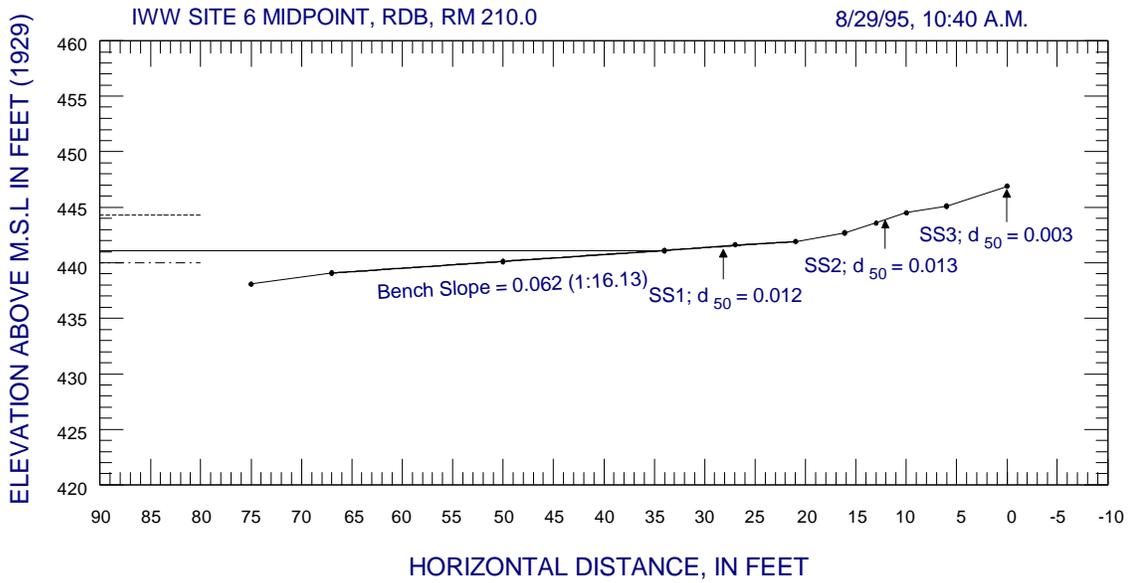
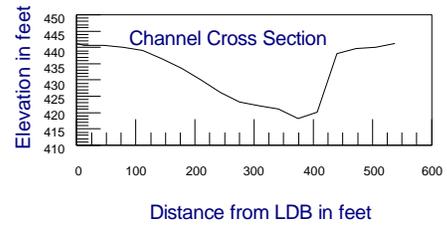
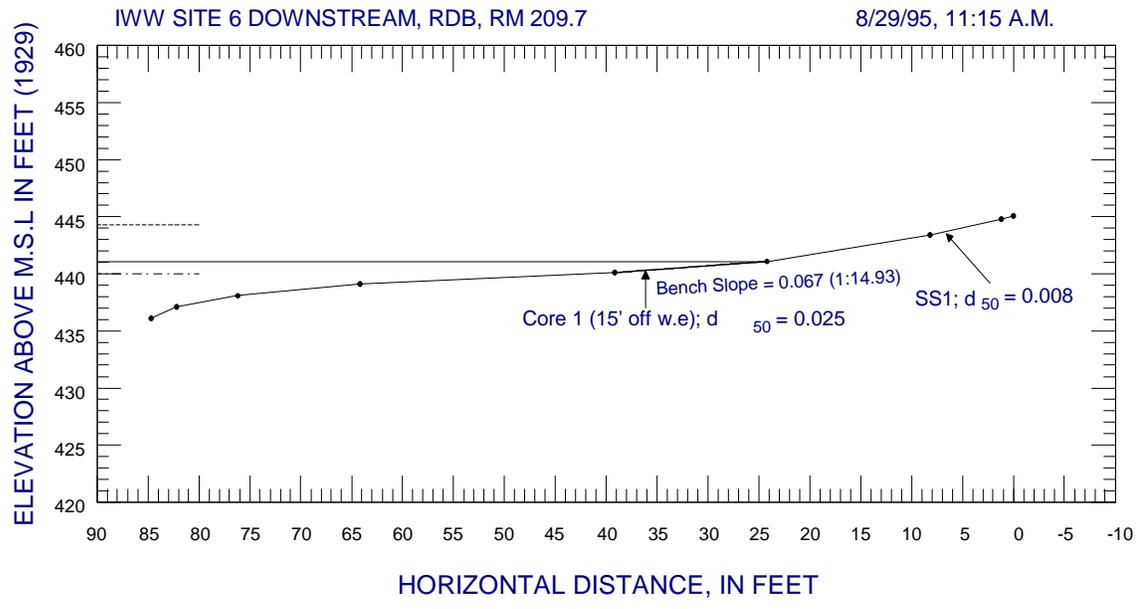
**Figures 6-60. Bank sections at site 6**

Figure 6-60 shows the three measured bank sections and two reduced cross sections. The thalweg was farther away from the water's edge downstream. The OHW is 443.2 feet and NP is 440.0 feet above msl. Mature trees were growing at the water's edge; the midsection and downstream section were measured between trees. Banks between the trees were eroded. The crown of the tree roots appeared to be higher than the bank top. A flood stage higher than 10% recurrence frequency will overtop the bank (see table 6-16). Standing (but dead) trees were in place in water at the NP level.

At the midsection, the  $d_{50}$  varied from 0.003 mm at the top surface of the bank to 0.012 mm on the bench. A core sample at a depth of about 1 foot of water on the downstream section had  $d_{50}$  equal to 0.025 mm. Gradation plots of bank soils and nearshore sediment are presented in appendix F. The detailed river cross-section and coordinates are shown in appendix G.

Bench slopes varied only slightly from 1V:16.1H at the midsection and downstream section. The three sections, from upstream to downstream, are classified as types 4, 5, and 6 (figures 6-21, 6-22, 6-23, and table 6-4). Traffic-induced currents appear to be a significant factor for the subaqueous scarp at the upstream section. Small worms nesting in the bank soils also will weaken the bank strength. Eddy currents, induced by fallen trees or nearshore land features, exist at the midsection and downstream section. These eddy currents can cause local scours. Other erosion mechanisms include surface drainage for the upstream section, piping, and floods for the whole reach.

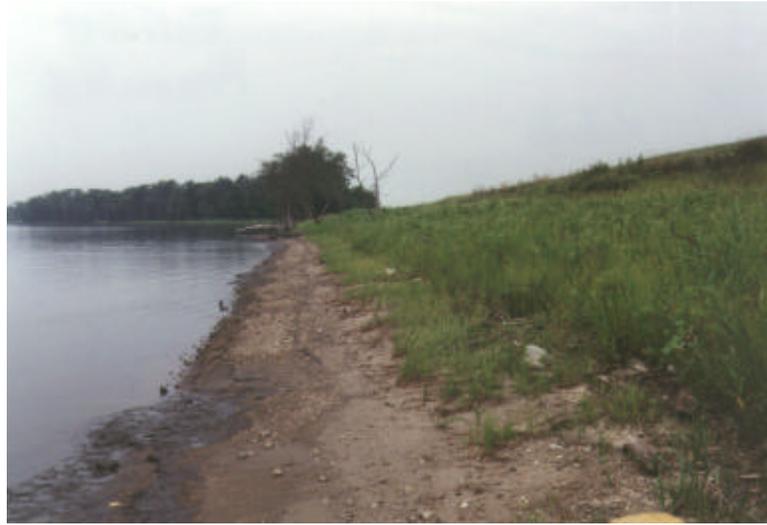
**Figure 6-62. Site 7 on the Illinois Waterway**

Site 7 is at the Hennepin Levee System about 400 feet from the sailing line, and no tributaries enter the site. Bhowmik and Schicht (1980) noted almost the entire riverbank from the Upper Twin Sister Island to site 6 as eroding bank. Hagerty's observation (1988) was similar to that of Bhowmik and Schicht (1980), but the erosion reaches indicated by Hagerty (1988) were shorter and were shown mostly on the RDB. Hagerty (1988) also noted erosion on both the Upper and Lower Twin Sister Islands on the sides facing the channel. The back side (facing levee) of Upper Twin Sister Island also had a long reach of overhanging matted roots as noted by Hagerty (1988).

At the site, a scarp 3-5 feet high was located about 2 to 4 feet below the levee crown. Tall weeds were growing on the berm and many small scarps were observed on the bench. Figure 6-63 shows the three measured bank sections and a reduced cross section. The OHW is 443.9 feet and NP is 440.0 feet above msl. The OHW corresponded well with the lower edge of the weed zone on the shore where debris was found, in the bench area. Stages above 447.5 feet (about 10% recurrence frequency, see table 6-17), reach the base of the scarp near the top of the levee.

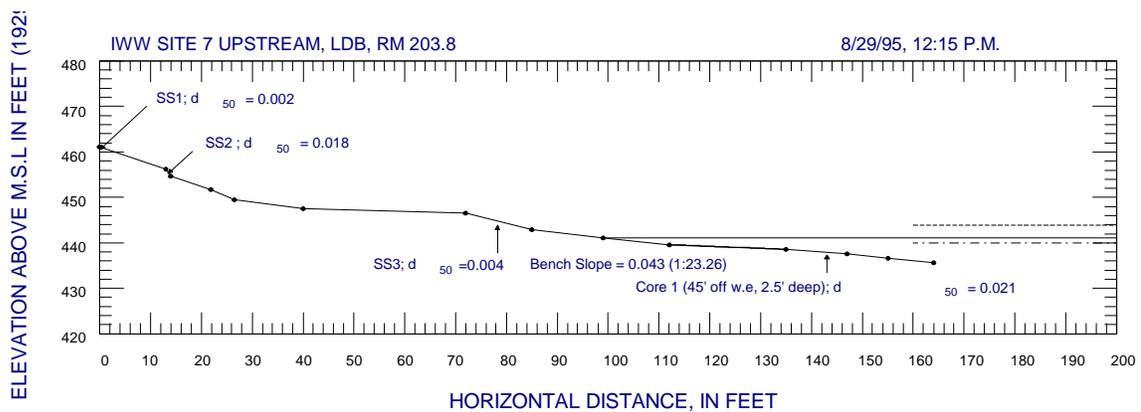
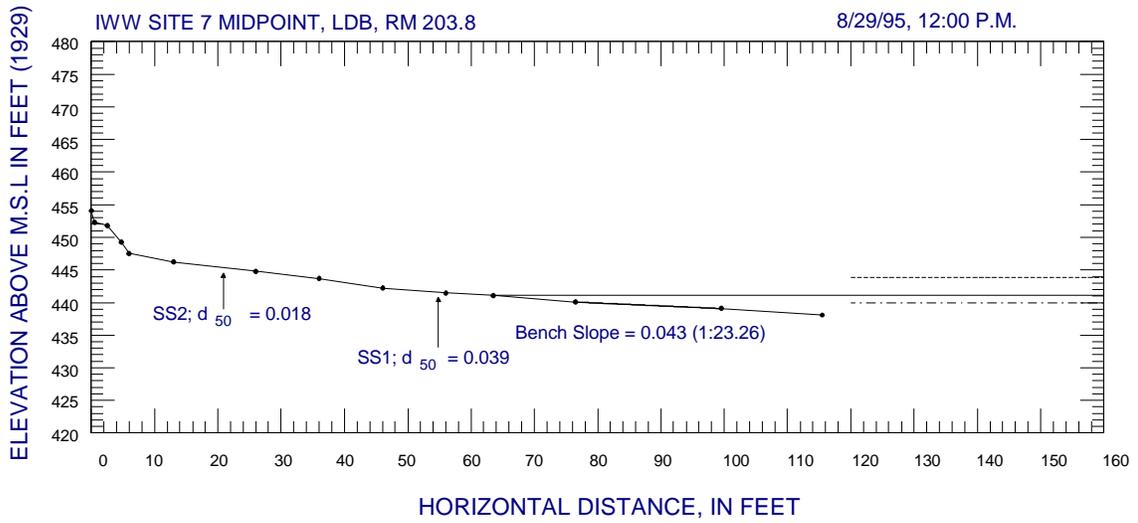
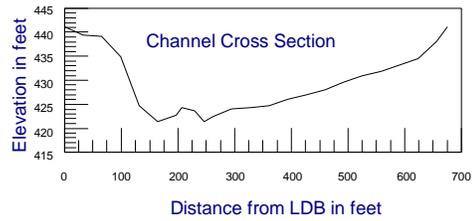
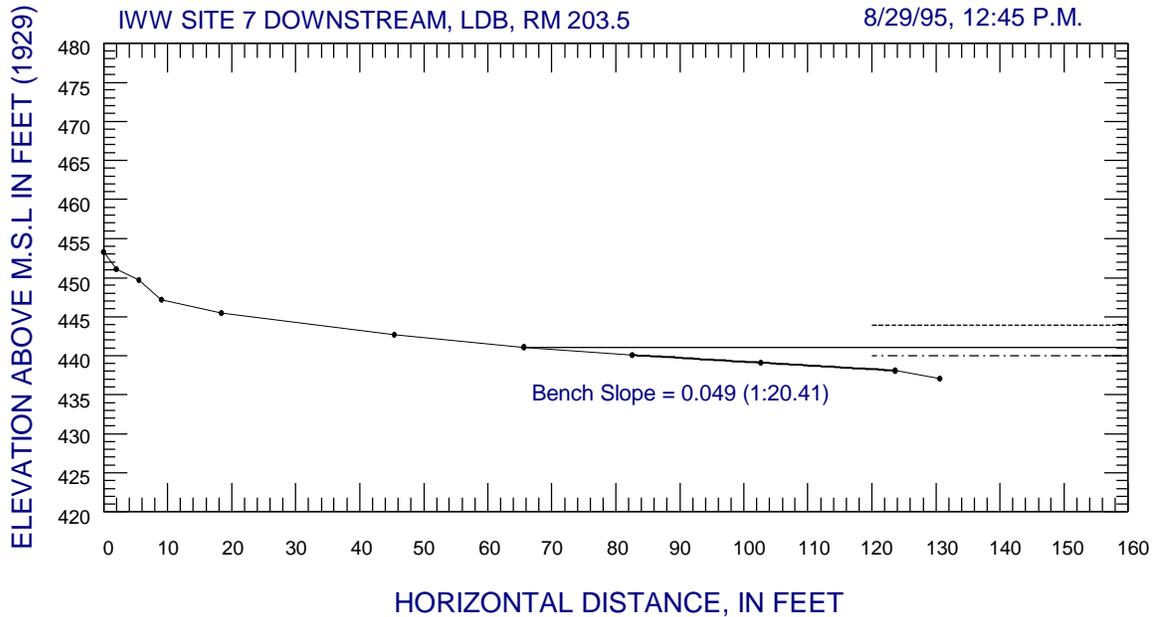
**Figure 6-63. Bank sections at site 7**

Bench slopes varied only slightly from 1V:23.3H. This site can be classified as type 5 (figure 6-22 and table 6-4). The scarp was located above most flood stages. Rework and transport by wave and currents are major factors in removing failed soil or recent sediments from the bench.

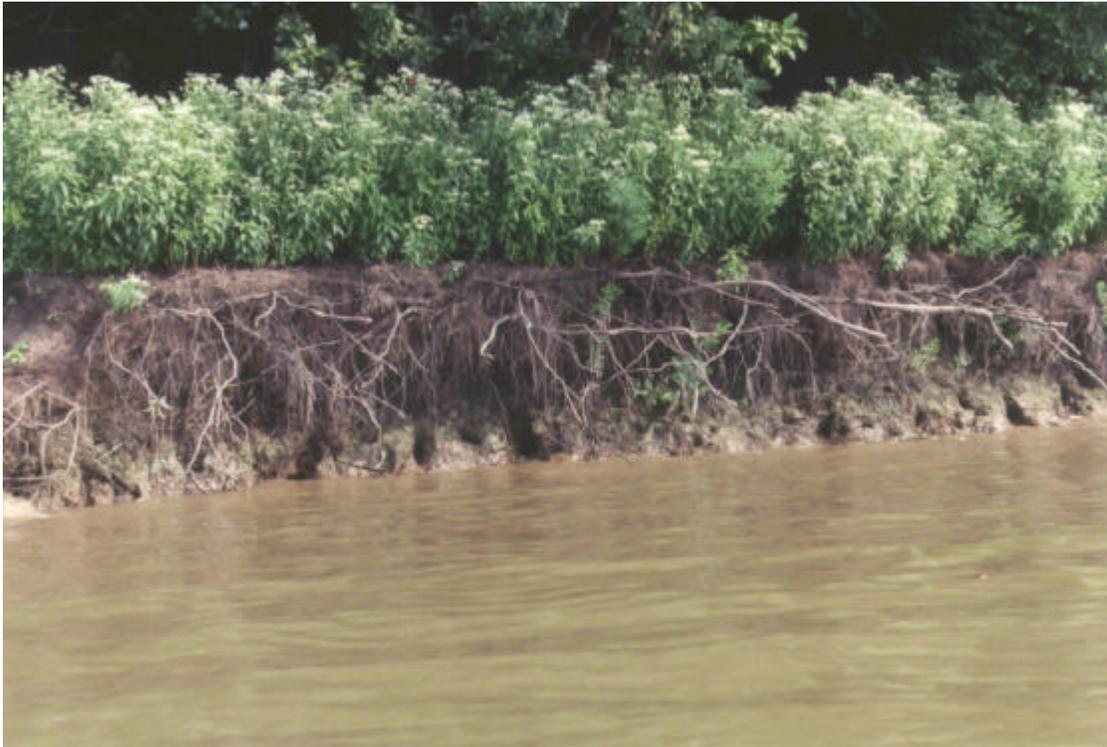
**Figure 6-65. Site 8 on the Illinois Waterway**

The site is about 330 feet from the sailing line. Hagerty (1988) recorded this site as severely eroded, while Bhowmik and Schicht (1980) noted erosion at the opposite bank. The opposite bank had several moored barges at the time of the survey. The site had a steep scarp right on the edge of the water. The scarp is about 3 to 5 feet high and covered with fine roots on the top. These roots belonged to the mature trees inside the bank area, but the top of the bank is covered with tall seasonal vegetation. The scarp was composed of cohesive soil and contains piping holes or holes that riverine animals use, generally with a diameter of 1 to 4 inches. The subaqueous bench was gently sloping, extends far out, and was covered with silt and clay.

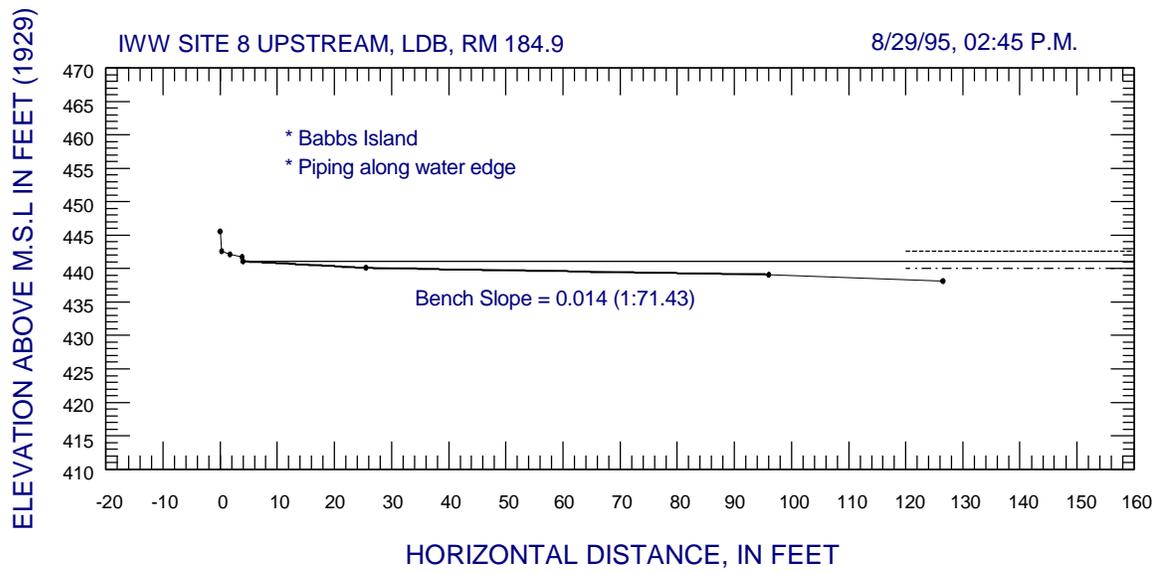
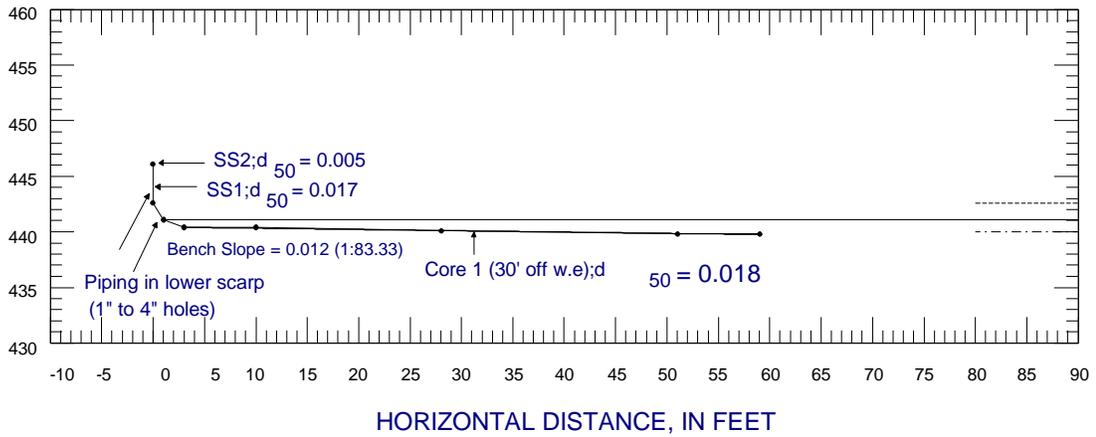
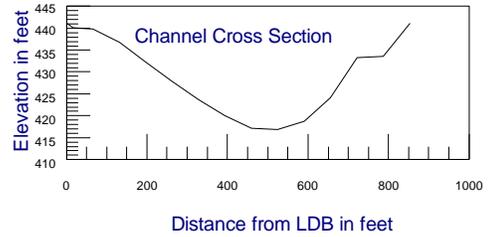
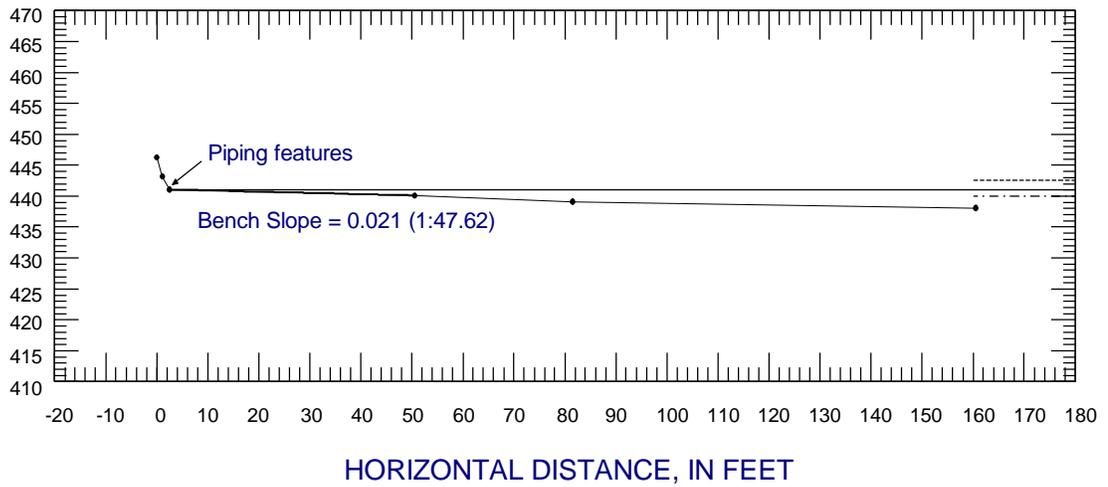
**Figure 6-66. Bank sections at site 8**

Figure 6-66 shows the three measured bank sections and a reduced cross section. The OHW is 442.6 feet and NP is 440.0 feet above msl. The OHW corresponds to the base of the scarp. Floods with stage higher than 447.5 feet (about 10% recurrence frequency) overtop the bank (table 6-18).

Bench slopes varied from 1V:83.3H to 1V:47.6H. This site is classified as a combination of types 4 and 5 (figures 6-21, 6-22, and table 6-4). Bank failures are initiated by piping or burrowing activities from riverine animals. Rework and transport of failed bank soils by wave action at NP appeared to be significant. Wave action probably was responsible for an erosion scarp at water's edge.

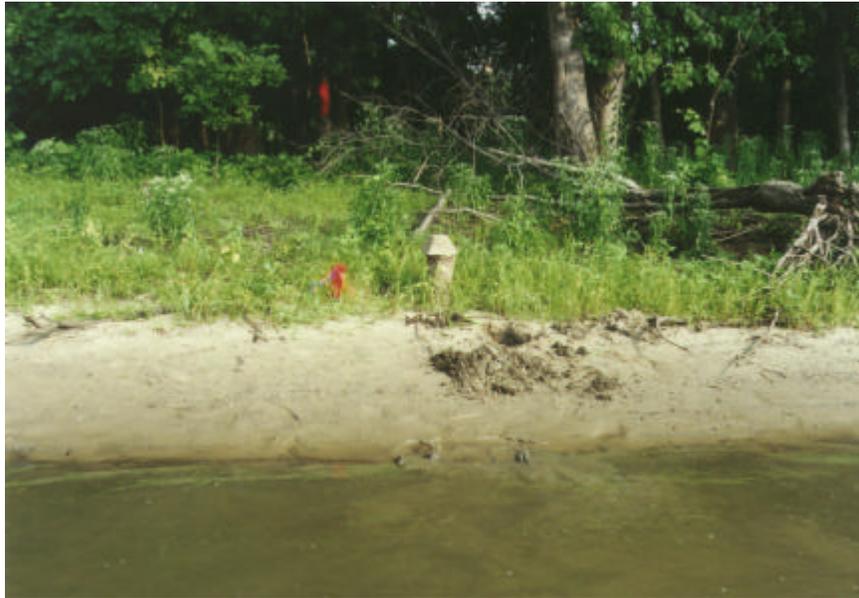
**Figure 6-68. Site 9 on the Illinois Waterway**

The site is about 310 feet from the sailing line, and the Chillicothe Sports & Marine Small Boat Harbor is located across the river. Bhowmik and Schicht (1980) and Hagerty (1988) marked this as an erosion site. The bank was mildly sloped and covered with weeds of medium density. The foundation of an old monument on shore was exposed for about a foot. A scarp about 0.3 feet high existed on the lower bank where the weed zone ends, above sandy bench. A scarp also existed at the water's edge. The wet bench did not support large weights. Submerged nearshore material, however, was hard clay mantled with sand.

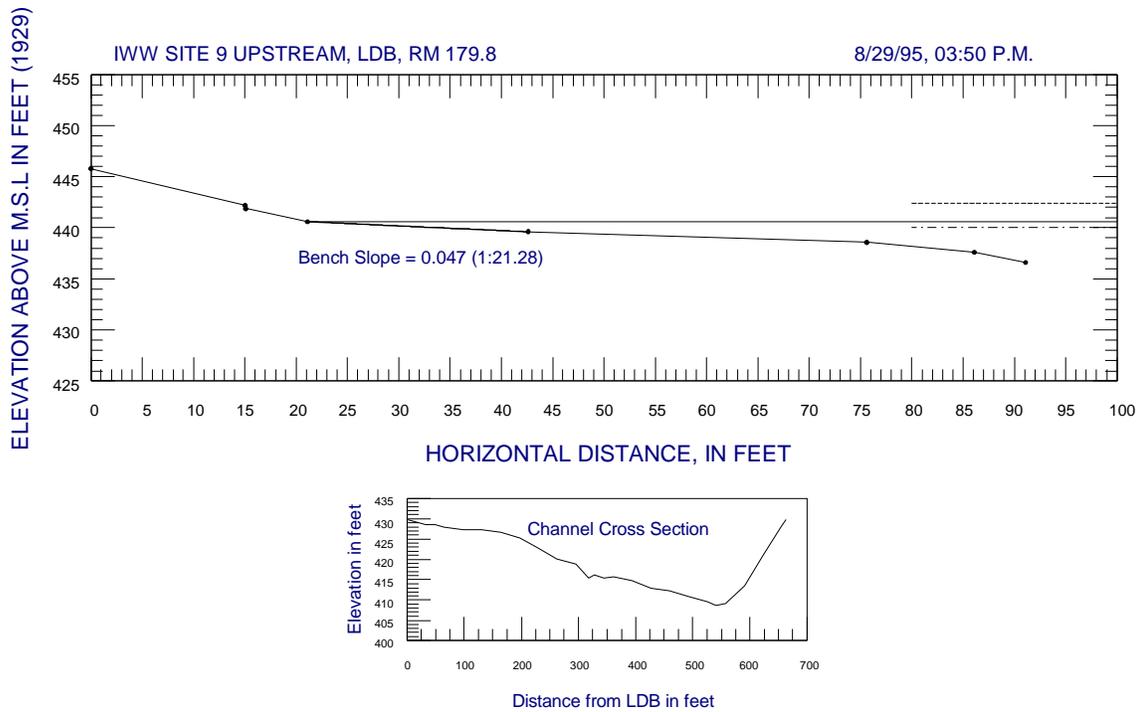
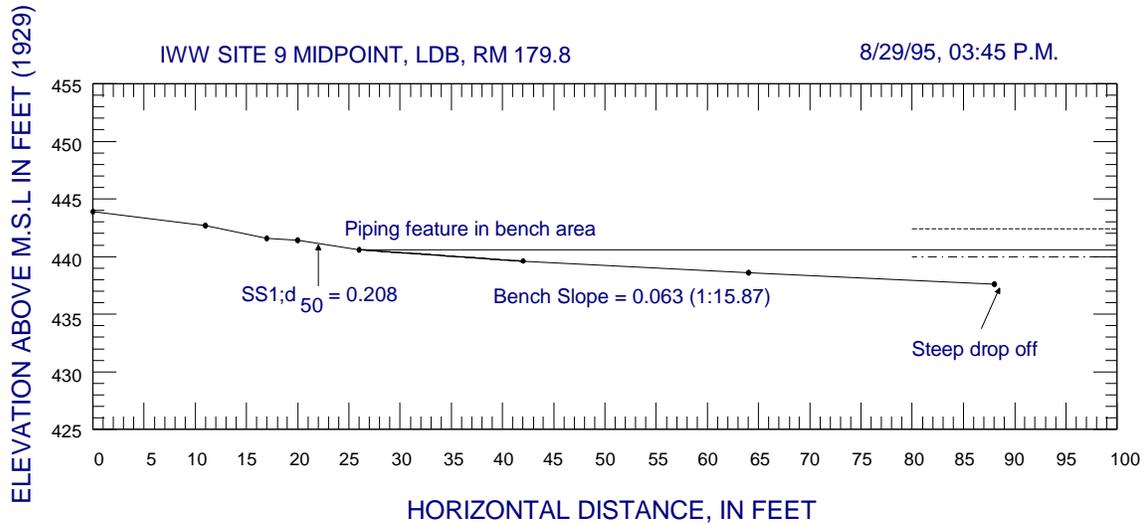
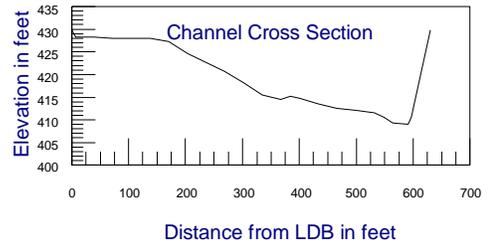
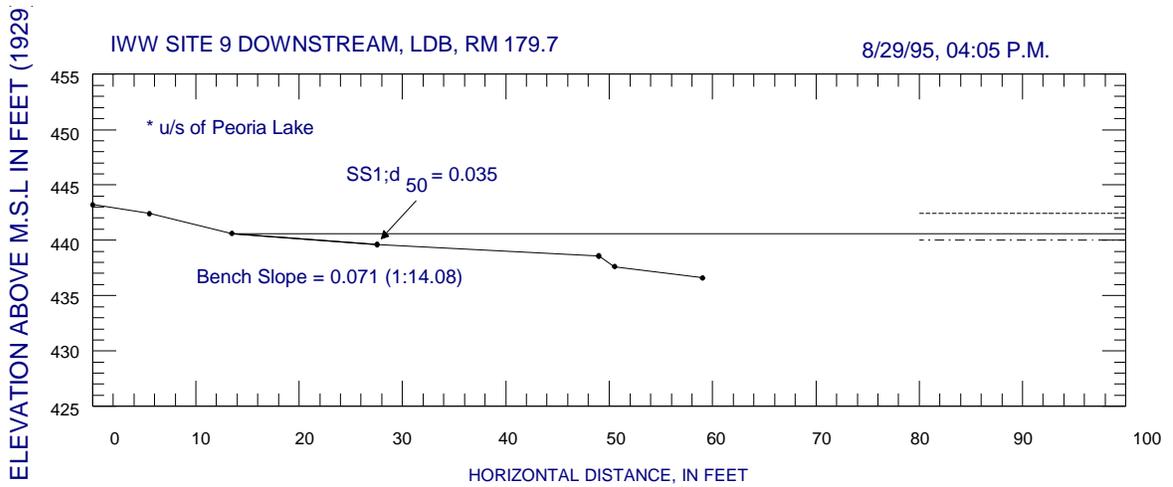
**Figure 6-69. Bank sections at site 9**

Figure 6-69 shows the three measured bank sections and a reduced cross section. The OHW is 442.4 feet and NP is 440.0 feet above msl. The OHW corresponds well to the lower edge of the weed zone. Stage exceeding 447.5 feet (10% recurrence frequency, table 6-19) submerges the entire bank.

The  $d_{50}$  on the bench varied from 0.208 mm at the upstream section to 0.035 mm at the downstream section. Gradation plots of bank soils and nearshore sediment are presented in appendix F. The detailed cross section and coordinates are shown in appendix G.

Bench slopes varied from 1V:21.3H at the upstream section to 1V:14.1H at the downstream section. This site is classified as types 4 and 6 (figure 6-23, and table 6-4). The combinations of wave actions and seepage within bench near NP elevations could be the major causes of erosion at this site. Recreational and commercial traffic volumes are high at site 9. Traffic-induced waves and current can also be the cause of erosion at this site.
