**8. Site 8 at RM 677.5 RDB (Pool 9)**

**9. Site 9 at RM 677.5 LDB (Pool 9)**

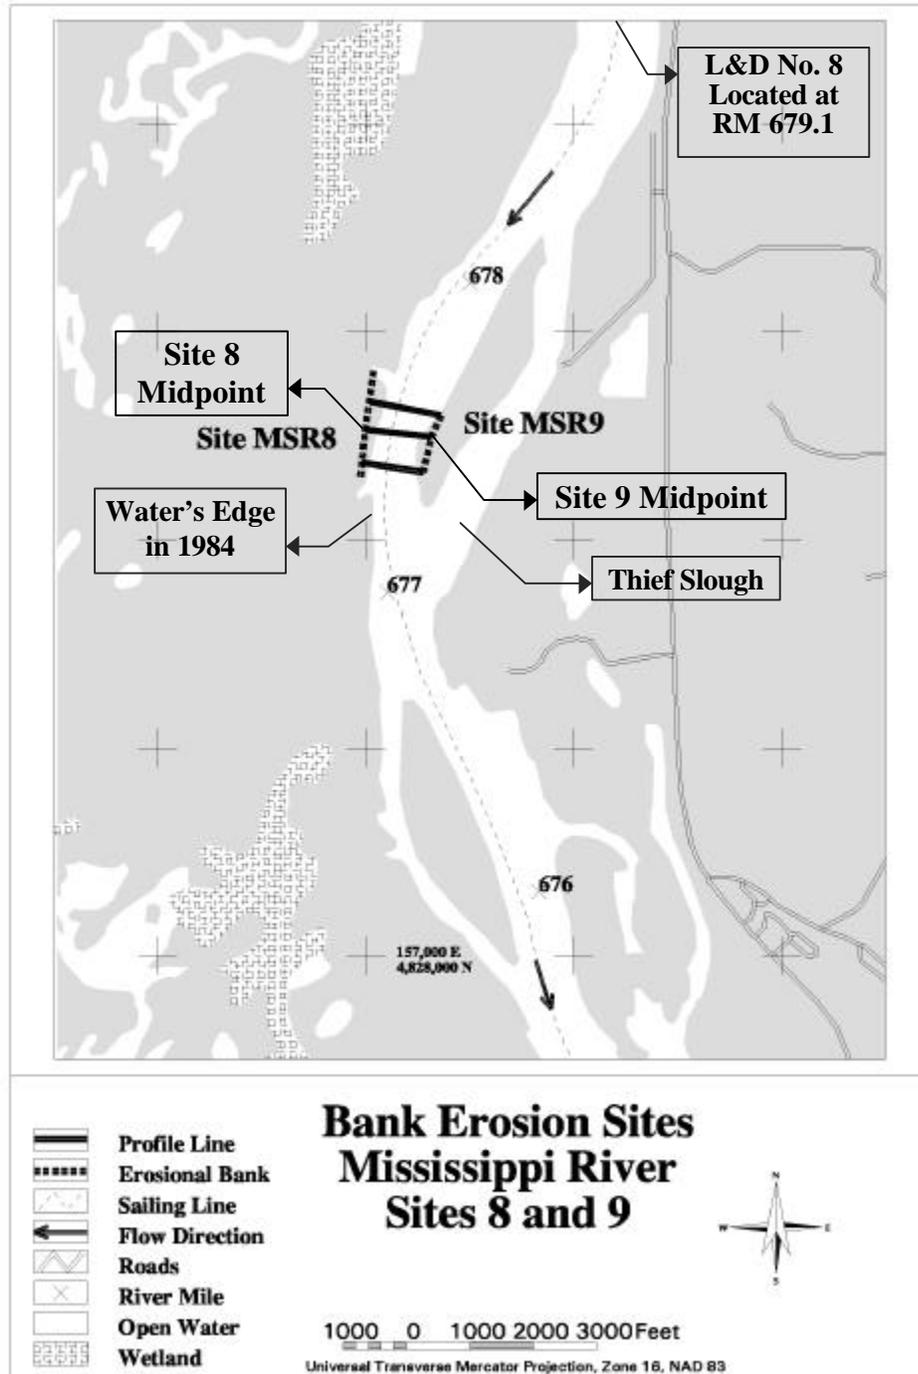
Figure 7-29 A map showing Mississippi River Sites 8 and 9

the bank line at this site had retreated considerably in comparison with that in 1984.

This left-bank site on the inside of a slight bend, shown in figure 7-29, is located opposite Site 8. An upstream view of the site is shown in Photo 7-25. On the other side of this island is Thief Slough. Site 9 is located within a wing-dam field. Bank retreat at this site since 1984 is apparent in figure 7-29. The bank section is shown in figure 7-33, and the bank soils are old dredged material (VFS-MS). A small scarp was covered by a layer of failed grass-root mat.

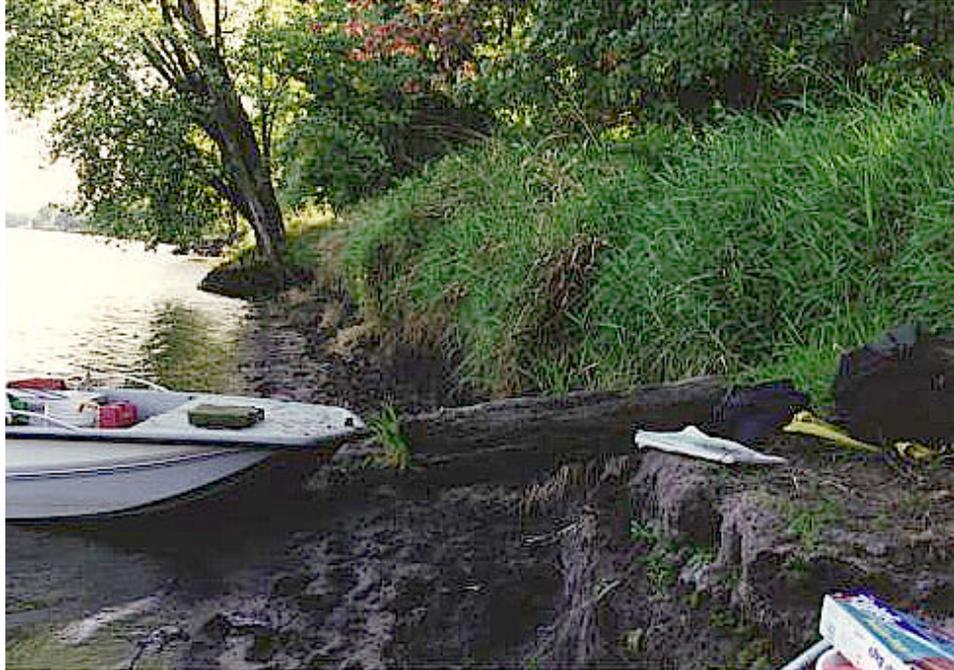
**Photo 7-24 A downstream view of Site 8 midpoint**

This right-bank site on the outside of a slight bend, shown in figure 7-29, is located only about 1.7 miles downstream from Lock & Dam No. 8. A downstream view of the site is shown in Photo 7-24. Three bank sections obtained at this site are plotted in figures 7-30 through 7-32. The bank soils are predominantly coarse silt (CST defined in table 7-3), and piping features were observed within the entire bank face. The river cross

Causative factors for bank retreat at this site include flood-flow erosion, wave-flow related rework-transport of failed soils and recently deposited sediments, and piping. Potential for wave erosion of bench areas is significant. This site is classified as Type C.

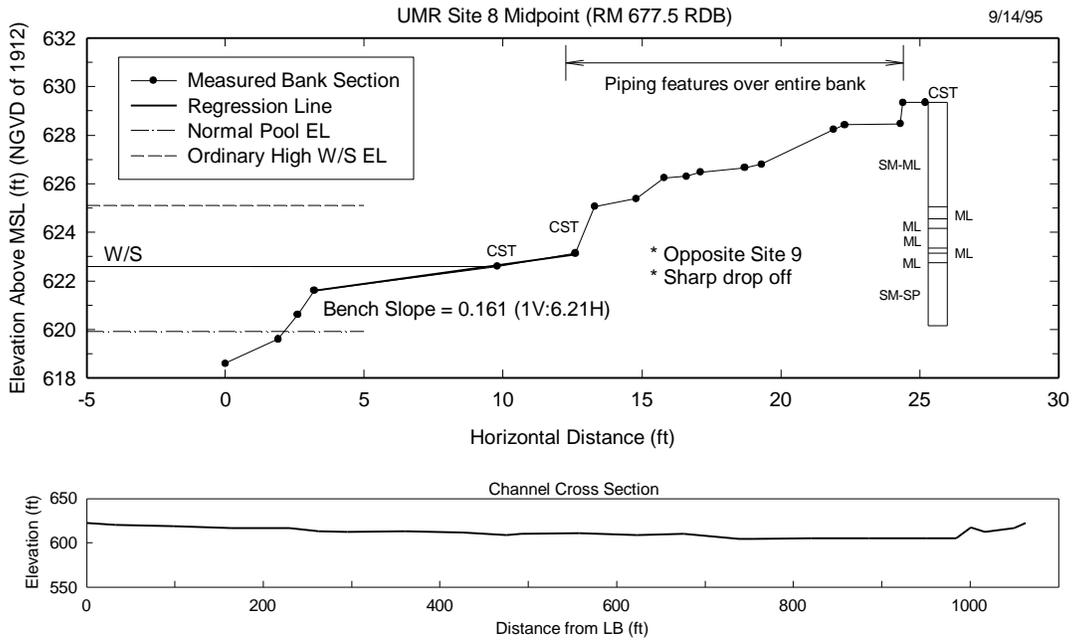
**Figure 7-31 Bank section and channel cross section measured at Site 8 midpoint**

section shown in figure 7-31 is typical for a river bend. Bed level at this site drops off sharply, and the thalweg sailing line is very close to the site. As shown in figure 7-29,

Historical alluvium was encountered from the surface to a depth of 4.3 ft, as shown in figure 7-31. Below the alluvium are late Holocene levee deposits with two buried soils. Multiple-age Holocene surfaces are encountered in this part of Pool 9. The

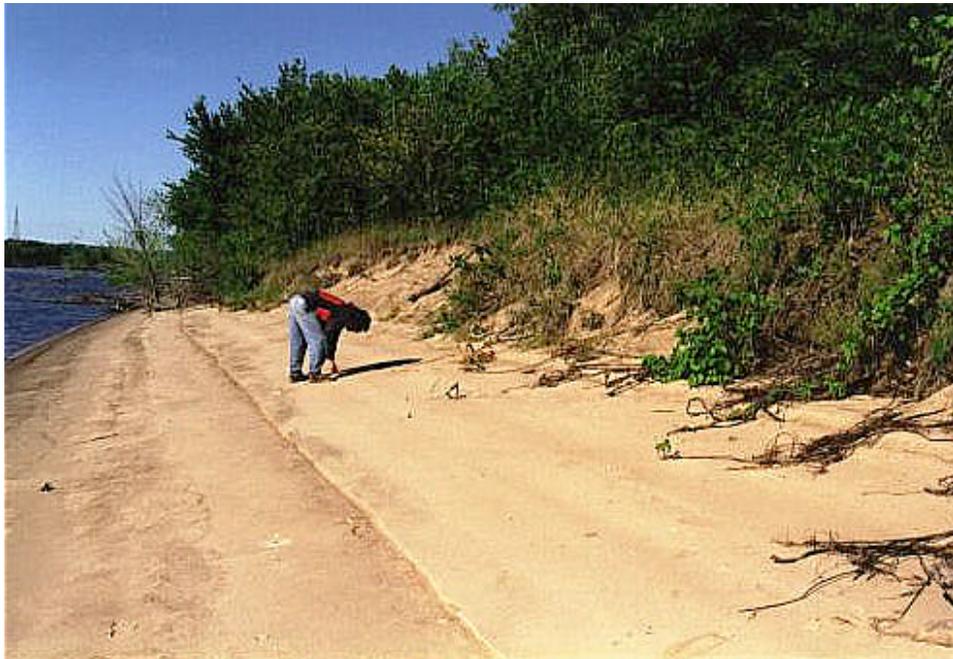
**Photo 7-25 An upstream view of Site 9 midpoint**

The site is far from the thalweg sailing line. Causative factors for bank retreat at this site include wave and rework-transport of failed soils and recently deposited sediments in berm and bench areas, and flood and secondary current erosion. Because of the nature of sandy bench cover, there is potential for wave erosion in bench areas. This site is characterized by a combination of bank Type E and Type F.

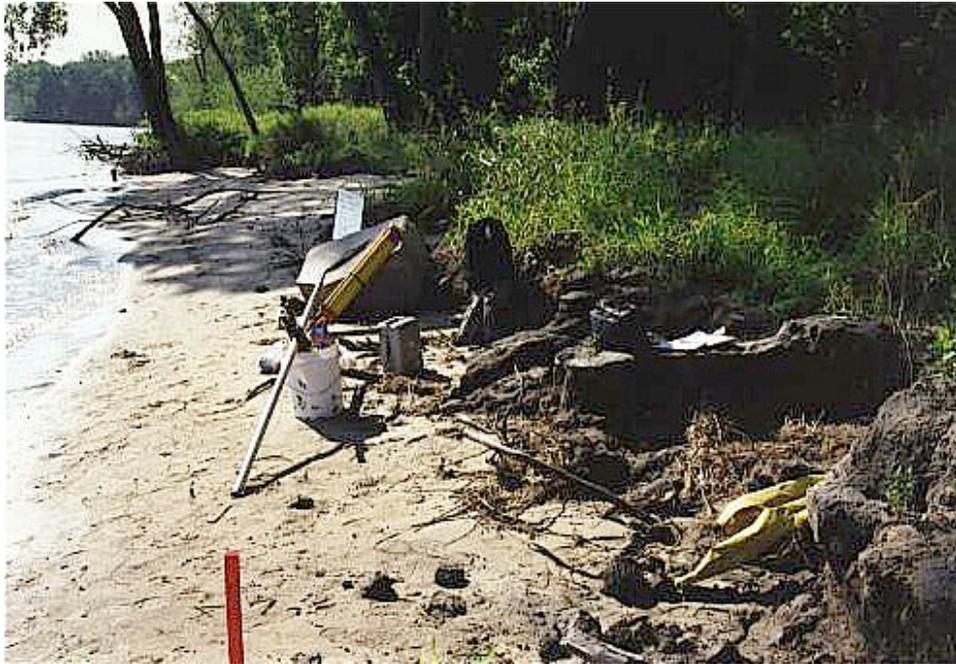
**Photo 7-26 A downstream view of Site 10 midpoint**

This right-bank site on the outside of a mild bend, shown in figure 7-34, is located only about 1.5 miles downstream from the mouth of the Upper Iowa River. The bank is covered by fine silt (FST) and sand (VFS-MS), and subaqueous soil is silt (FST-CST). A downstream view of the site is shown in Photo 7-26, and a close-up view of the scarp is shown in Photo 7-27. Three bank sections are shown in figures 7-35 through 7-37. Numerous fresh, fallen silty soil blocks, 6 in. to 2 ft high, were found along the sand

Causative factors for bank retreat at this site include flood-flow erosion, secondary currents, overland flow, wave and rework-transport of failed soils and recently deposited sediments, and piping. There is potential for wave erosion in bench areas. The bank section at this site is classified as a combination of bank Type D and Type E.

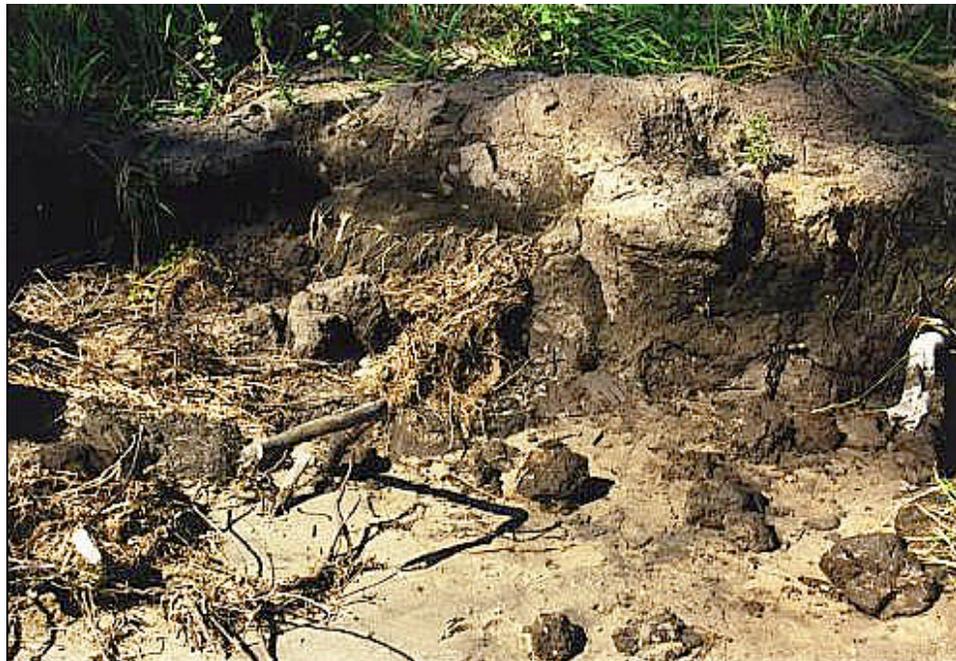
bench, which indicates that Site 10 is an active bank failure and erosion location. At the upstream section, a rocky bottom was observed about 30 ft from the water's edge (see figure 7-35).

**Photo 7-27 A close-up view of scarp at Site 10 midpoint**

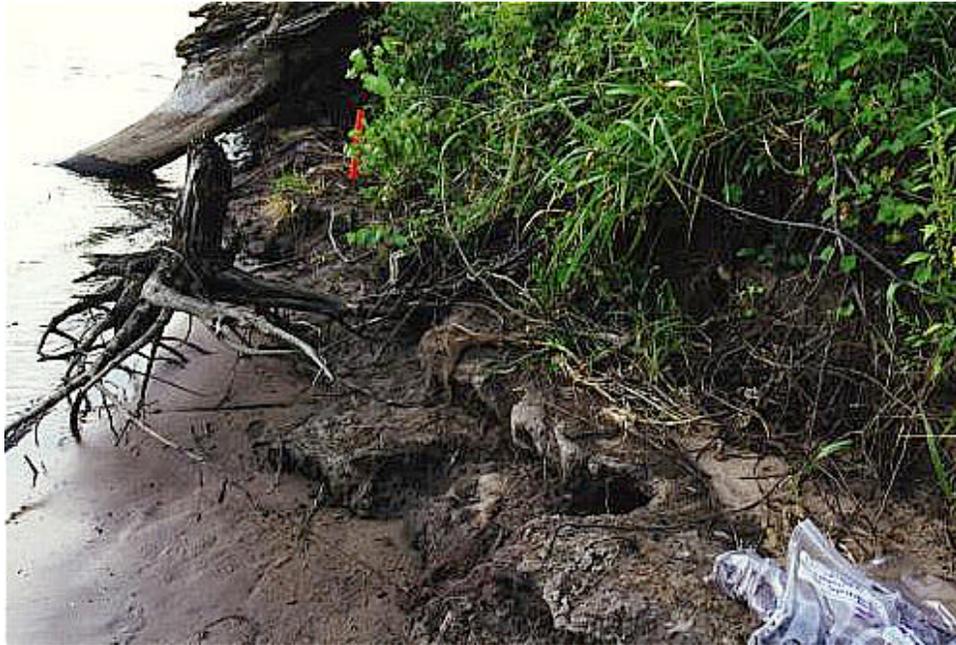
**Photo 7-28 An upstream view of Site 11 midpoint**

This island site, shown in figure 7-38, is located within a relatively narrow section of the valley, about 5.5 miles upstream from Lock & Dam No. 10, in the crossover reach between two mild bends. Upstream and downstream views of this site are shown by Photos 7-28 (see undercutting) and 7-29, respectively. Three bank sections are shown in figures 7-39 through 41. There are two wing dams, the upstream wing dam extends about 700 ft, and the downstream wing dam extends approximately 1,000 ft from the island. The midpoint section is just upstream from the longer downstream wing dam. The river

Causative factors for bank retreat at this site include flood-flow erosion, rework-transport of failed soils and recently deposited sediments within bench areas, undercutting, and piping. Because this site is located away from the sailing line along the right bank, impacts of traffic-induced waves on erosion of bench areas is minor. This eroded bank is classified as a combination of bank Type D and Type E.

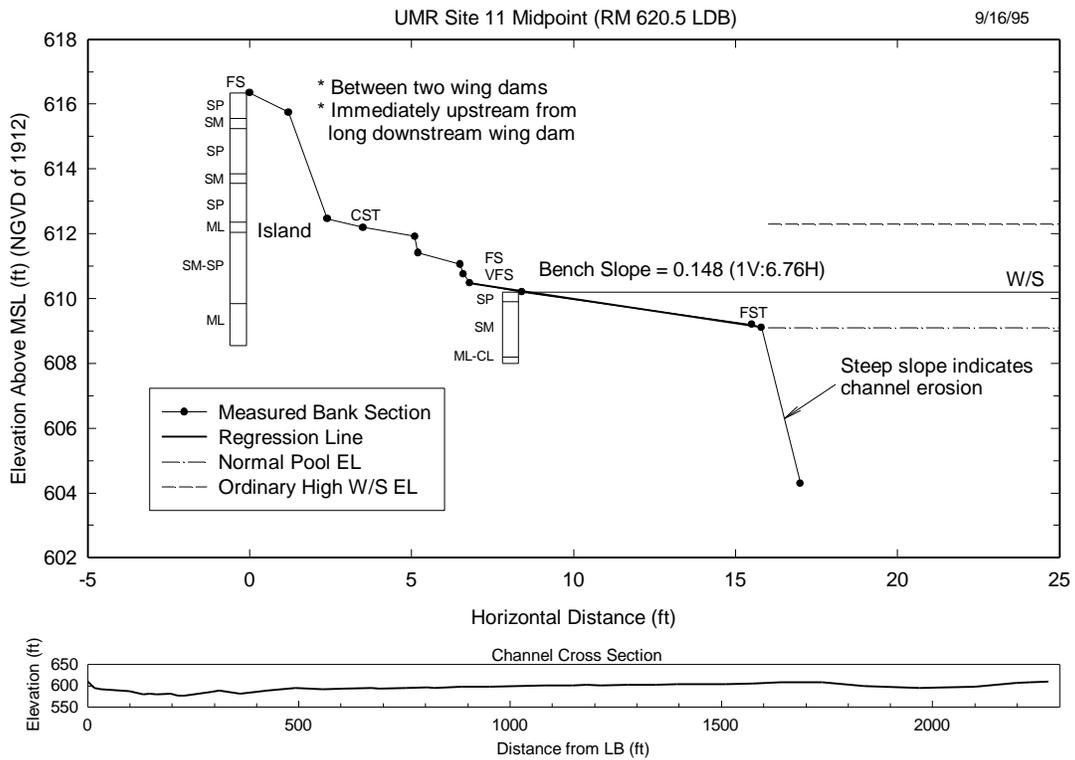
**Figure 7-40 Bank section and channel cross section measured at Site 11 midpoint**

cross section in figure 7-40 seems to indicate that the thalweg developed along this left bank. It appears that the shorter upstream wing dam is not able to direct river flow

toward the main channel, which resulted in strong currents impinging on the longer downstream wing dam, eroding the subaqueous bank at the midpoint section. The bank section in figure 7-40 shows a sharp drop of the bed near the bank. At both the upstream and downstream sections, near-bank water depth was small. The bank soils consist primarily of coarse silt (CST) and sand (VFS-FS).

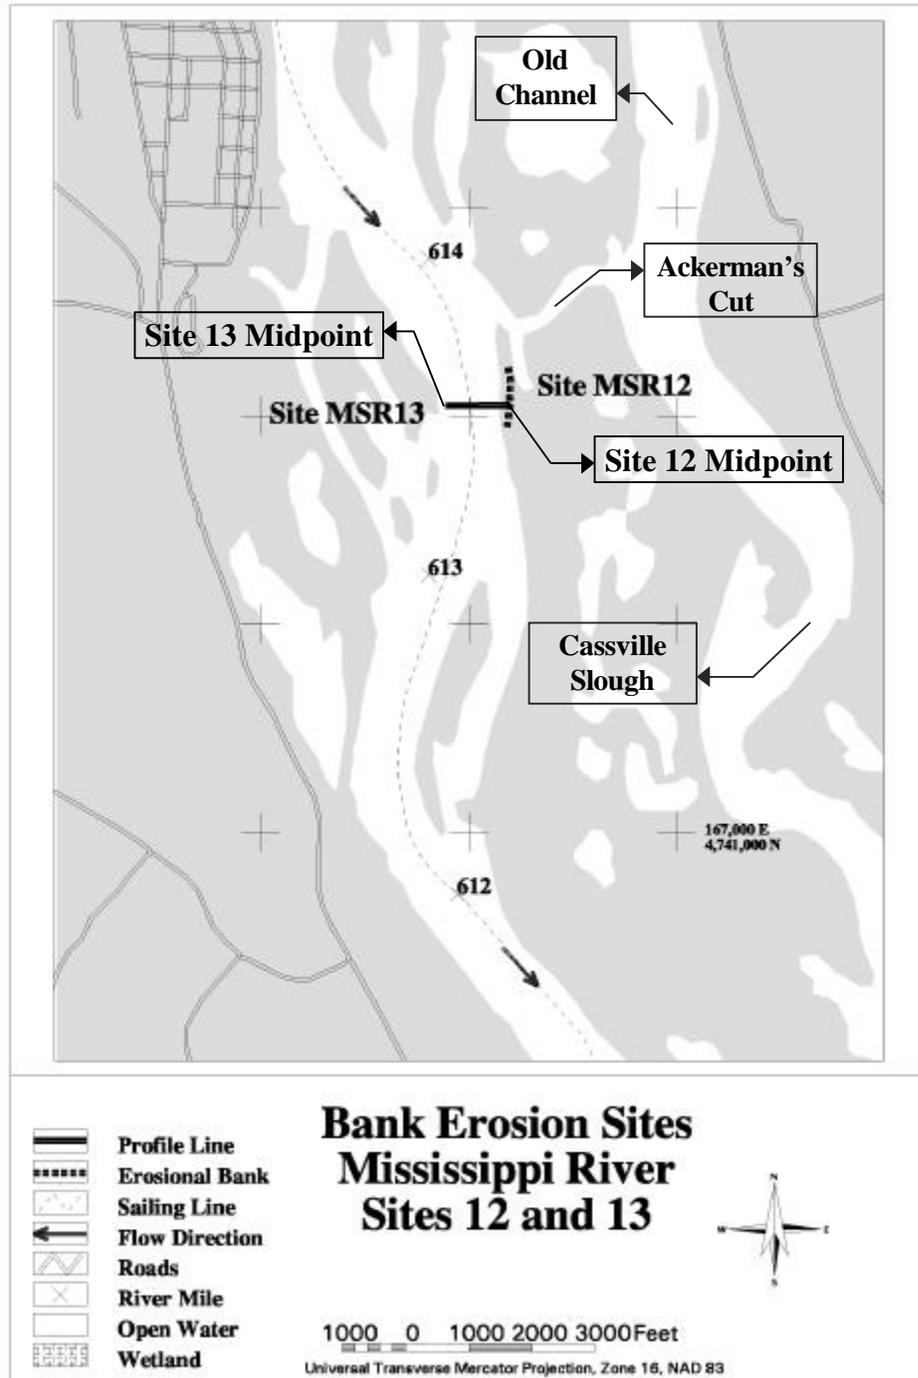
**Figure 7-42** A map showing Mississippi River Sites 12 and 13

7-43 through 7-45. Bank retreat at Site 12 since 1984 is apparent in figure 7-42. As can be seen in figure 7-44, the thalweg is very close to this left bank, and evidence of severe channel erosion was observed at the site. This site was a dredged material disposal site. At the upstream section, failed revetment rocks were found adjacent to the water's edge (see figure 7-43). Since the upper end of Cassville Slough (eastern limb of the MR) was closed when Lock & Dam No. 10 was completed in 1938, the new MR channel flow, downstream from the dam spillways located on the west side of the river, had a tendency to return to the old channel slough, resulting in Ackerman's Cut. According to Nakato (1983), as much as 28 percent of the river flow was passing through Ackerman's Cut, causing reduction of sediment-transport capacity of the main channel and transport of sediment into the slough. In order to protect the fishery resources of Cassville Slough and to reduce dredging requirements in the downstream navigation channel, the COE-RID constructed partial closure structures in Ackerman's Cut in 1985. A post-construction study was conducted in 1986 and it was found that the flow diversion rate was reduced to 18 percent from the previous 28 percent (Toda and Nakato 1987). The bank was covered

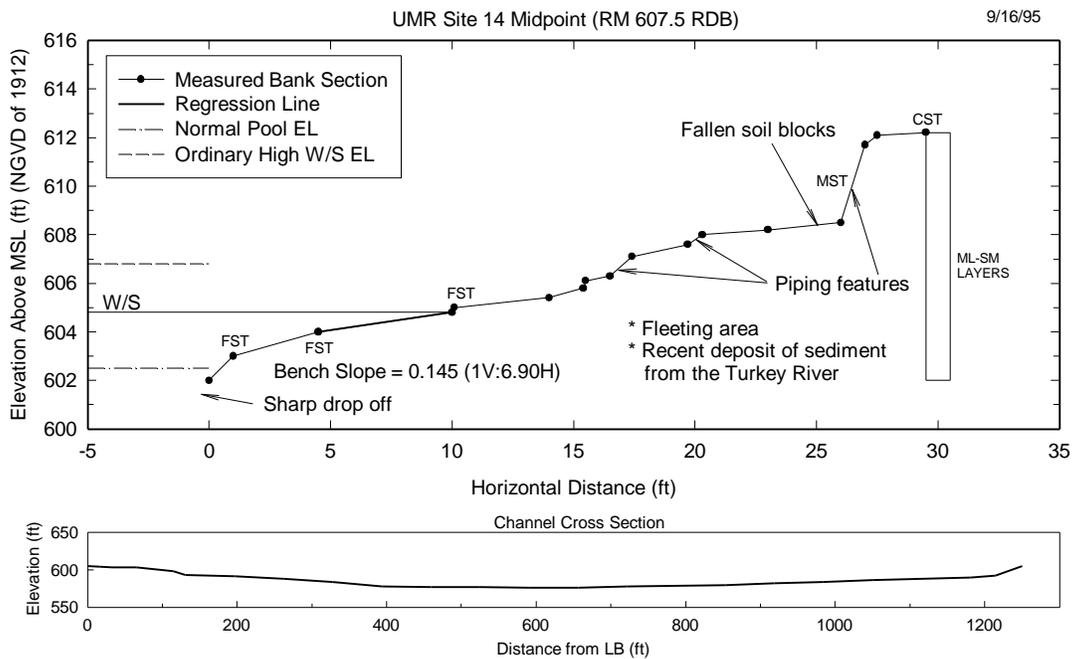
**Figure 7-49 Bank section and channel cross section measured at Site 14 midpoint**

50. The bank soils consist of fine silt (FST) to coarse silt (CST). Fallen soil blocks were observed at the base of the scarp, and piping features were observed within the bank scarp as well as at minor scarps within the berm and bench rework-transport zones. As can be seen in figure 7-49, the surveyed river cross section is atypical for a river bend because the site is located near the upstream end of the bend.

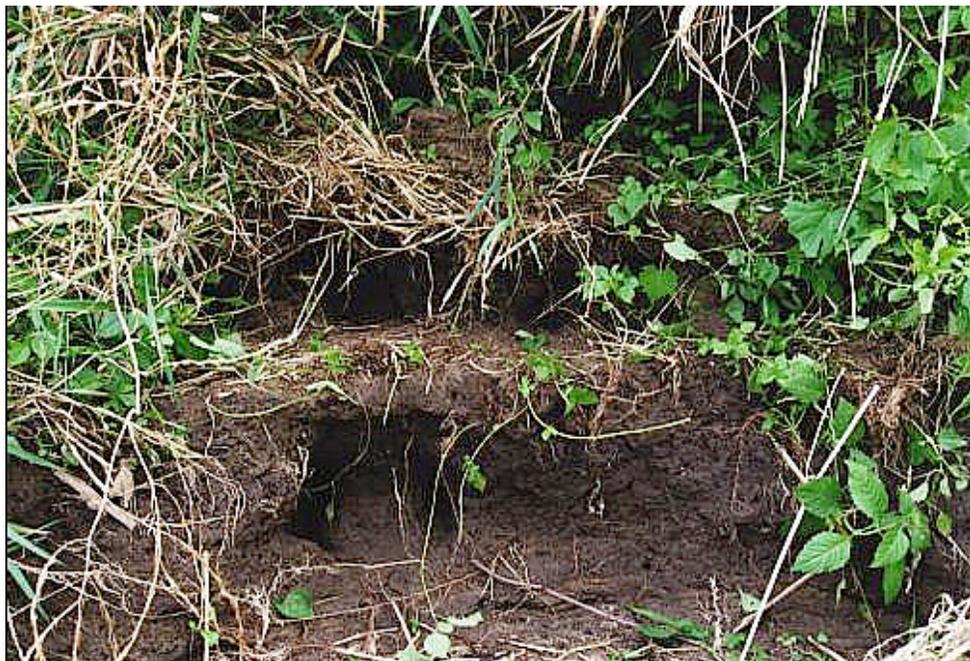
**Photo 7-36 Piping feature of Site 14 midpoint**
