**Ice Jam near Minneapolis Water Works Plant Intakes,
Mississippi River at Minneapolis, Minnesota.
November-December, 1991**

December 10, 1991

MEMORANDUM FOR RECORD

SUBJECT: Ice Jam near Minneapolis Water Works Plant Intakes, Mississippi River at Minneapolis, Minnesota, November-December, 1991. (PDF)

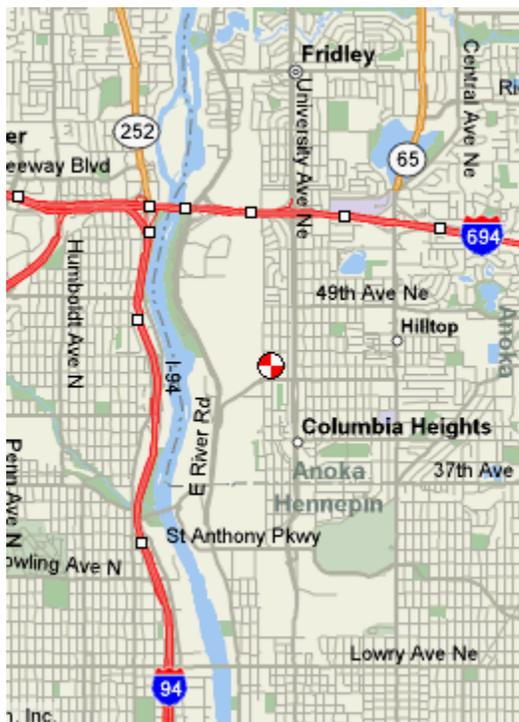
24. A good deal of information and experience was obtained during this ice jam event. Enclosed with this MFR is a map showing the location of the jam, a copy of the ice jam field survey, and a graph showing the rate of rise of the water surface elevation at the Minneapolis Water Works pumping station due to the ice jam.

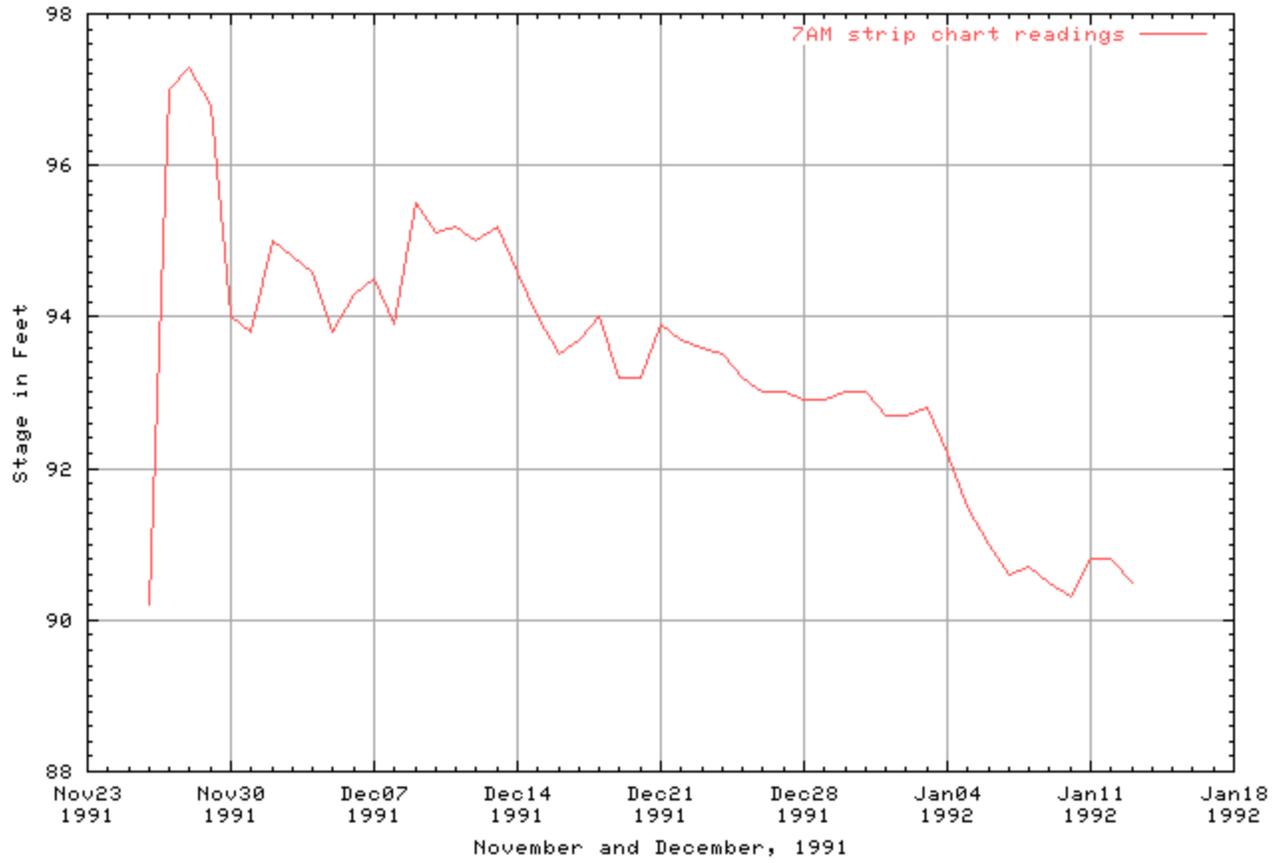
Ice Jam near Minneapolis Water Works Plant Intakes,
Mississippi River at Minneapolis, Minnesota

15. We visited the pumping plant where the intakes for the City are located. The pumping station houses the strip chart gage recorder. Personnel at the pump station were very helpful in explaining their operations and observations they had made during the ice jam event. Some of their observations included the following: a) The ice forms later and breaks up sooner since completion of the power plant upstream at Monticello. b) The Water Works has photos showing construction of the main intakes and pipes across the river. The photos show the pipes being constructed on top of the ice. c) In recent years, beavers have moved onto the islands near the west bank. The beavers have been felling small and medium size trees which have float downstream and become lodged in the pier structure of the Soo Line Railroad Bridge, especially on the west end of the bridge. I obtained a copy of the strip chart records for November 26th and 27th. Since this is a continuous recording chart, the growth of the ice jam induced stage increase is clearly plotted.
