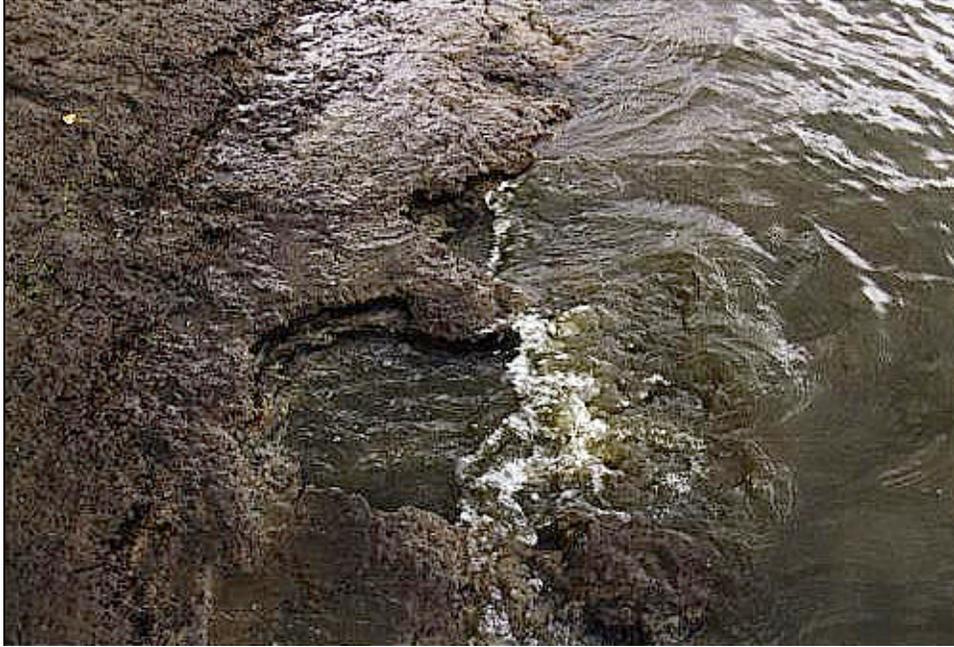
Photo 7-37 A close-up of bench of Site 14 midpoint

Causative factors for bank retreat at this site include flood-flow oversteepening and rapid recession slumping, wave and rework-transport of deposited sediments within berm and bench areas, and piping-related cantilever and block failures (see Photo 7-36). The thalweg sailing line is remote from this site; however, heavy fleeting activities surrounding this site generate significant waves (see Photo 7-37 for evidence of wave erosion). A combination of Type A and Type B characterizes Site 14.

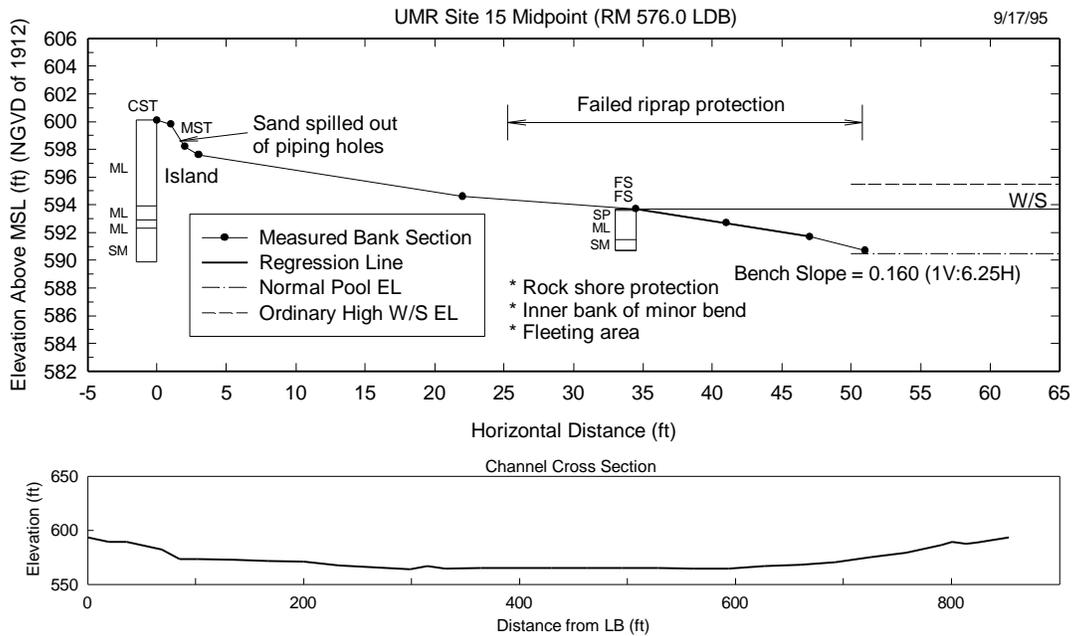
Figure 7-53 Bank section and channel cross section measured at Site 15 midpoint

field are shown in figures 7-52 through 7-54. The bank soils are primarily MST to CST and the soil near the water's edge is FS. Subaqueous sediments are sand (VFS-FS). Failed revetment stone was observed along the bench, as indicated in figure 7-53.

The site is on a late Holocene island, and two sampling tube cores advanced at the site showed thick historical alluvium to at least 10 ft, as shown in figure 7-53. Archaeological site 11JD124 is located approximately 1 mile upstream from the erosion site, and site 11JD126 is about 1 mile downstream.

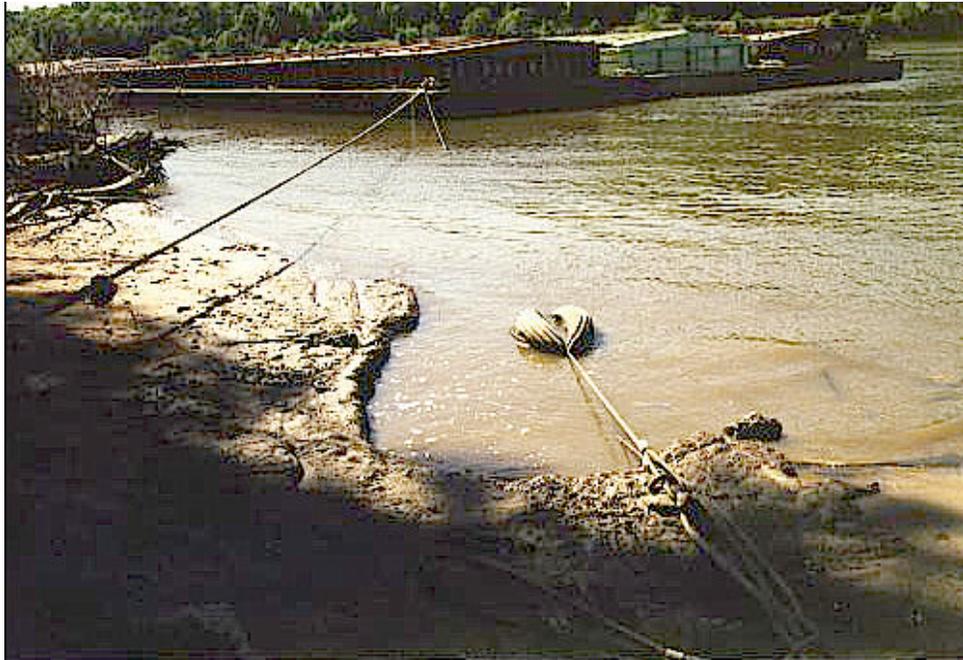
Photo 7-39 Disturbed bankline of Site 15 midpoint

Evidence of severe erosion was observed where barges were moored. Heavy infestation of zebra mussels was observed on riprap materials as well as on moored barges. Photo 7-39 shows the bankline disturbed by mooring activities. There were some piping features within the scarp, and fine sand at the midpoint section was being displaced by piping (see Photo 7-40). Causative factors for bank retreat at this site include wave

erosion and rework-transport of failed soils and recently deposited sediments, piping-related failures. This site has been subject to barge run-up and beaching. The site can be classified as Type C.

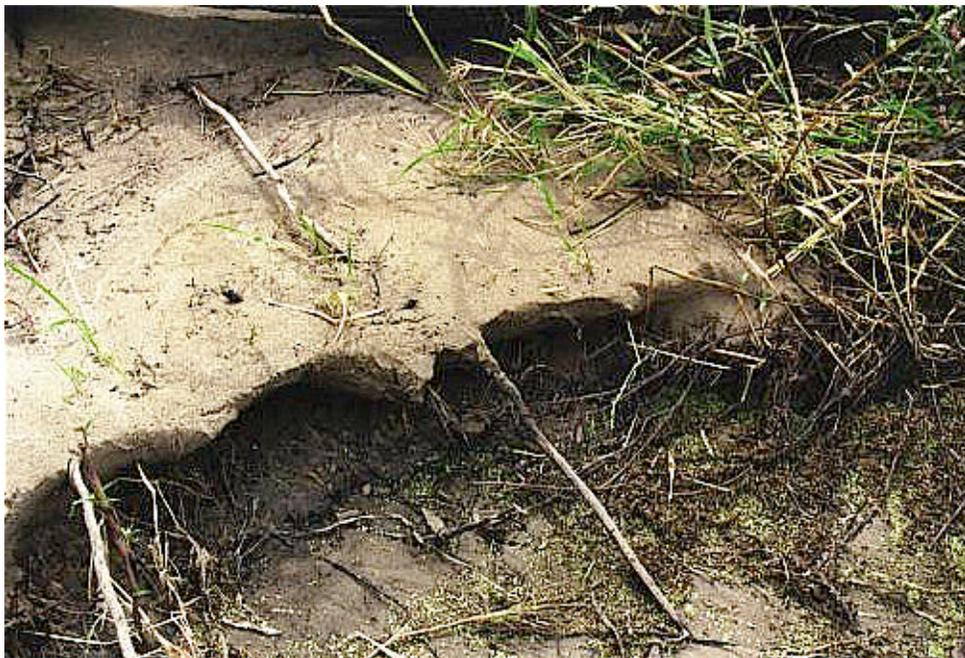
Photo 7-48 Sand removal near toe of island of Site 17

This site is a mid-channel island site in a rather straight river reach, 9.8 miles downstream from Lock & Dam No. 14, as shown in figure 7-59. Upstream and downstream views of the midpoint site are shown in Photos 7-45 and 7-46, respectively. Photo 7-47 shows an upstream view of the toe of the island, and Photo 7-48 shows wave removal of sand from the bench cover near the toe of the island. Substantial downstream accretion of the island since 1984 can be seen in figure 7-59. In order to investigate bank erosion characteristics on the island, five bank sections were taken along the channel side and two sections were taken along the back channel (see figures 7-60 through 7-66). The bench area cover is primarily sand with recently deposited silt. Subaqueous sediments are medium sand (MS) at the upstream limit, coarse silt (CST) at the midpoint section, and CST on top of FS at the downstream limit, indicating the reduction in bed-material particle size along the island. The island is located within two large wing dams which extend toward the main channel from the left bank approximately 1,700 ft, and immediately downstream from Beaver Slough along the right bank. Beaver Slough is heavily used by barge traffic, and the area across from this island site is a busy fleeting site. The upstream tip of this island is eroded and the toe of the island appears to be extending downstream, indicating that the island is shifting downstream.

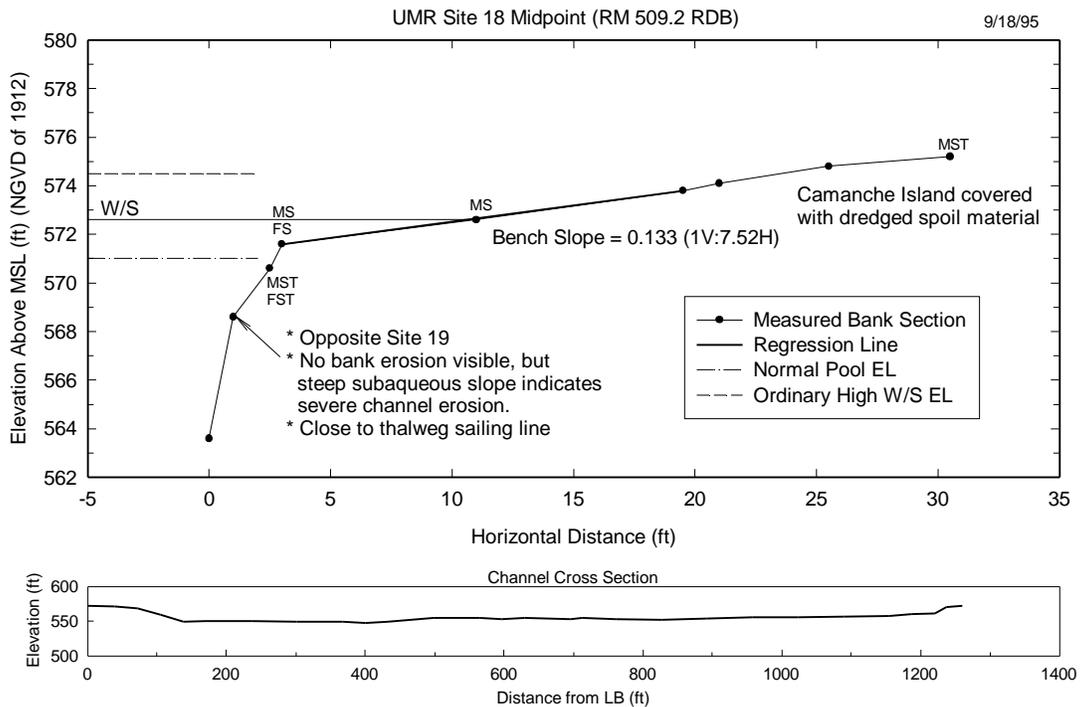
Figure 7-69 Bank section and channel cross section measured at Site 18 midpoint

As can be seen in figure 7-69, the scarp of the subaqueous bank is practically vertical at the midpoint section. Causative factors for bank retreat at this site include primarily undercutting by currents, and wave and rework-transport of recently deposited sediments within berm and bench areas. Because of the closeness of the channel thalweg to this site, potential for further in-channel flood-flow erosion exists at this site. This site is characterized by a combination of Types D, E, and F.

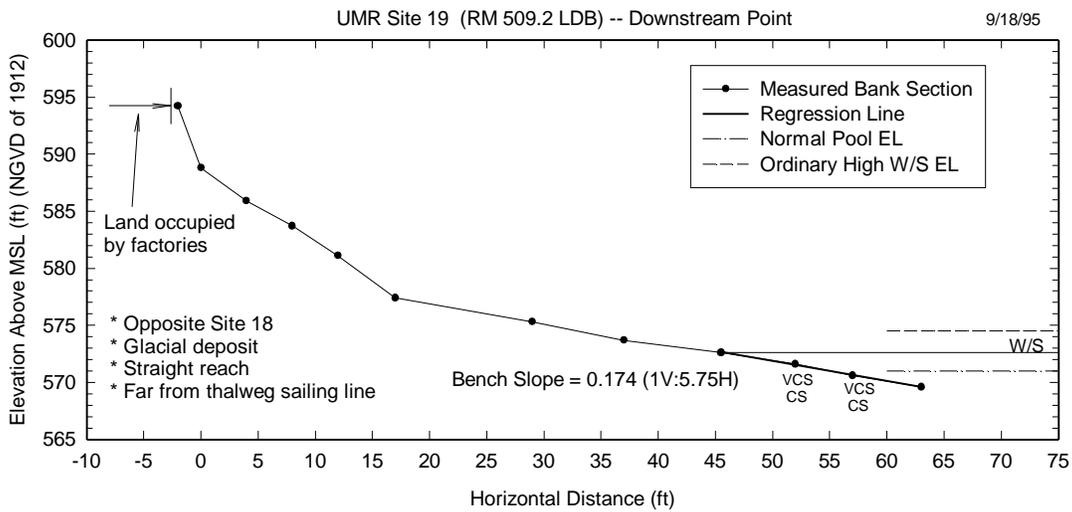
Figure 7-72 Bank section measured at Site 19 downstream point

As shown in figure 7-72, subaqueous bed sediments (CS and VCS) are much coarser than the bank soil, indicating high fine-sediment transport along this site. Causative
