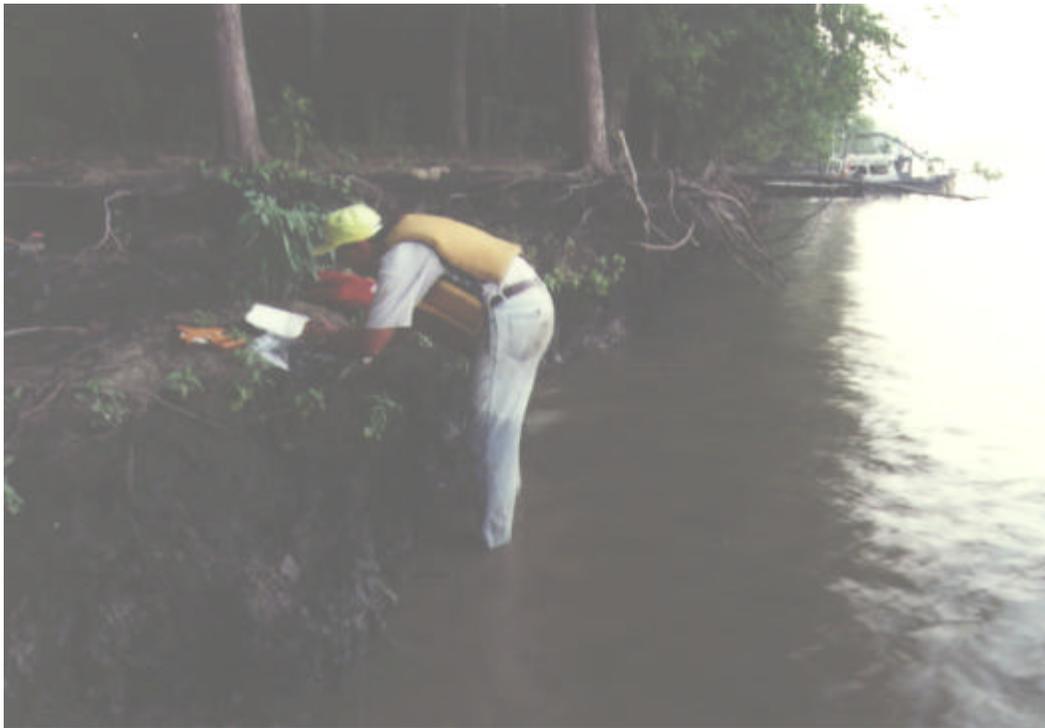
Figure 6-71. Site 10 on the Illinois Waterway

Bench slopes varied between 1V:15.0H and 1V:5.6H, and the subaqueous bench extends more than 70 feet. Soils on the scarp were cohesive. The site can be classified as a combination of types 4 and 5 (figures 6-21 and 6-22, and table 6-4). Piping related internal erosion weakens the bank. Soils exposed and displaced by bank failures are susceptible to removal by wave and current actions during normal stages. Traffic is heavy at this site and could add to the tractive forces by waves and currents.

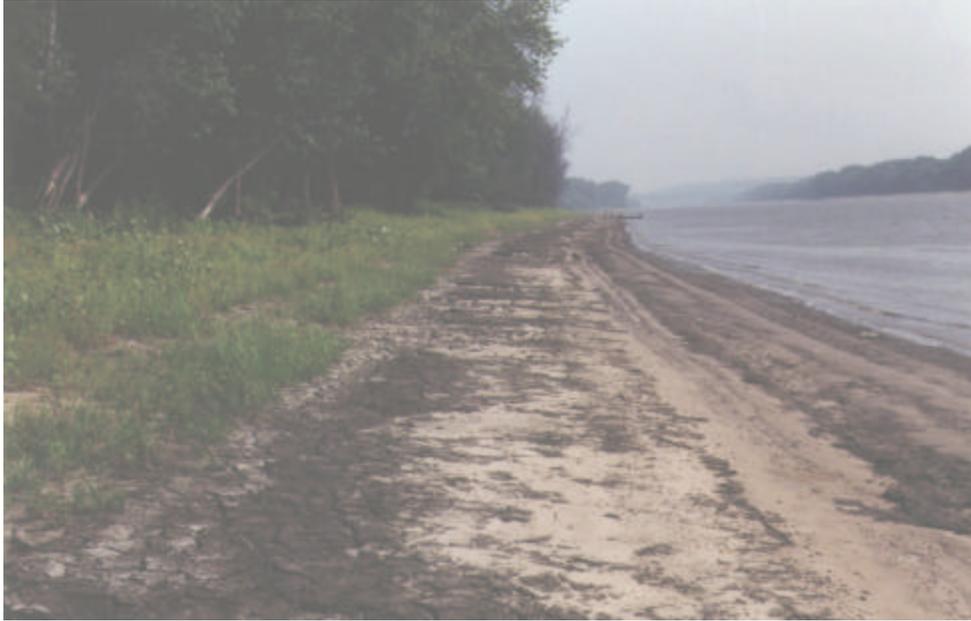
Figure 6-74. Site 11 on the Illinois Waterway

Figure 6-75 shows the three measured bank sections and a reduced cross section. The whole bank is mildly sloped with a small scarp remote from the water at the top of the bank. Trees with exposed roots exist at the crest of the bank, above a weed zone and a bare bench with several small wave scarps covered with recent sediments. The OHW is 440.8 feet and NP is 429.5 feet above msl. Stage fluctuations at the upper part of the pool are generally large, and banks often are presented with mildly sloped benches. The OHW can reach the upper part of the bank close to the base of a small scarp at the downstream section. Table 6-21 shows the recurrence frequencies for various stages at this site.

Bench slopes varied slightly between 1V:11.2H and 1V:9.0H. This site is classified as type 6 (figure 6-23 and table 6-4). Wave actions are primarily responsible for rework and transport of failed soil or recently deposited sediments on the bench at various stages within the normal range of pool level fluctuations.

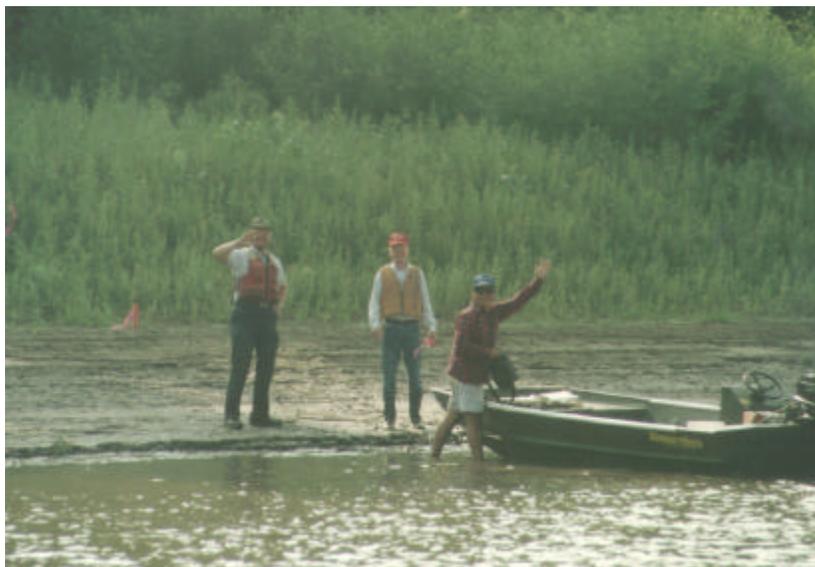
Figure 6-76. Site 12 on the Illinois Waterway

An obvious scarp was present at the water's edge. Figure 6-77 shows the three measured bank sections and a reduced cross section. The wide bench has a mild slope. At the top of the bank, tall trees and a scarp were hidden behind a belt of tall weeds and young willows. Vegetation formed a band approximately 90-100 feet wide on the bank. A berm was present inside the vegetation zone and its soils were desiccated. The open bench area was wet and clayey, and had piping features. The OHW is 440.7 feet and NP is 429.5 feet above msl. At OHW, the water would submerge some of the vegetation on the bank. Small scarps in the vegetation zone were below the OHW level and the scarp at the upstream section was at the water's edge. Table 6-22 gives the recurrence frequencies for various stages at this site.

Bench slopes varied between 1V:16.9H and 1V:9.0H. This site is classified as type 5 (figure 6-22 and table 6-4). Wave action is suspected to be one of the main mechanisms for

erosion, because of the scarps on the sloping bank. Piping also was noted at the lower subaerial bench. Rework and transport could be significant at various stages within the normal range of pool-level fluctuations at this site.

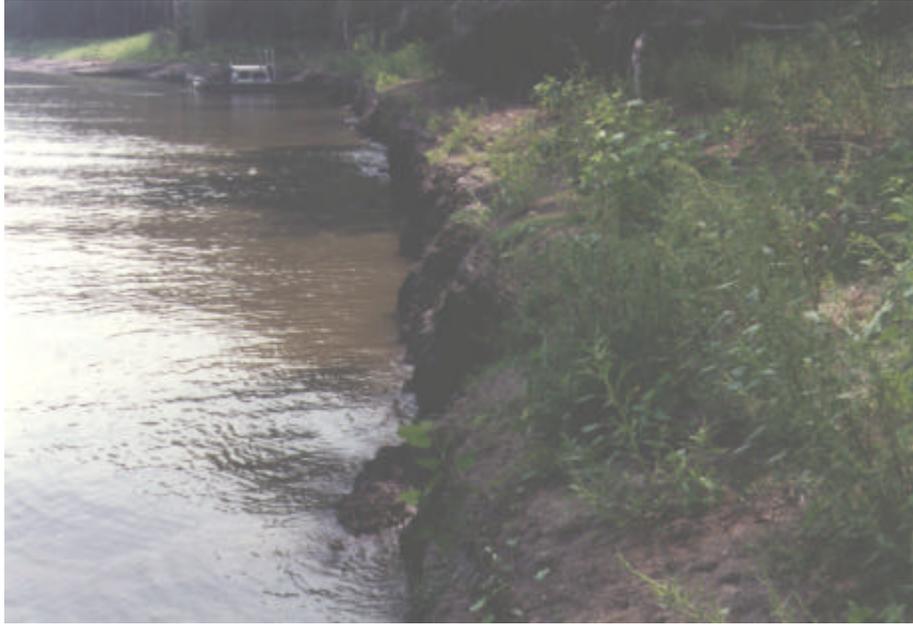
Figure 6-79. Site 13 on the Illinois Waterway

The site is about 370 feet from the sailing line, and there are two barge canals for a coal pit on the LDB at RM 150.9. Hagerty (1988) marked this site as severely eroded and included it as a study site. Bhowmik and Schicht (1980) did not mark this site but marked a reach at the downstream end at about RM 149.5-150.0. A vertical scarp was present right at the water's edge. When tows pass near this bank reach, direct impact is likely, especially when water stages are low. There were multiple scarps on the upper bank. Dredged materials had been deposited here, and two layers of different soils were observed on the bank. There were dense small holes on the bank surface, which may be created by worms. Bhowmik and Schicht (1980) and Hagerty (1988) referenced erosion on both banks at this river mile.

Materials on the scarp are cohesive. This site can be classified as type 4 (figure 6-21 and table 6-4). Under normal stages, waves and turbulence created by traffic are causes for bank erosion. Rework and transport by current at stages within the normal range of pool level fluctuation can be significant. Seepage and nesting worms can also weaken bank strength.

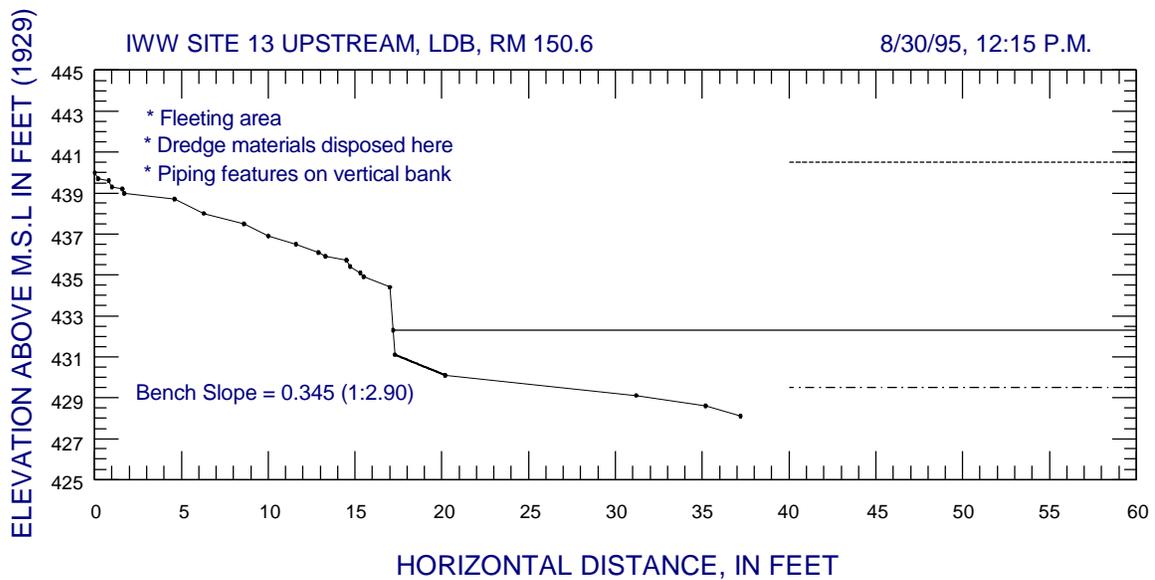
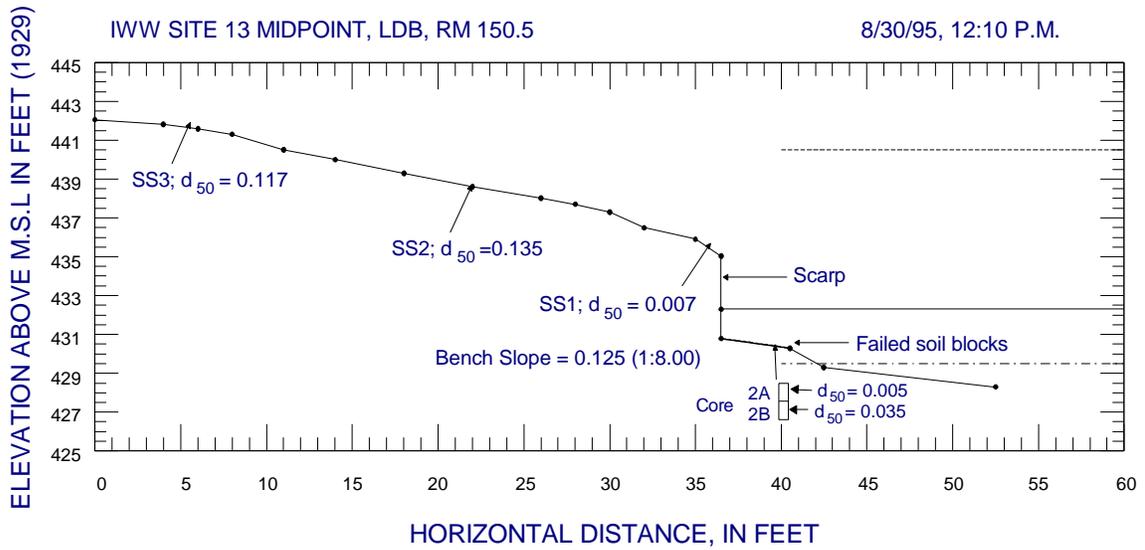
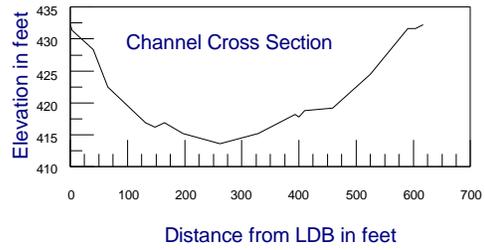
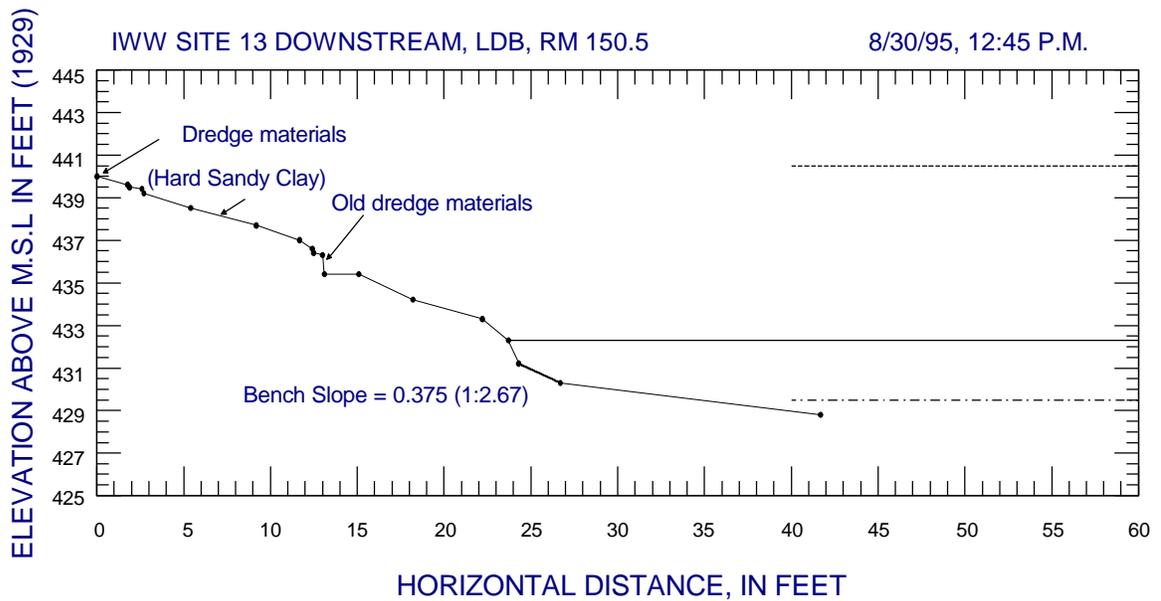
Figure 6-80. Bank sections at site 13

Figure 6-80 shows the three measured bank sections and a reduced cross section. The OHW is 440.5 feet and NP is 429.5 feet above msl. The NP elevation is about at the base of the berm, and the OHW reaches the upper part of the bank. Table 6-23 gives the stages for various recurrence frequencies at this site.

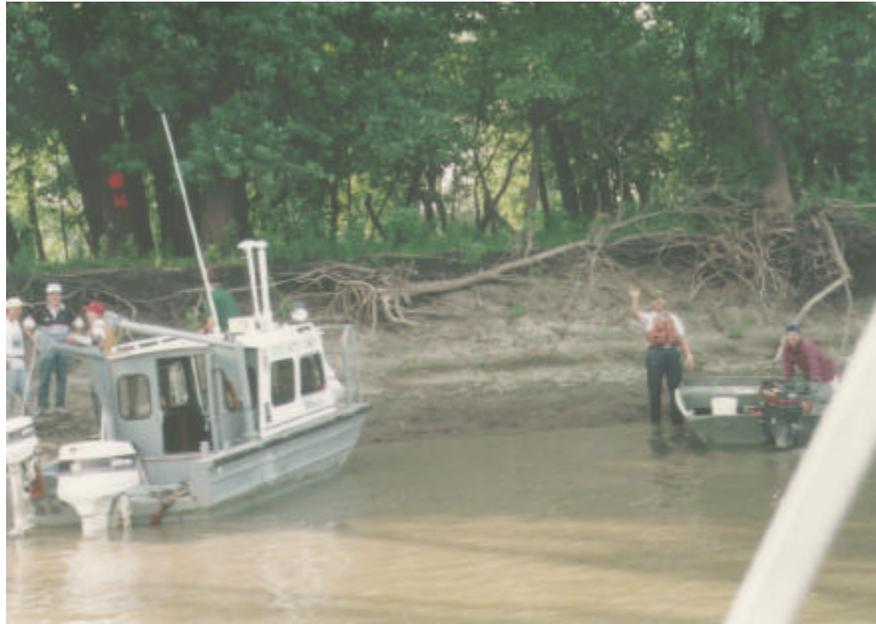
Figure 6-82. Site 14 on the Illinois Waterway

Site 14 is about 270 feet from the sailing line, and no major tributary enters the IWW at this location. Approximately 600 feet behind this site is the East Liverpool Levee System. Bhowmik and Schicht (1980) marked erosion on the opposite bank on an island. Hagerty observed erosion on this bank but not on the opposite bank. Trees are close to the bank crest at many locations at this site, and some roots extended beyond the bank face. A scarp about 1.5 feet high was located on the upper part of the bank, which was covered by seasonal grasses. Several breaks in the bank sections appeared to correspond to different erosion mechanisms at this site. Dislodged peds and some micro-scale piping existed on a bare bench area. The bench between the scarp and the water's edge was covered with moist, soft clay.

Bench slopes varied from 1V:10.1H at the upstream section to 1V:7.9H at the midsection. The slope for the subaqueous bench was 1V:14.5H below a water's edge scarp at the downstream section. The site is classified as type 4 (figure 6-21 and table 6-4). The subaerial bench was wet due to poor drainage. Wave wash, in combination with piping, appeared to have created the downstream small scarp on the bench. Rework and transport of failed soils and recently deposited sediments at stages within the normal range of pool-level fluctuations could be significant.

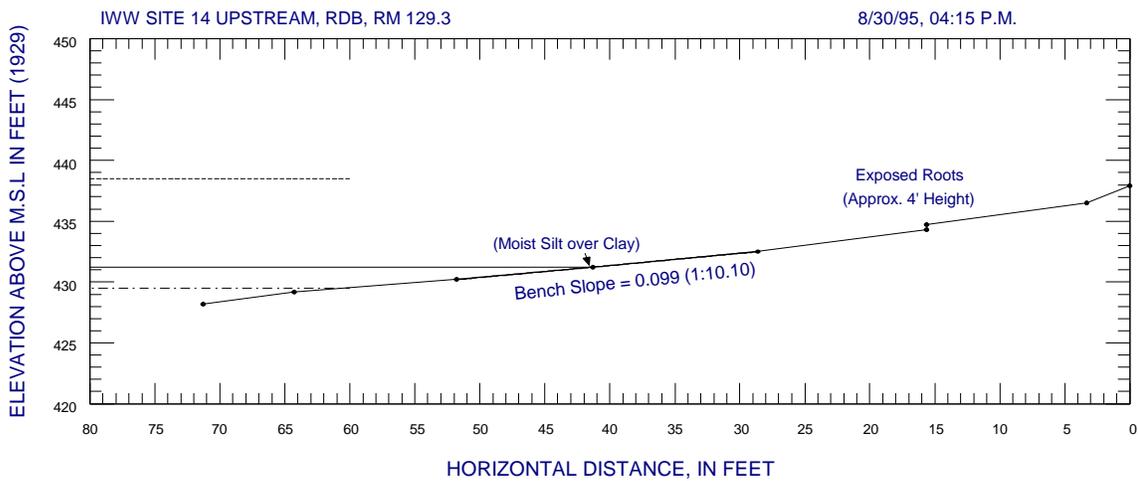
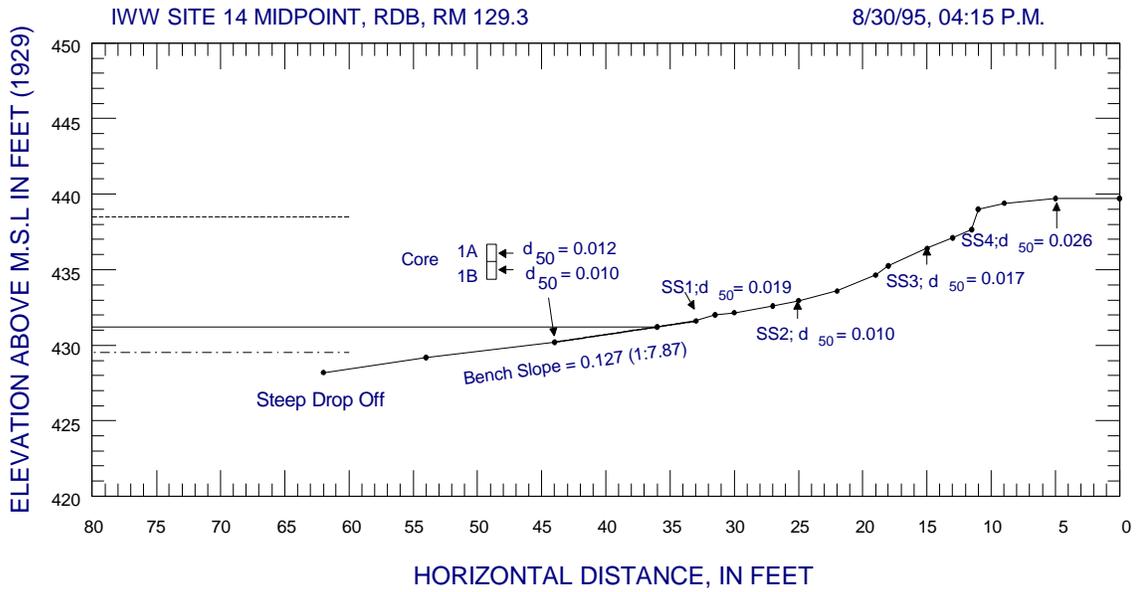
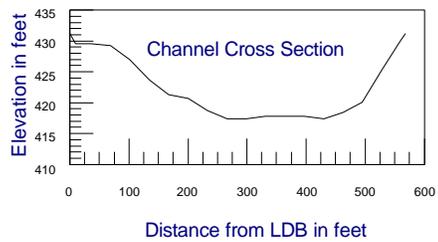
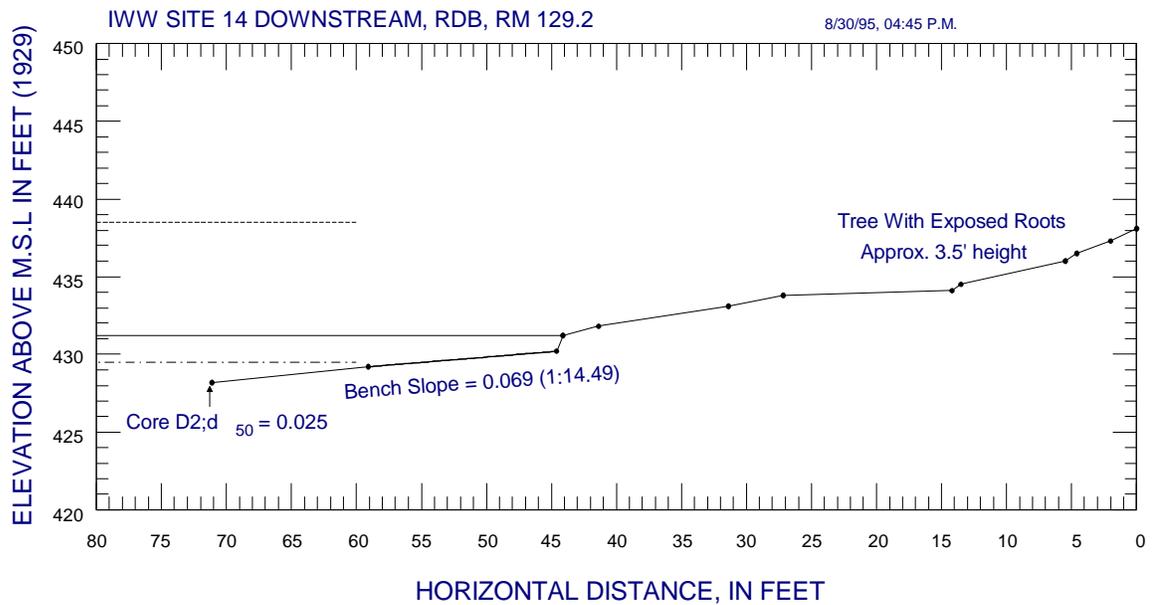
Figure 6-83. Bank sections at site 14

Figure 6-83 shows the three measured bank sections and a reduced cross section. The OHW is 438.5 feet and NP is 429.5 feet above msl. A scarp was noted at the downstream section, where the NP elevation matched the base of the scarp. The OHW elevation is about the same height as the short scarp at the midsection, and any stages higher than the OHW elevation will top the bank (see table 6-24 for the recurrence frequencies for various stages).

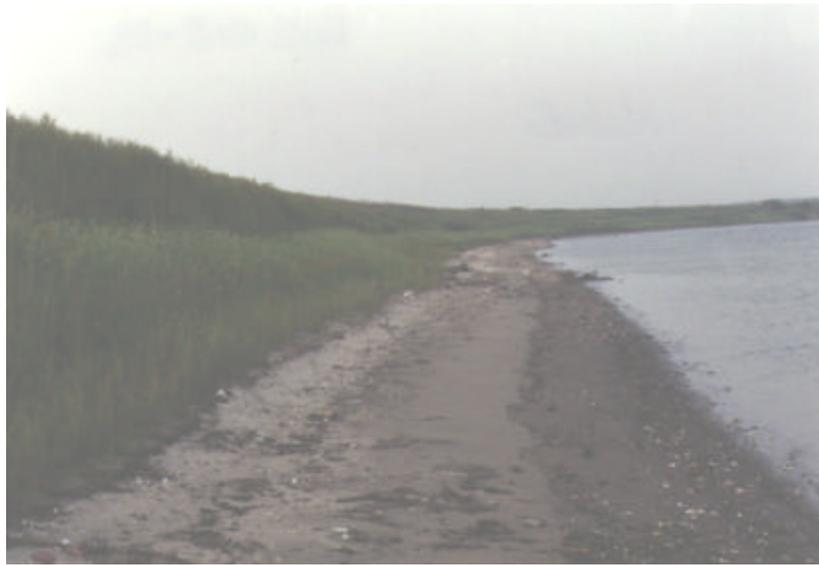
Figure 6-85. Site 15 on the Illinois Waterway

the opposite bank. Tall grass covered the bank face, with scarps inside the grass zone. The bench below the grass zone contained a series of small scarps.

Bench slopes varied from 1V:8.1H at the upstream section to 1V:11H at the downstream section. This site is classified as a combination of types 3 and 5 (figures 6-20 and 6-22, and table 6-4). The existing scarp was located at higher elevations that could be caused by floods. The peds indicated seepage activities. Rework and transport by waves and currents on failed soils or recent sediments could also be important at this site.

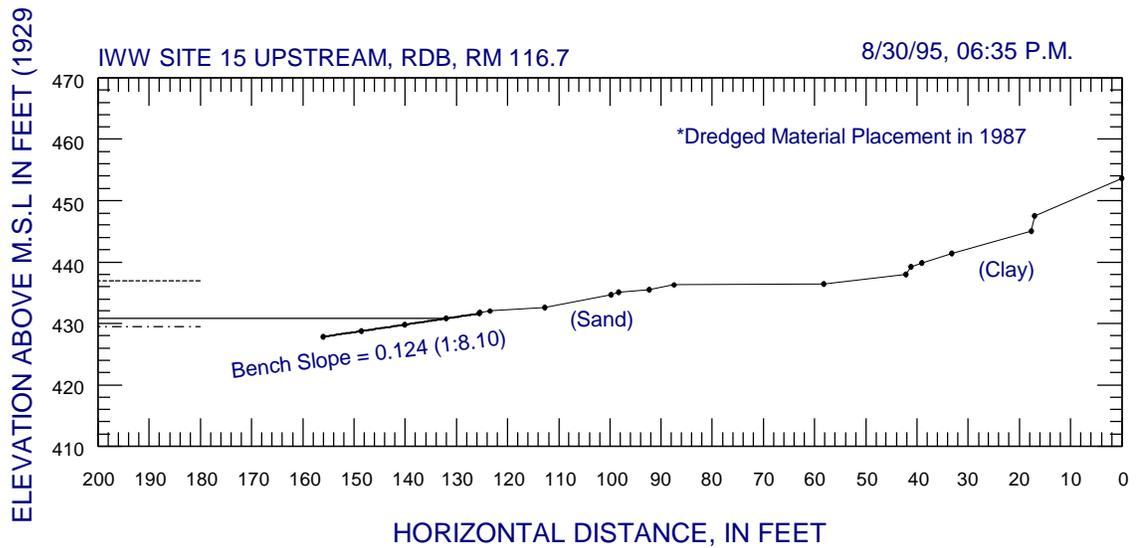
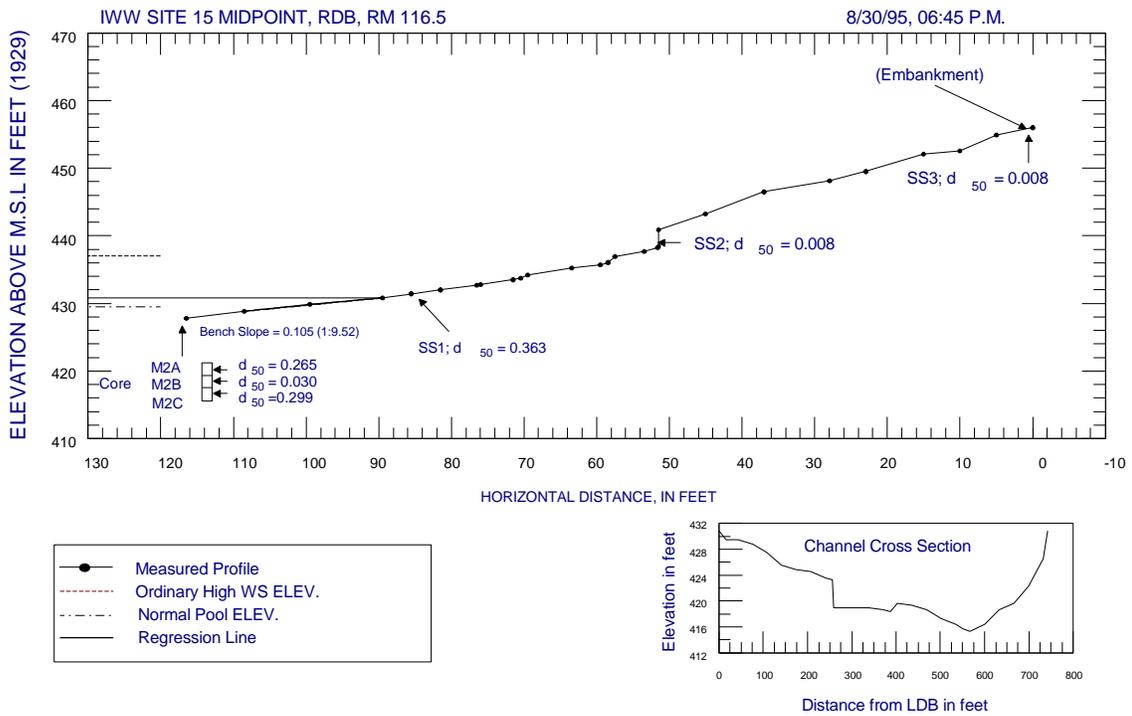
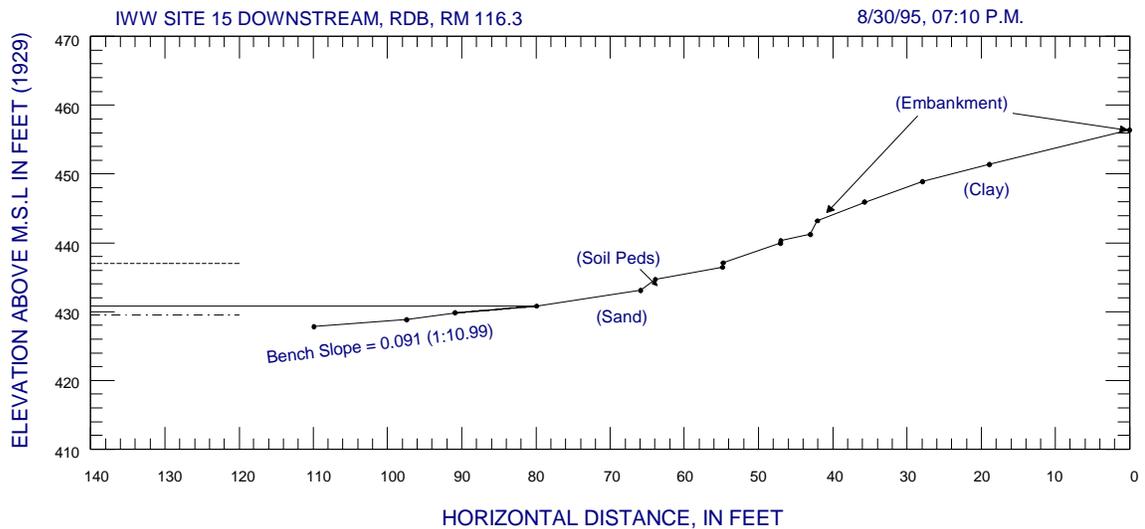
Figure 6-86. Bank sections at site 15

Figure 6-86 shows the three measured bank sections and a reduced cross section. The OHW is 437.0 feet and NP is 430.8 feet above msl. The NP elevation corresponds to a break in the subaqueous slope. From figure 6-86, the OHW elevation corresponds to the base of a small scarp.
