**Table 7-5a A summary of bank-erosion study sites and their characteristics**

### 3. Site 3 at RM 763.4 LDB (Pool 4)

#### ***4. Site 4 at RM 751.1 LDB (Pool 5)***

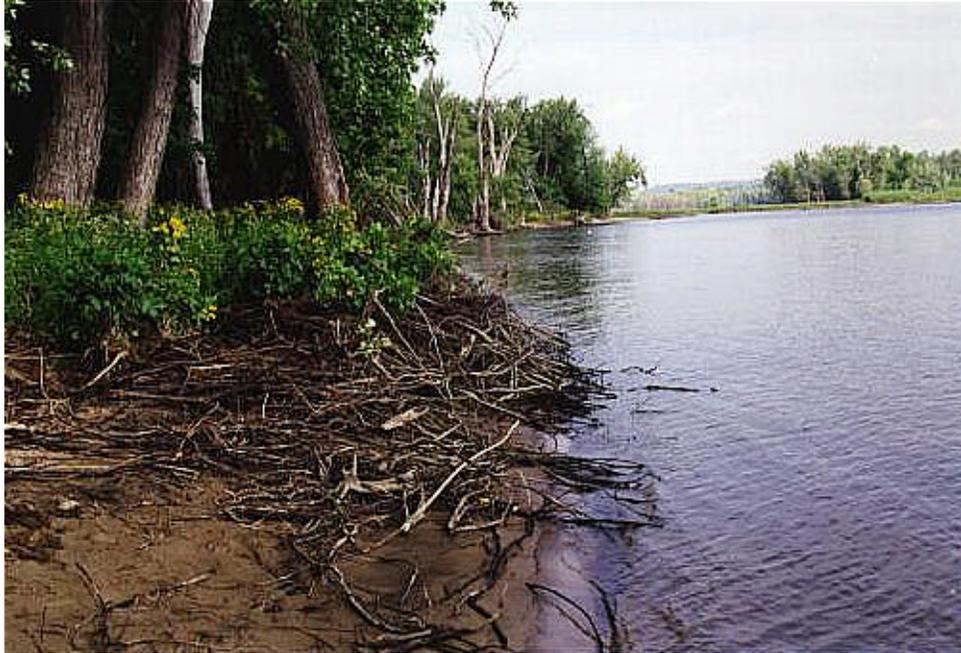
**Photo 7-13 An upstream view of Site 2 midpoint**

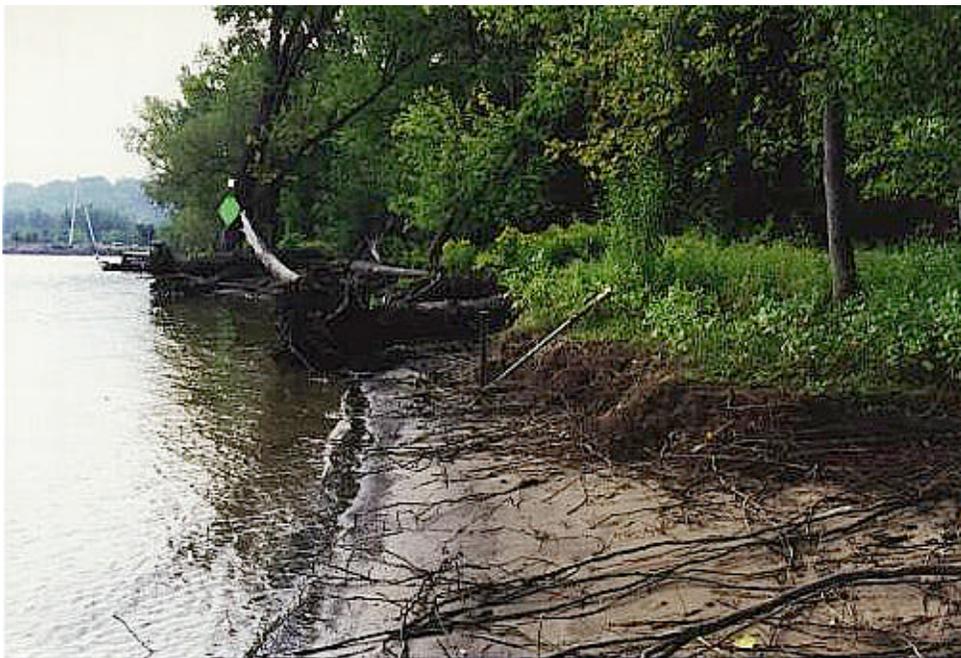
**Photo 7-14 A downstream view of Site 2 midpoint**

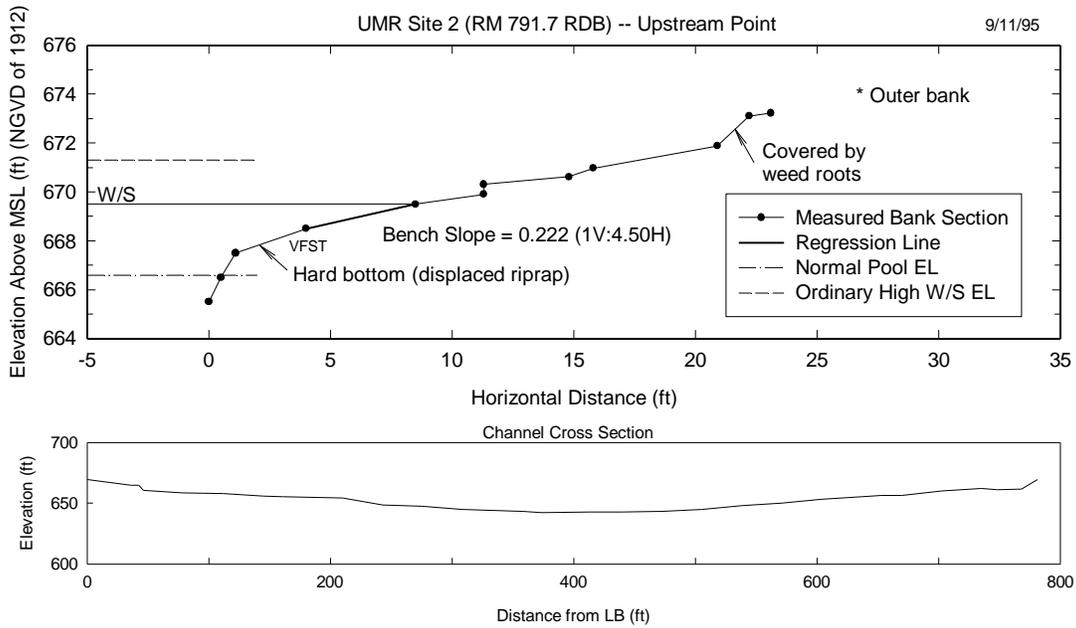
**Figure 7-9 Bank section and channel cross section measured at Site 2 upstream point**

sand (FS) to medium sand (MS); the stone slope-protection revetment apparently had failed. Subaqueous soil is very fine silt (VFST). Figure 7-9 exhibits a typical rework-transport bank-section pattern which is illustrated in figure 7-5. Several subaerial parallel benches seen in figures 7-9 and 7-10 are considered to be formed at different river stages within a range of stage between NPL and OHWL. Those parallel benches formed at different bank elevations were observed at many other sites investigated.

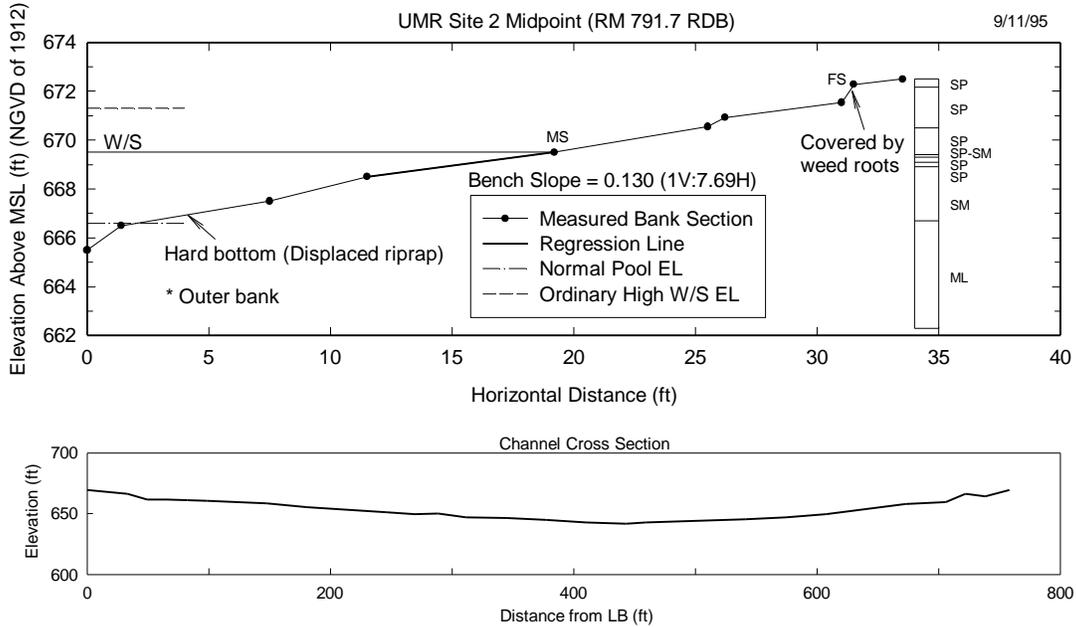
**Figure 7-10 Bank section and channel cross section measured at Site 2 midpoint**

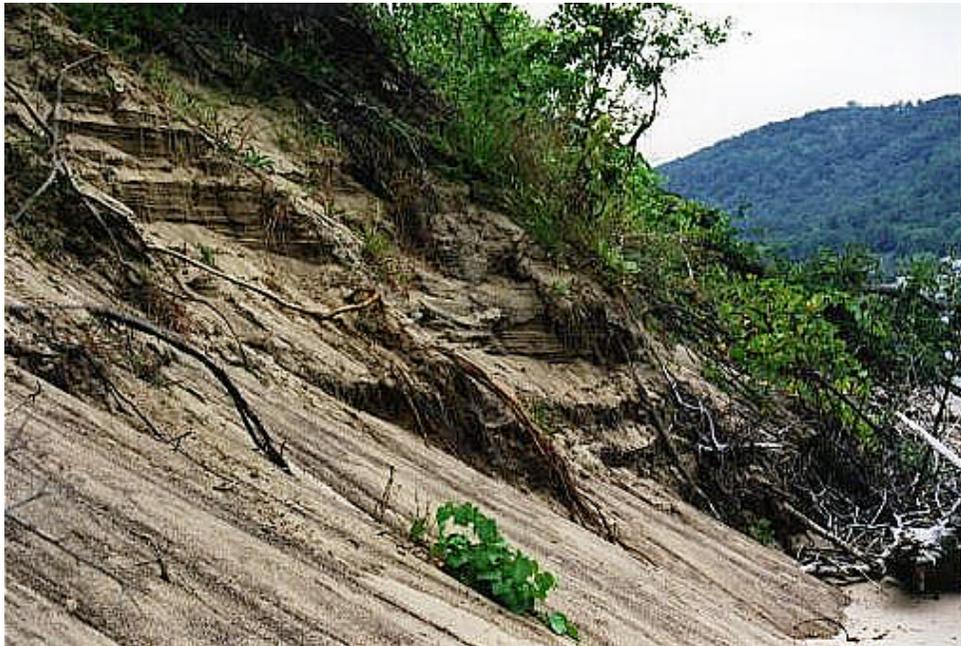
**Photo 7-15 A downstream view of Site 3 midpoint**

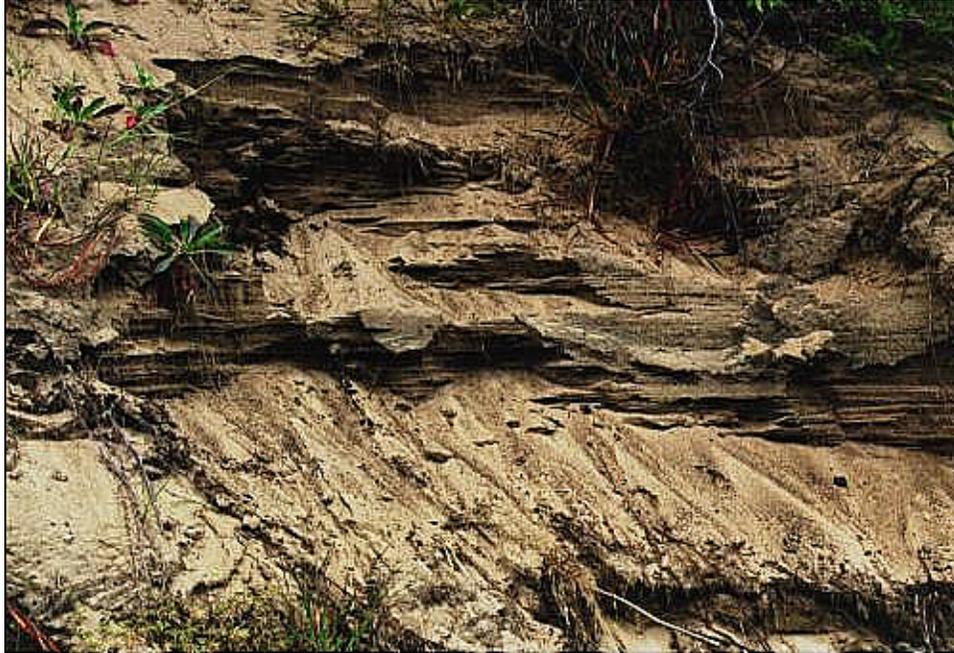
Site 3 is located at the distal end of the historical portion of a Chippewa alluvial fan complex. Numerous abandoned tributary channels (former fan outlets) were observed. Two sampling tube cores, taken at this site, indicate that sandy dredged material caps recent historical flood laminae. The native pre-settlement (before ca. 1830) soil was not encountered.

**Photo 7-16 Detailed bank-soil structure of Site 3 midpoint**

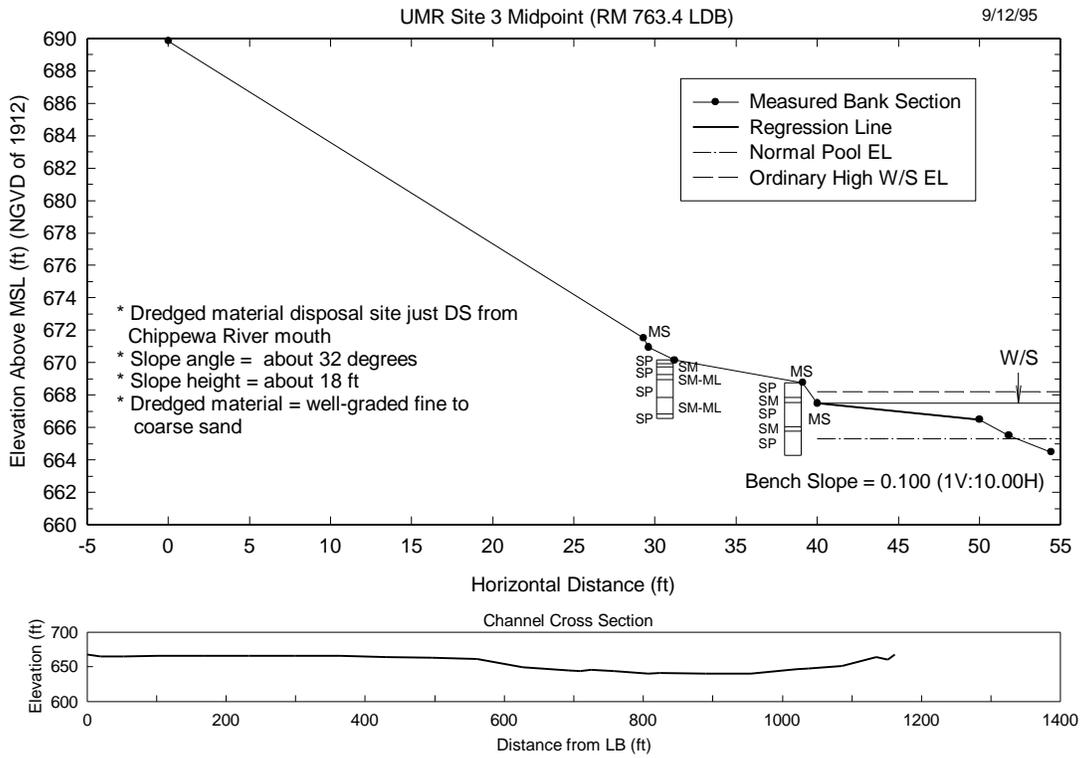
Because there is no erosion protection at this site, dredged material was reworked and transported to the river. The bank-section bench area can be seen clearly in figure 7-14 at the midpoint section. Dredged material at this site is prone to current and wave erosion. The bank sections at the upstream and downstream points are classified as a combination of bank Type E and Type F, and the midpoint section as Type F.

**Figure 7-14 Bank section and channel cross section measured at Site 3 midpoint**

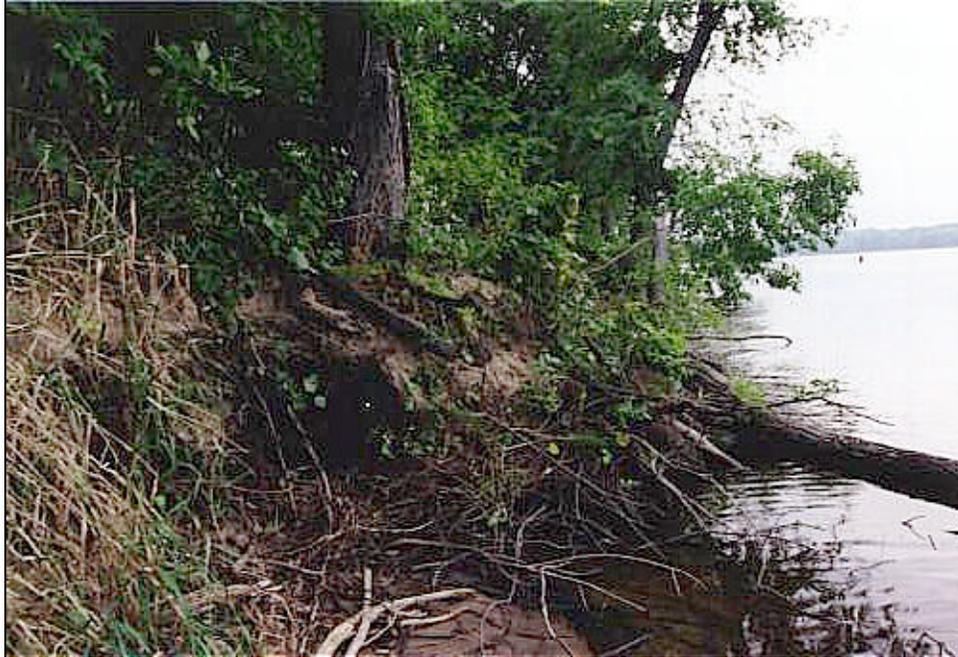
**Photo 7-17 A downstream view of Site 4 midpoint**

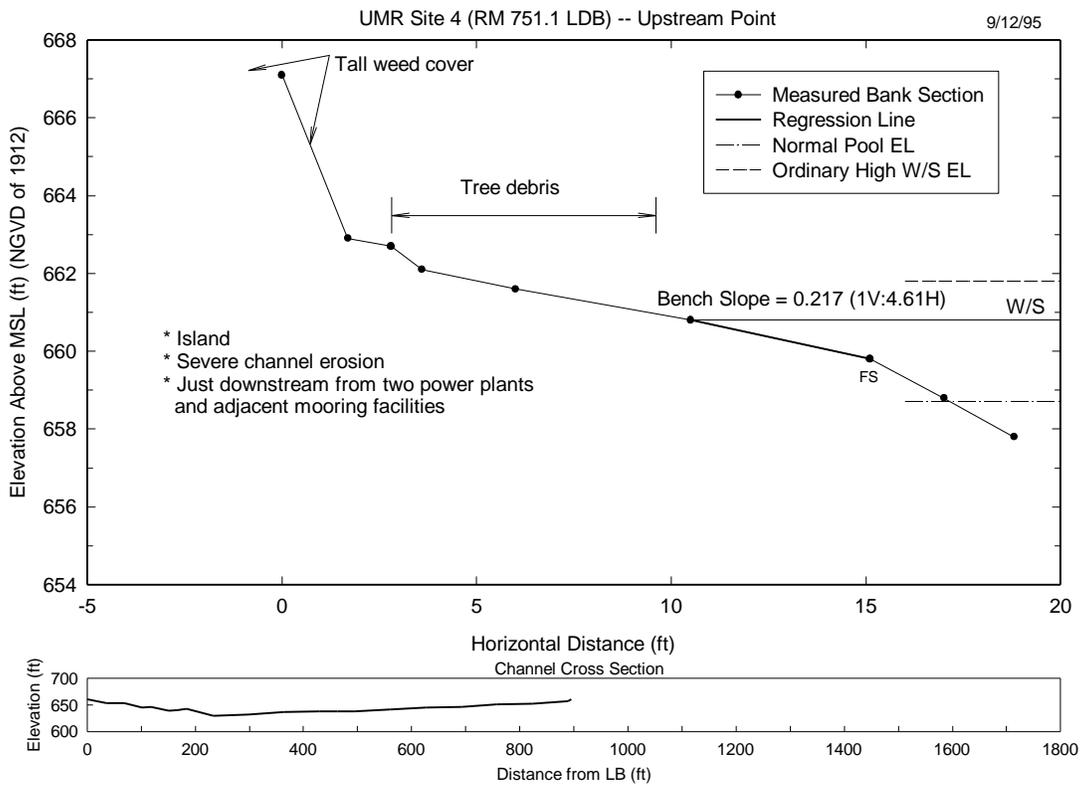
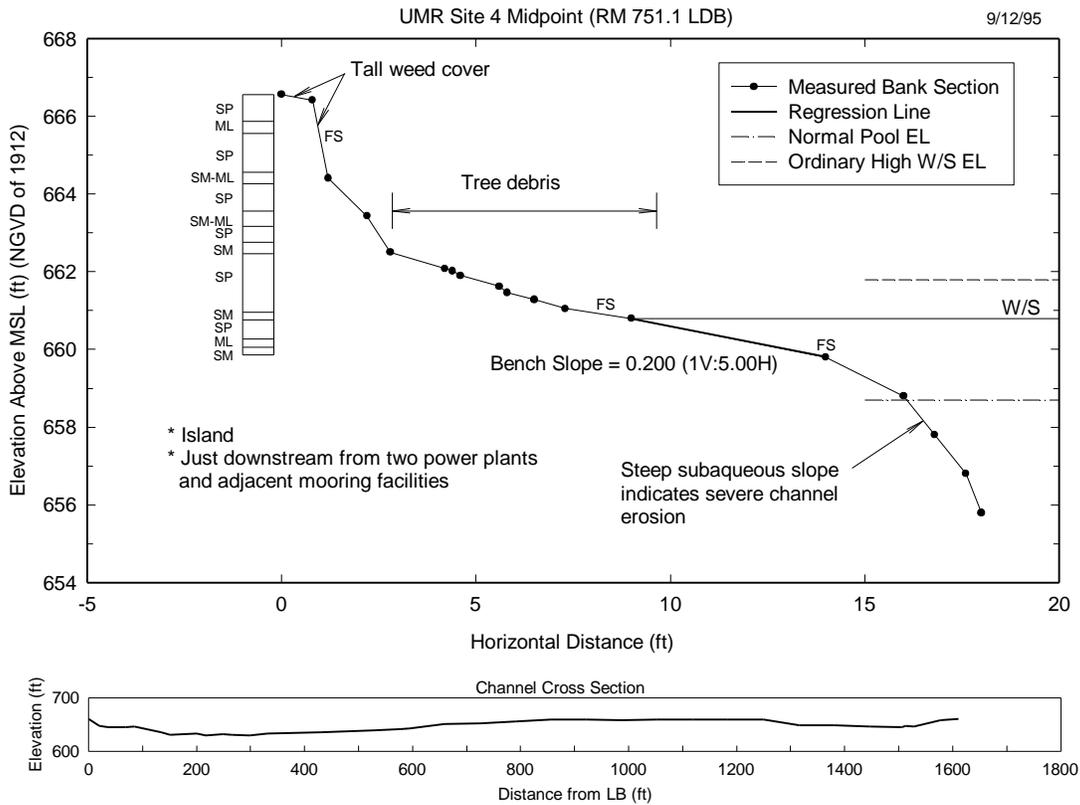
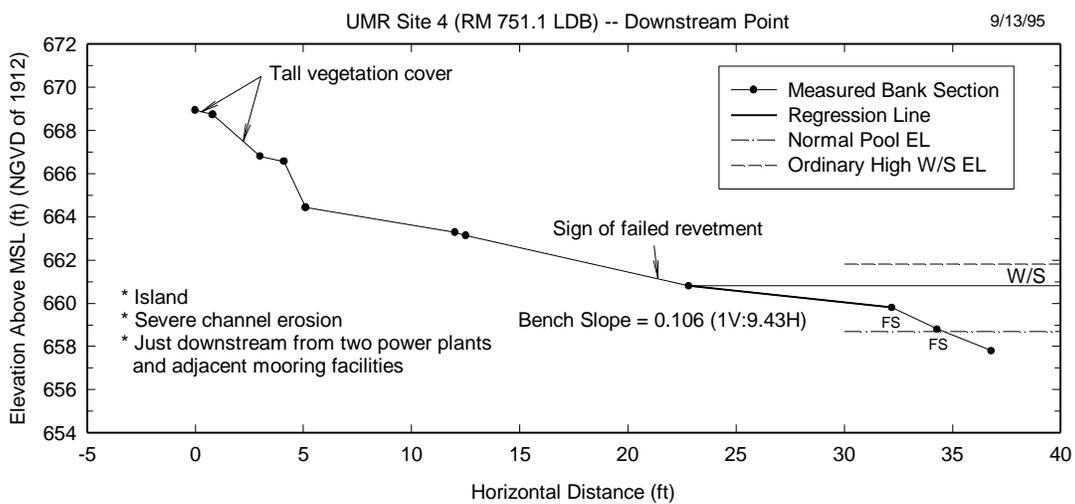
This left-bank site, shown in figure 7-16, is located only about 2 miles downstream from Lock & Dam No. 4, and is adjacent to mooring facilities used by two nearby power plants. A downstream view of the site is shown in Photo 7-17. As shown in figures 7-17 through 7-19, very steep subaqueous slopes exist at this site, which is indicative of in-channel erosion. At the downstream section, evidence of failed revetment was found near the water's edge (see figure 7-19). The bank soils are primarily FS. The soil core sample, taken at the bank and shown in figure 7-18, show multiple layers of SP-ML (see table 7-4) which are judged to be historical deposits due to a series of flood events.

Causative factors for bank retreat at this site include flood erosion and rapid recessional loading and failure, and wave and rework-transport of failed soil and recently deposited sediments. Because of the closeness to the thalweg sailing line and mooring activities, this bench area cover is eroded by waves. All three bank sections are classified as bank Type E.

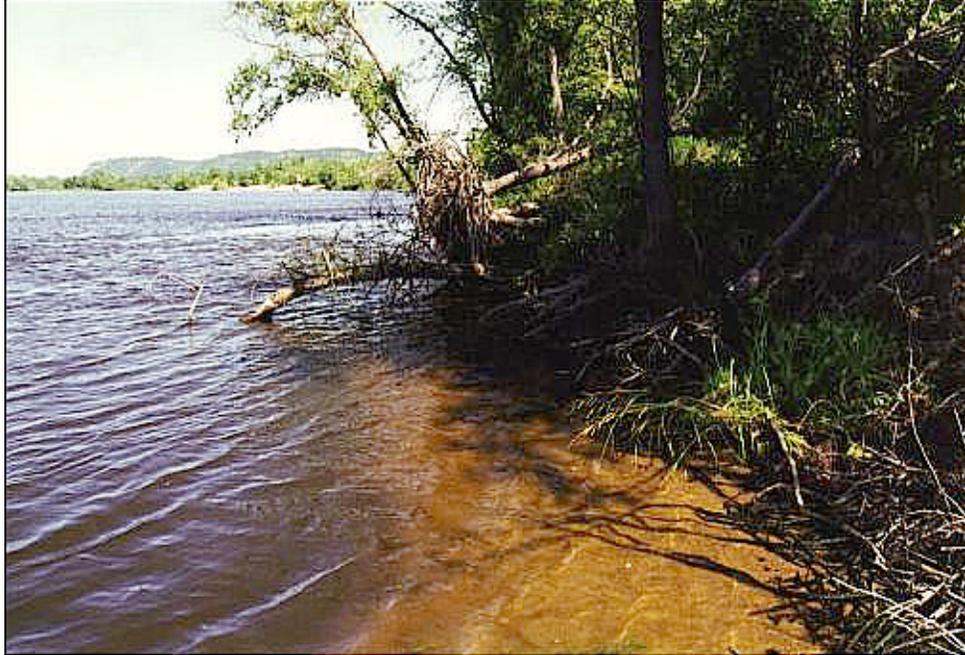
**Photo 7-18** An upstream view of Site 5 upstream point (see in-channel erosion)

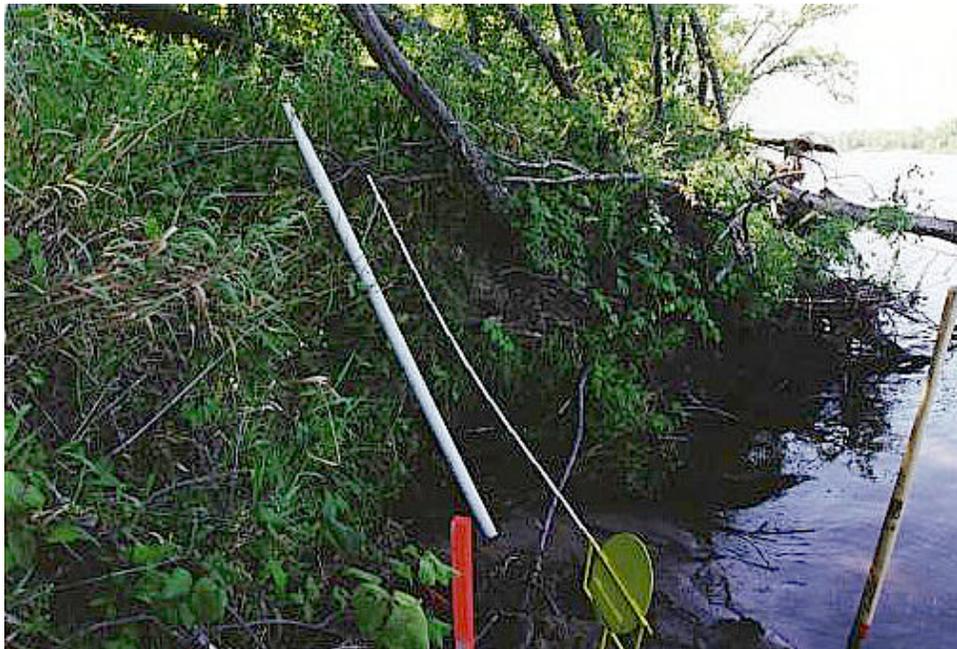
**Photo 7-19** A downstream view of Site 5 midpoint

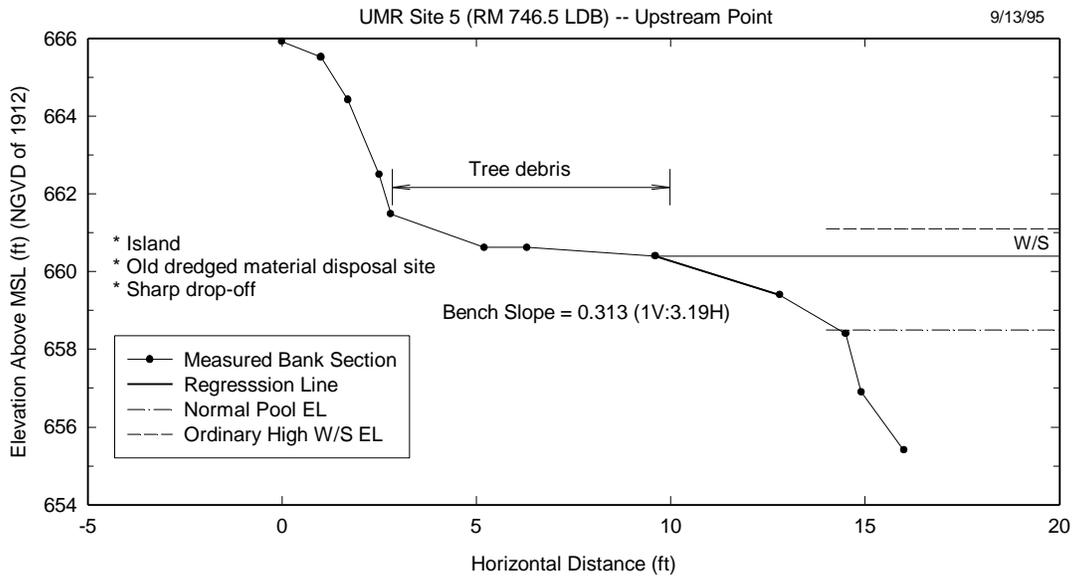
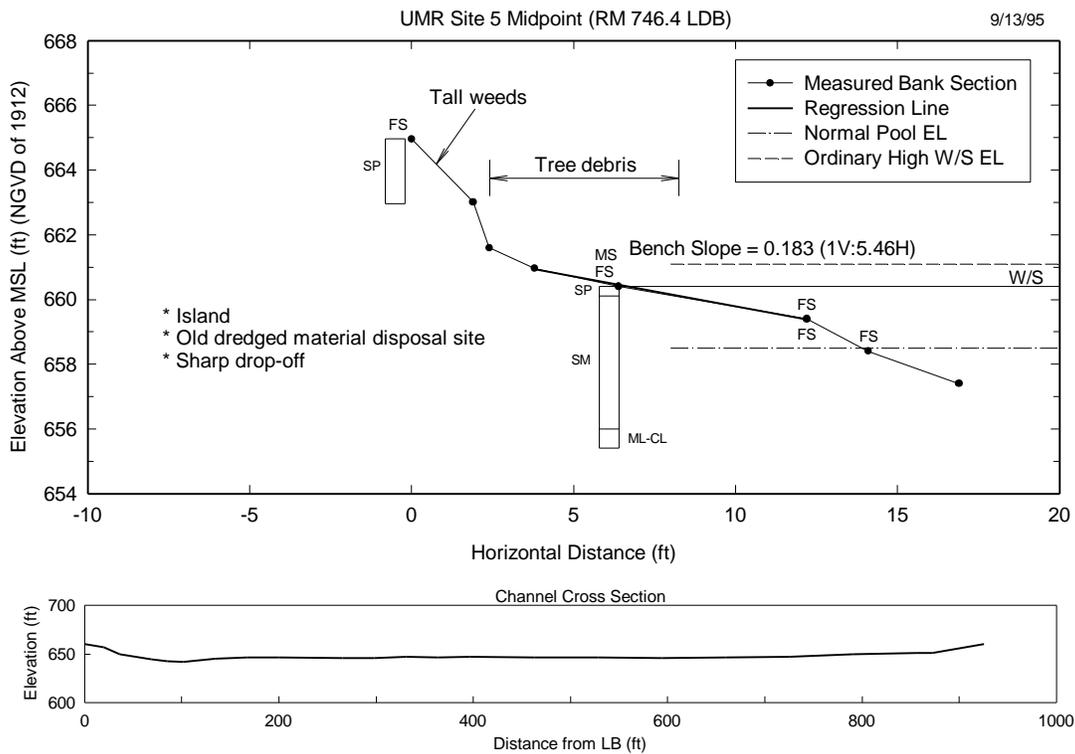
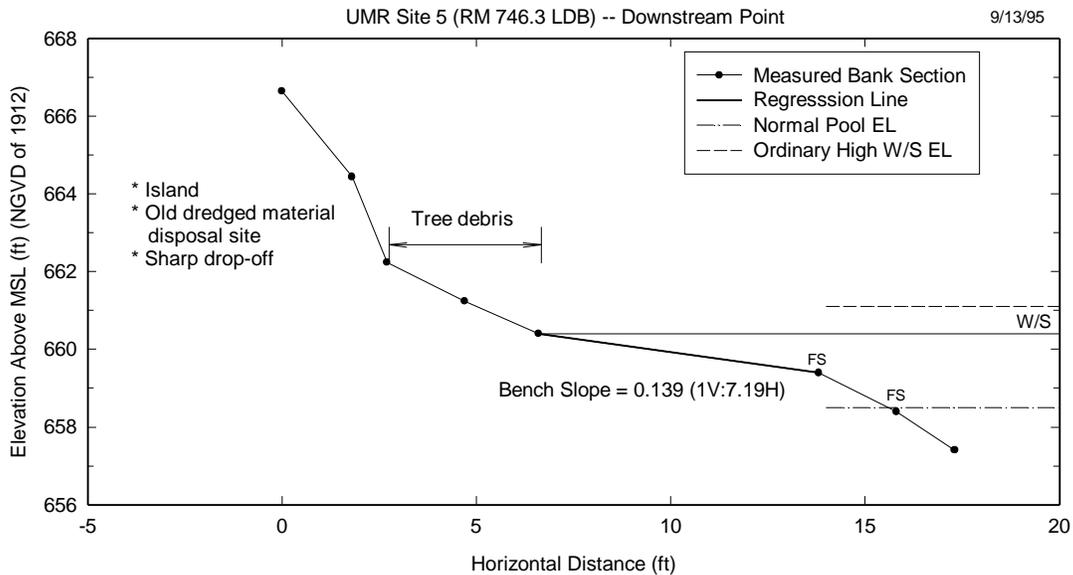
channel. The bench slope gradually decreased from 0.313 at the upstream point to 0.183 at the midpoint, and to 0.139 at the downstream point along the island. These eroded island banks exhibit steep bench topography near the tip of the island and the bench slope decreases toward the toe of the island. These morphological characteristics were observed at other island sites.

Causative factors for bank retreat at this site include wave and rework-transport of failed soil and recently deposited sediments and flood erosion. Wave erosion within berm and bench areas appear to be significant at this site. The bank section for this site is classified as Type F.

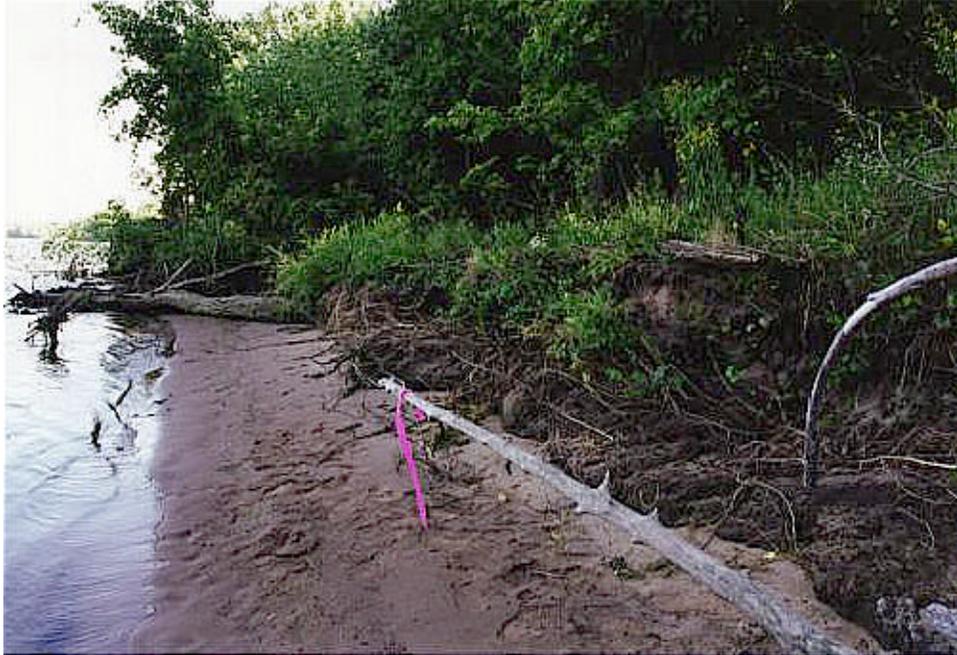
**Photo 7-20 A downstream view of Site 6 midpoint**

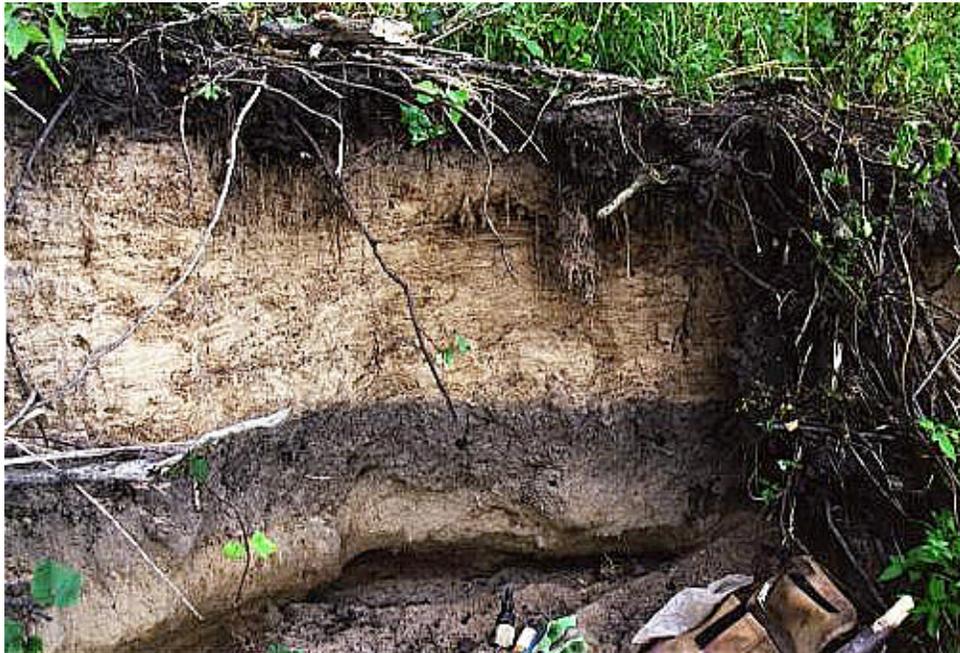
bank. The bank soil is primarily sand (VFS-MS) and subaqueous sediment is sand (FS-MS). The scarp was covered by grass roots and tree debris.

**Photo 7-21 A close-up view of scarp at Site 6 midpoint**

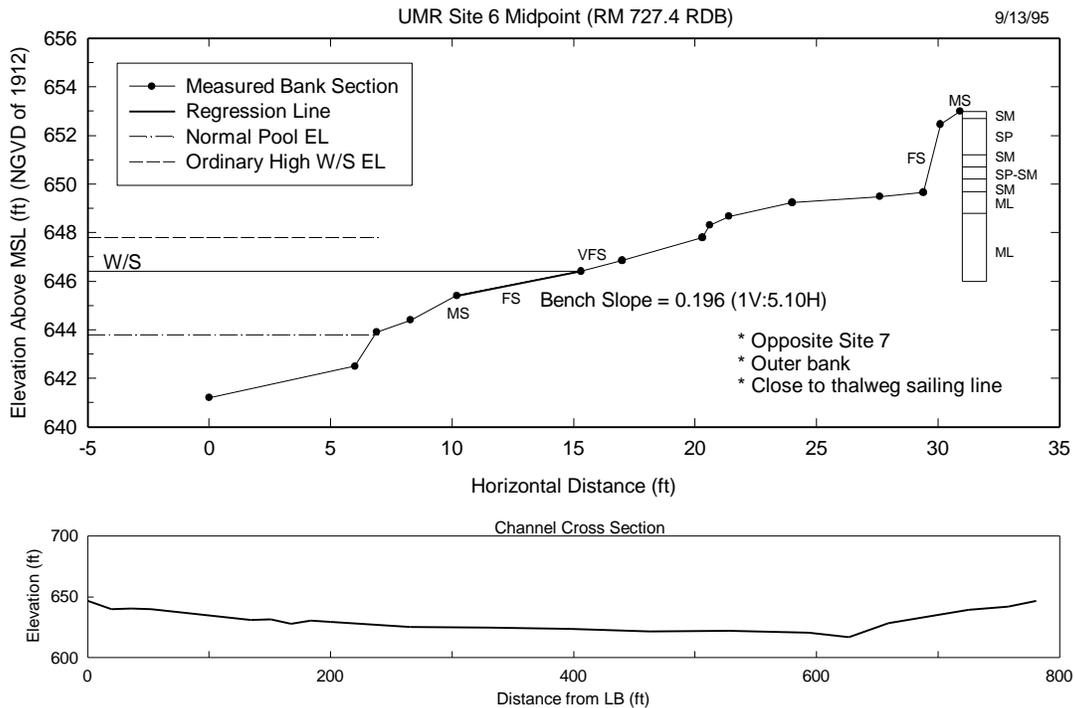
respectively. The three bank sections obtained at this site are depicted in figures 7-25 through 7-27. The river cross section in figure 7-26 shows the thalweg near the right

**Figure 7-26 Bank section and channel cross section measured at Site 6 midpoint**
