UPPER MISSISSIPPI RIVER SYSTEM
ENVIRONMENTAL MANAGEMENT PROGRAM (EMP)
DEFINITE PROJECT REPORT (DPR) WITH INTEGRATED
ENVIRONMENTAL ASSESSMENT
STAGE II

APPENDIX F
**FOX ISLAND DIVISION HABITAT REHABILITATION
AND ENHANCEMENT PROJECT**
**HAZARDOUS, TOXIC, AND RADIOACTIVE
WASTE DOCUMENTATION REPORT**

MISSISSIPPI RIVER POOL 20 -
RIVER MILES 358.5-353.6
CLARK COUNTY, MISSOURI

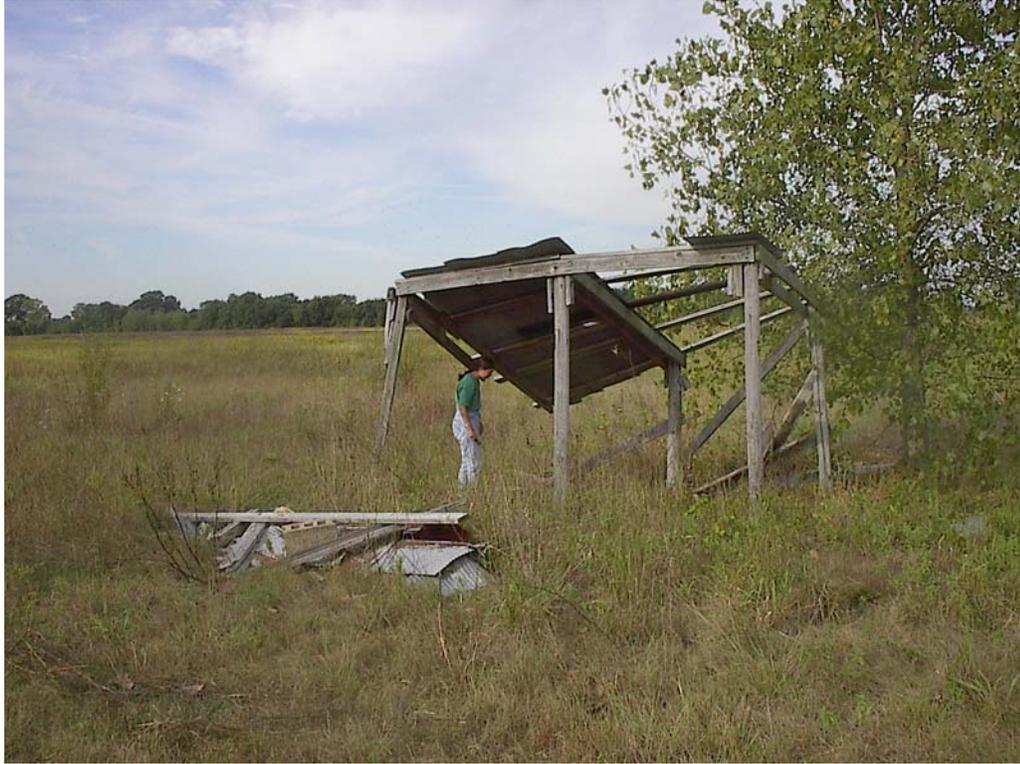
Photo #3: Structure surrounding an open well on the former Logsdon Property.

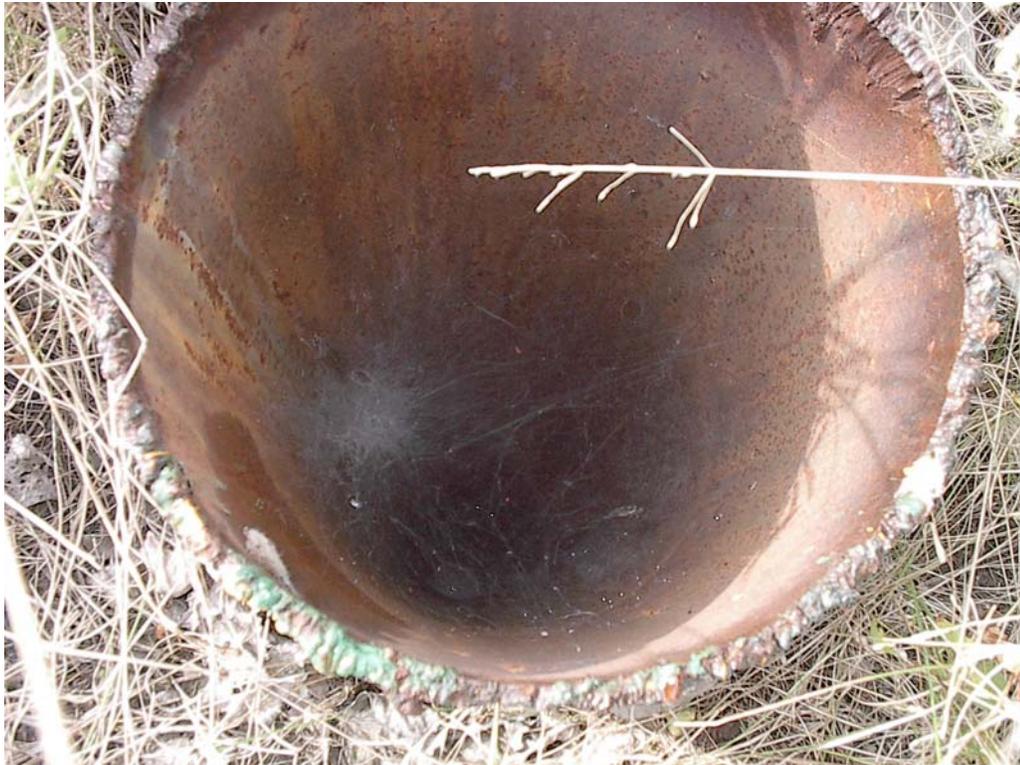
Photo #4: Looking down into well in Photo #3.

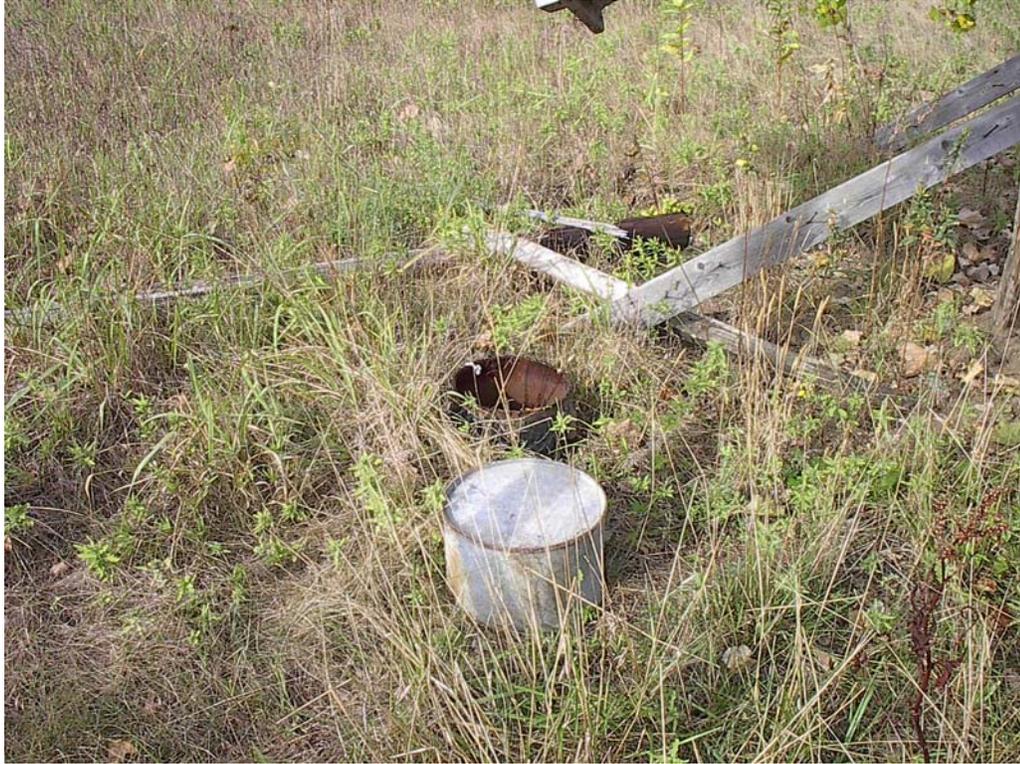
Photo #5: Well with metal cover from Photo #3.

1. Near an abandoned outbuilding on the former Logsdon Property, a small burn area was located that was likely used for burning trash.
2. Located on the former Logsdon Property is an unabandoned irrigation well.

No visual evidence of environmental contamination was noted at any of these sites. Therefore, no environmental testing is recommended. There were no environmental concerns except for the identified household goods, heating oil tanks, 55-gallon drum, and well tank. These items should all be removed and properly disposed of prior to land acquisition or construction. If it is not needed for the Habitat Rehabilitation and Enhancement Project (HREP), the pole-mounted transformer should be removed and properly disposed and the former irrigation well should be properly abandoned.

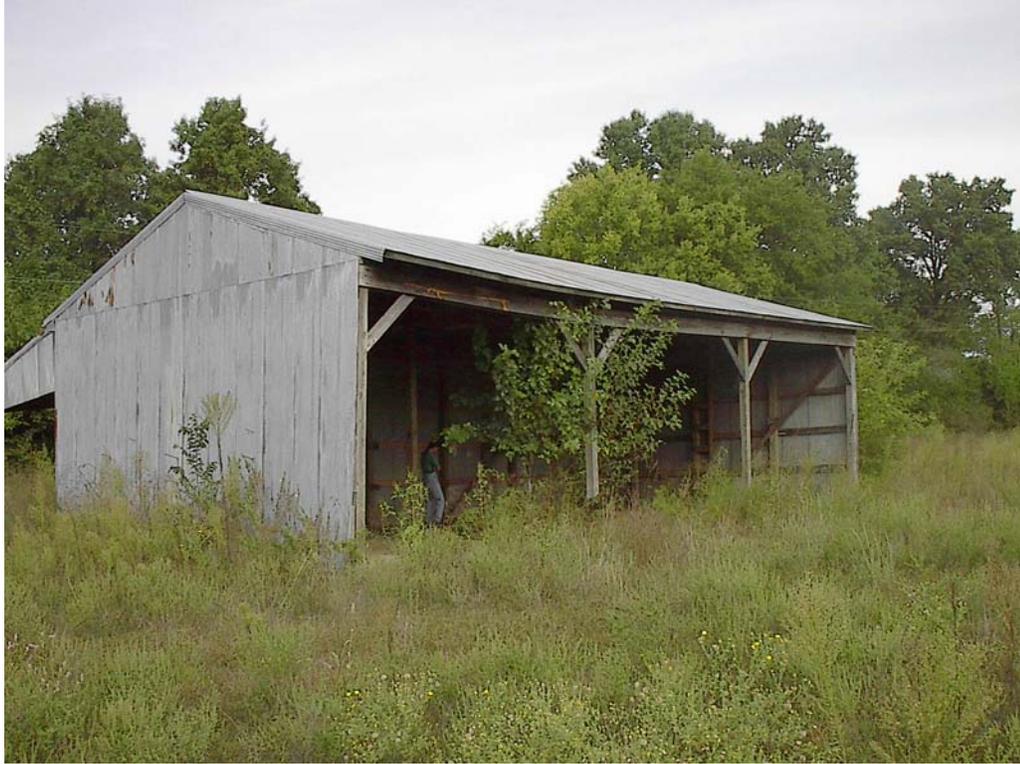
Photo #9: Looking west onto abandoned outbuilding on the former Logsdon Property.

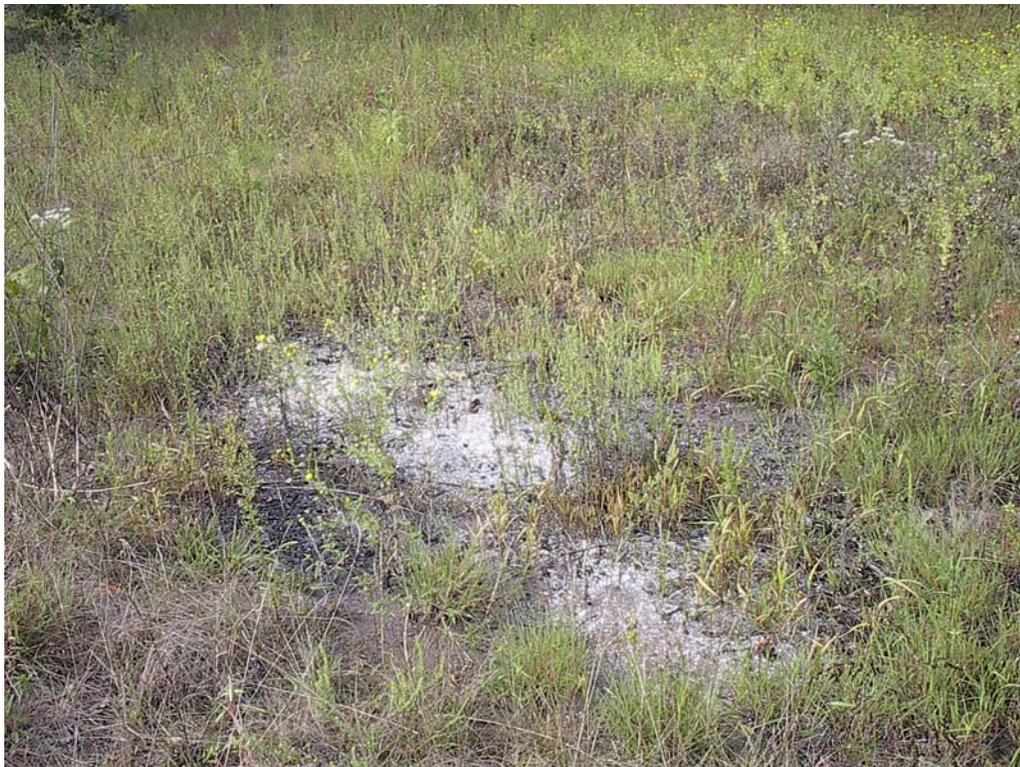
Photo #12: Burn area located to the west of the outbuilding in Photo #9.

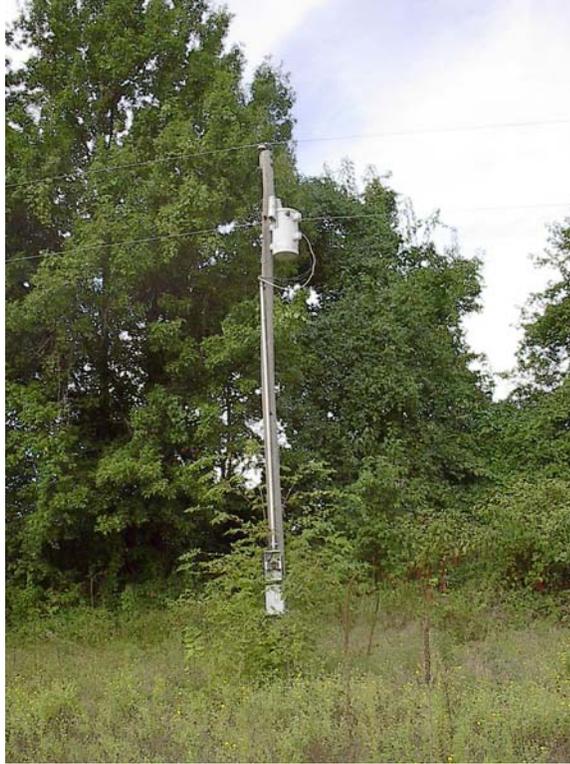
Photo #13: Pole-mounted transformer located to the southwest of the outbuilding in Photo#9.

3. Adjacent to the abandoned outbuilding on the former Logsdon Property, a pole-mounted transformer was found.
4. On property adjoining the northern-most portion of the Site, a small dump site of household goods, including a television, was identified.

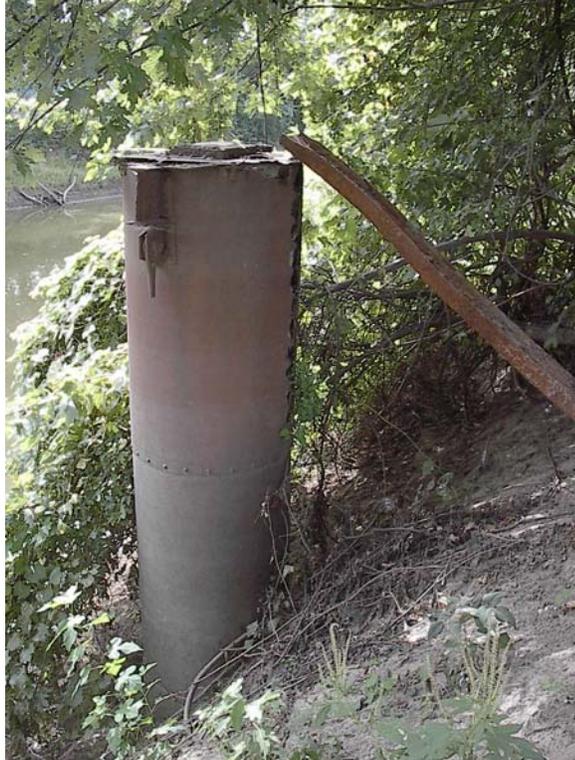
Photo #16: Close-up of bridge support from Photo 15.

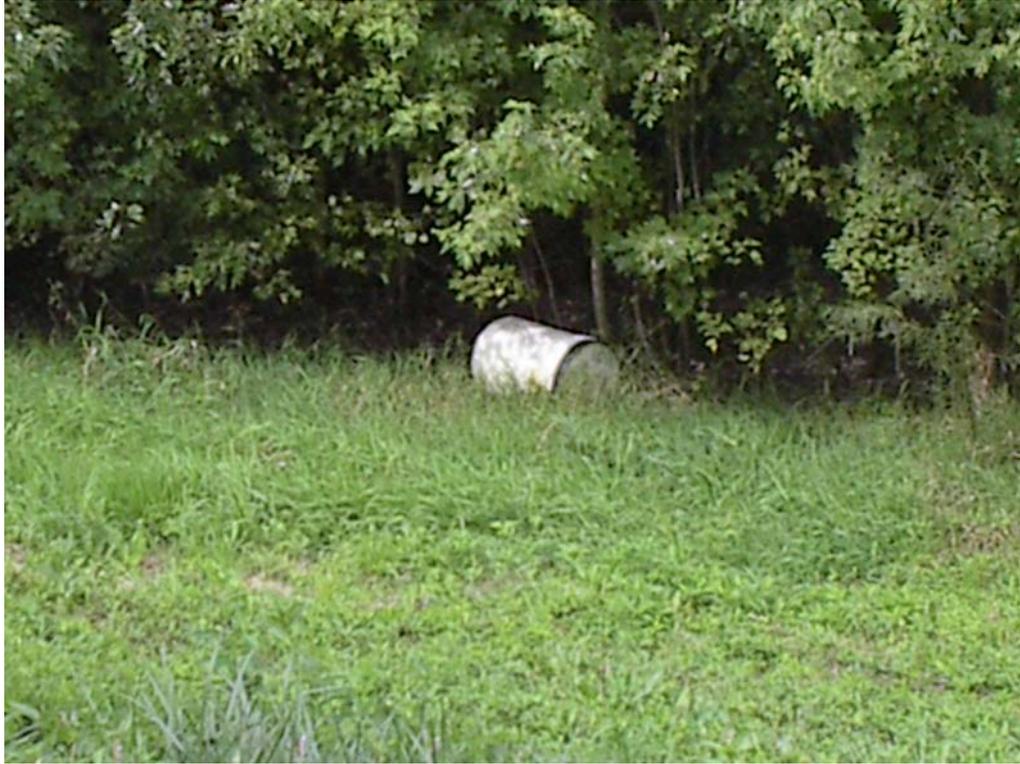
Photo #21: A 55-gallon drum located west of the levee, south of Photo #20. This is not located on the Site.

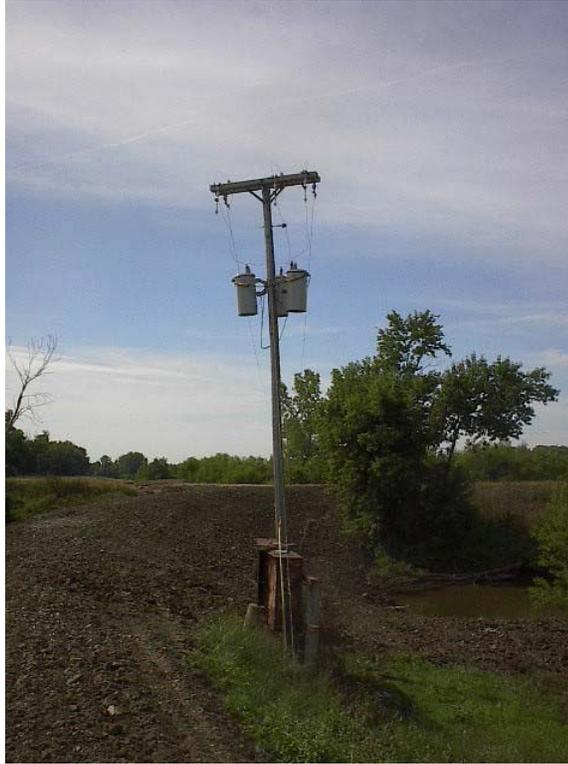
Photo #25: Three transformers used to power the generator for the gate structure shown in Photo #24. These are not on Site, but should be noted.

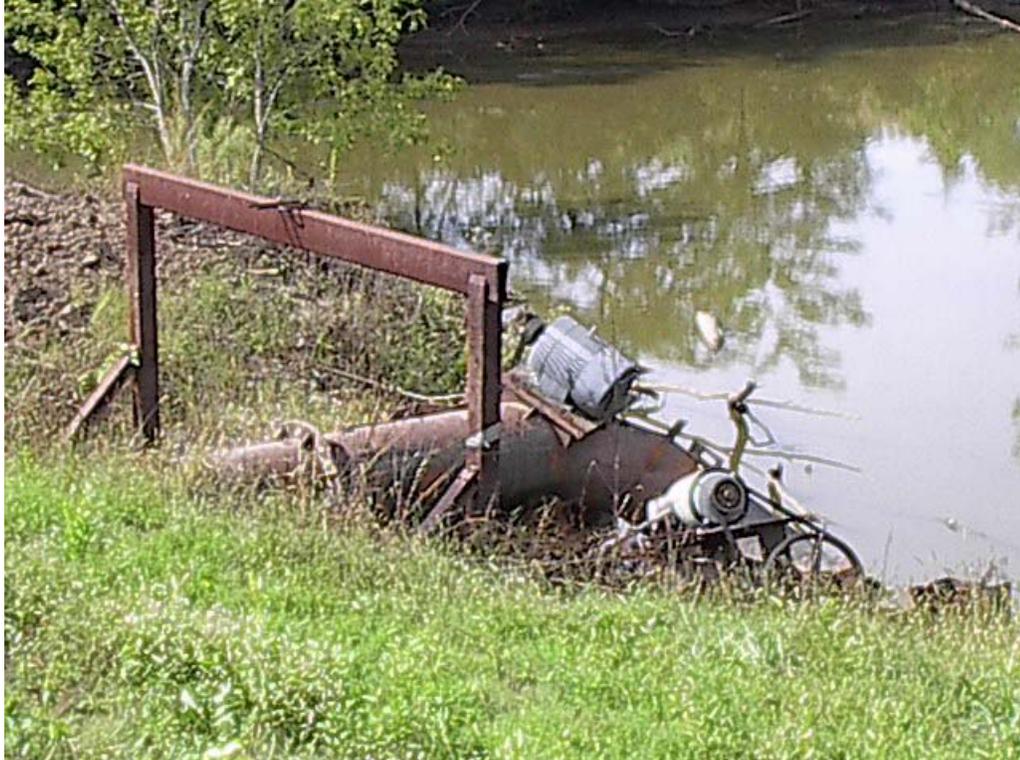
Photo #26: A Close-up of the gated structure in Photo #24:

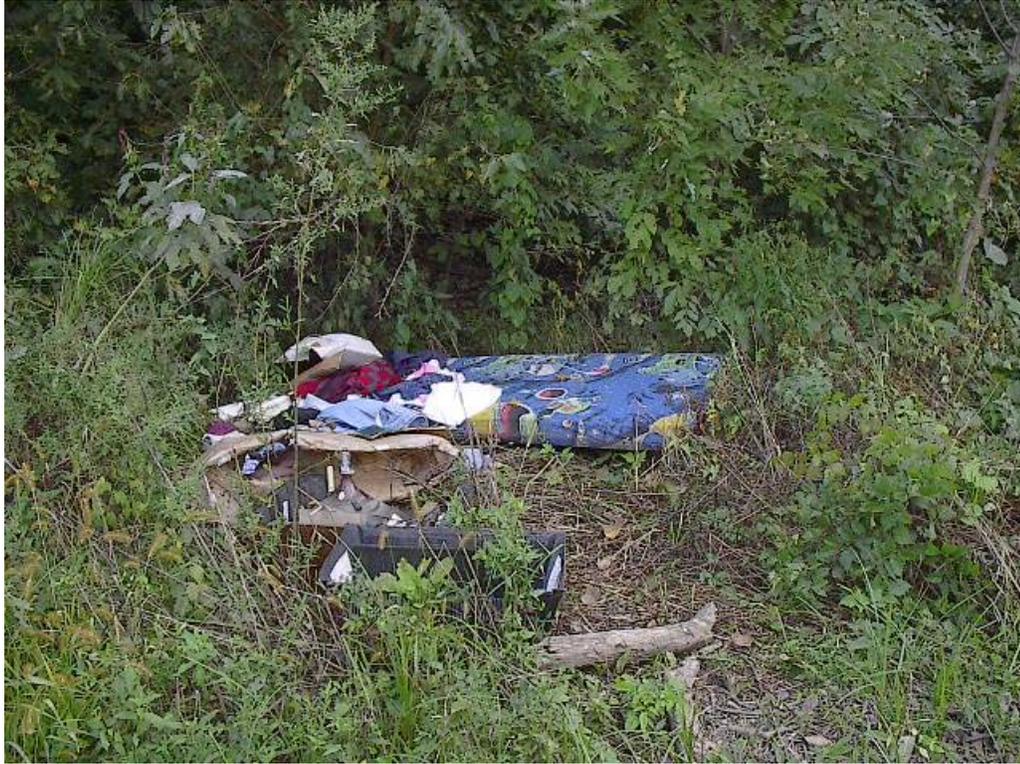
Photo #31: A dump area of household items, including a television, located adjacent to the northern-most portion of the Site on the east side of the road, a few feet outside of the Site boundary.

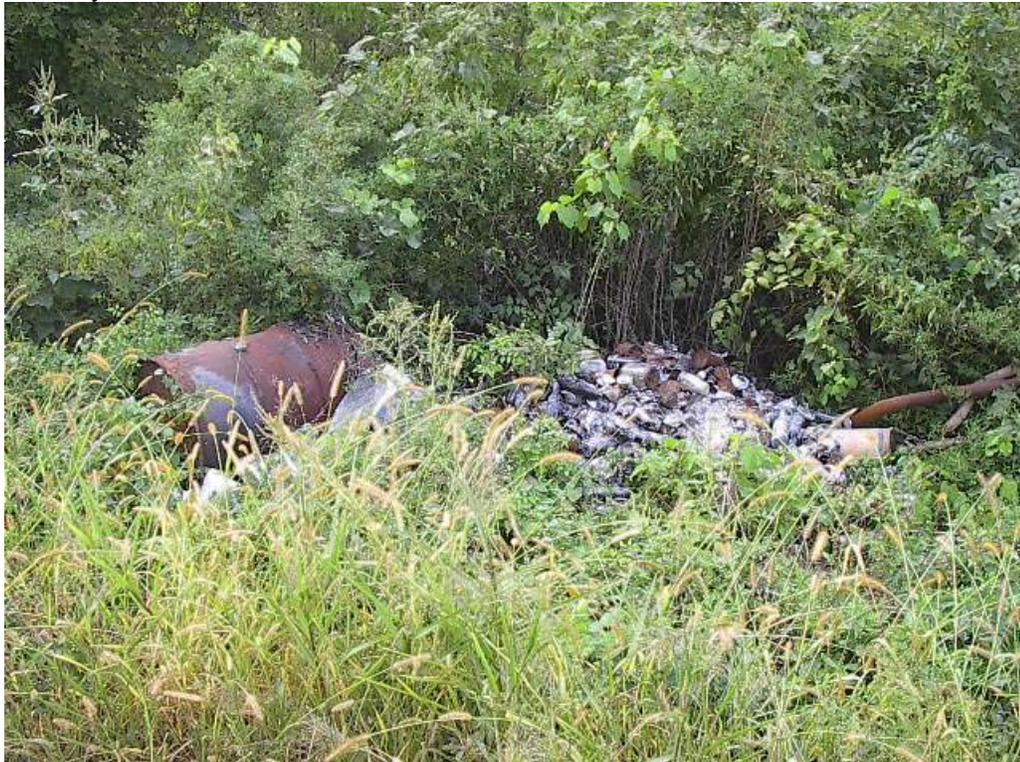
Photo #32: A burn area located on the opposite (west) side of the road noted in the Photo 31 description, not on the Site.

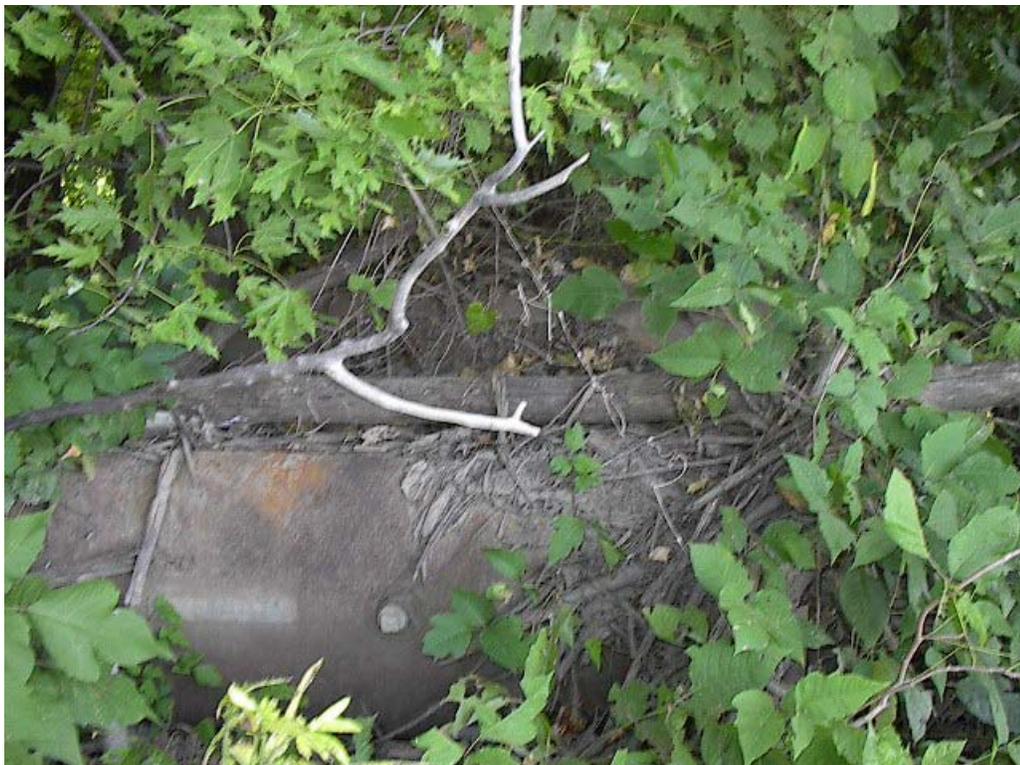
Photo #34: Two apparently empty heating oil tanks discovered to the east of the levee which bisects the property, roughly 1600 feet south of the Hemp Slough boundary.

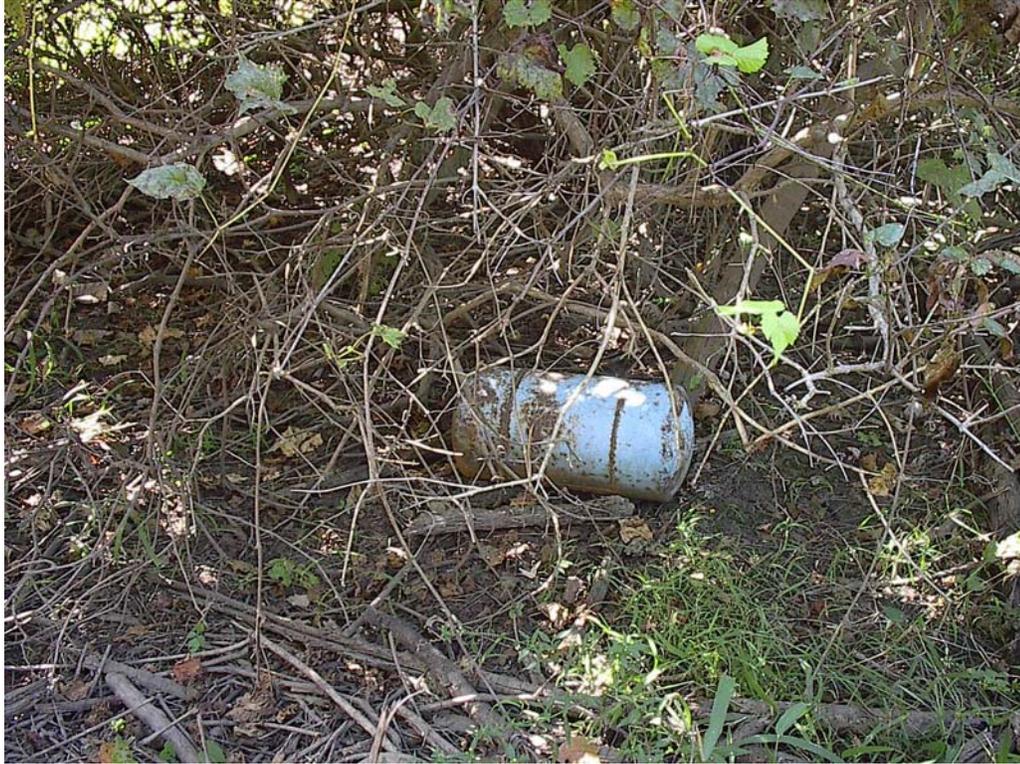
Photo #37: A pressurized well tank discovered alongside the field road on the southeastern side of Slim Slough.

7. Located alongside a field road on the southeastern side of Slim Slough, a pressurized well tank was discovered.

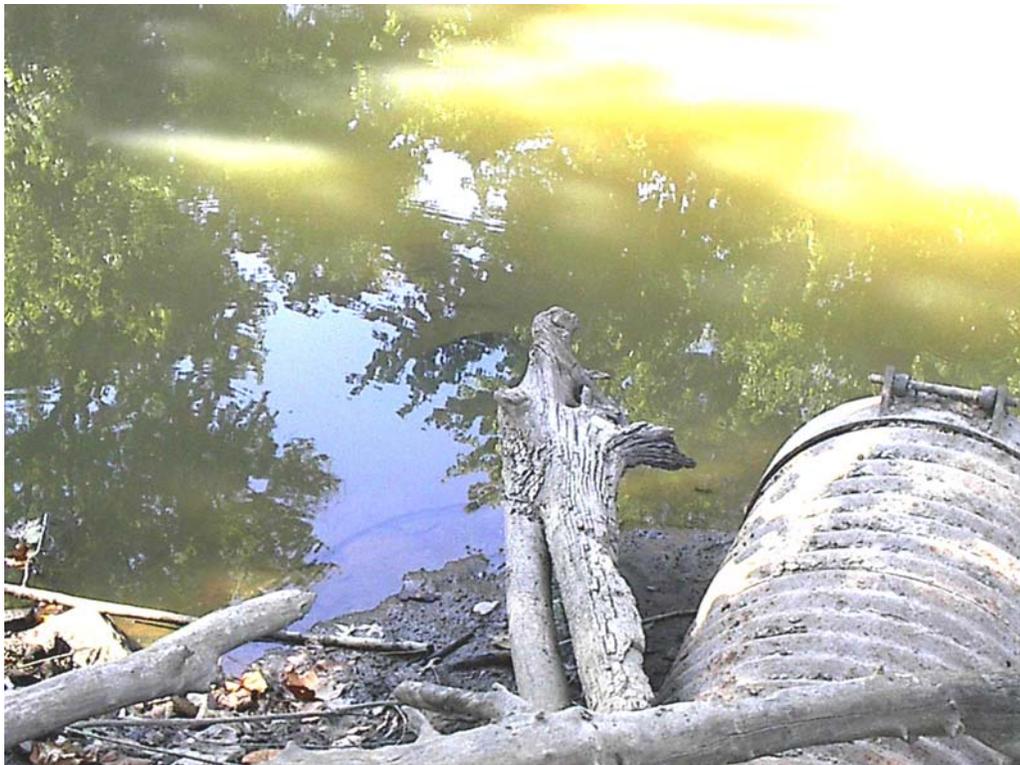
Photo #38: A 55-gallon drum just under the surface of the Fox River, at the end of a culvert discharging into the river from the existing water control structure south of the point where Honey Creek discharges into the Fox River.
