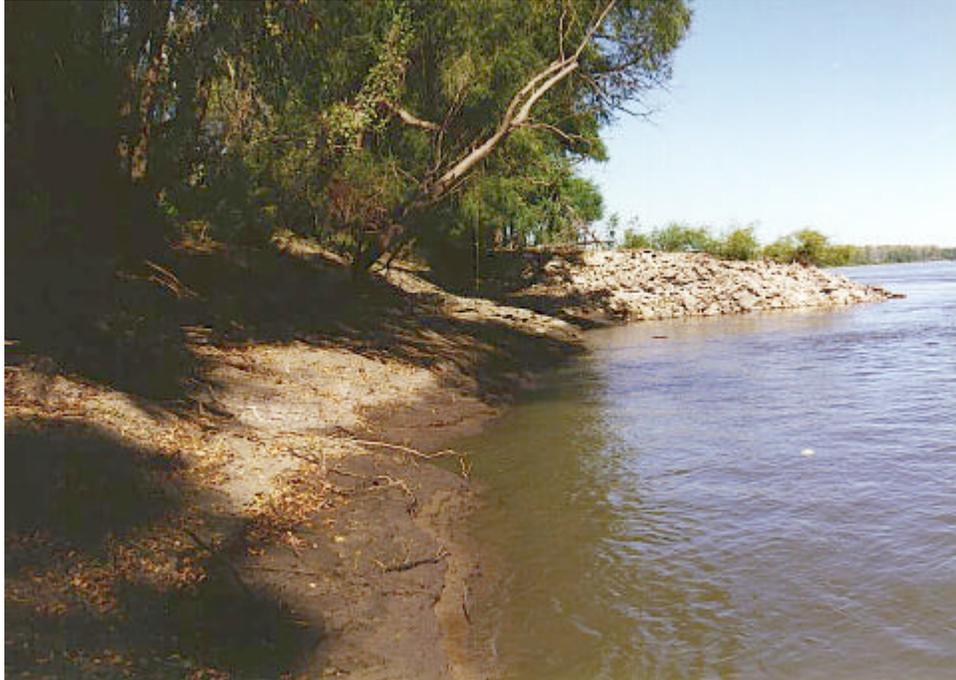
Photo 7-111 An upstream view of Site 40 downstream point

downstream from a wing dam which is just upstream from the tributary outlet, strong reverse currents were observed. The bank soils are primarily FST and MST. Piping cavities and overland drainage rills were observed at Site 40.

Causative factors for bank retreat at this site include flood-flow erosion and recessional failures, piping and collapse, seepage and overland-flow surface erosion, wave and rework-transport of failed soils and recently deposited sediments within berm and bench areas, and impacts due to flow-training structures. Type C describes this site.

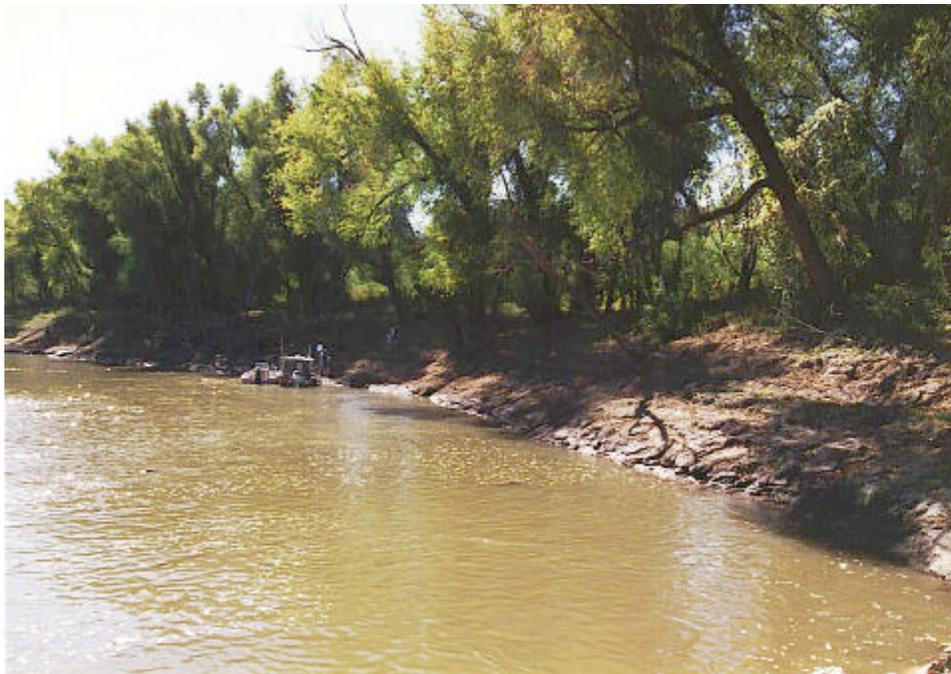
Photo 7-112 A downstream view of Site 40 downstream point

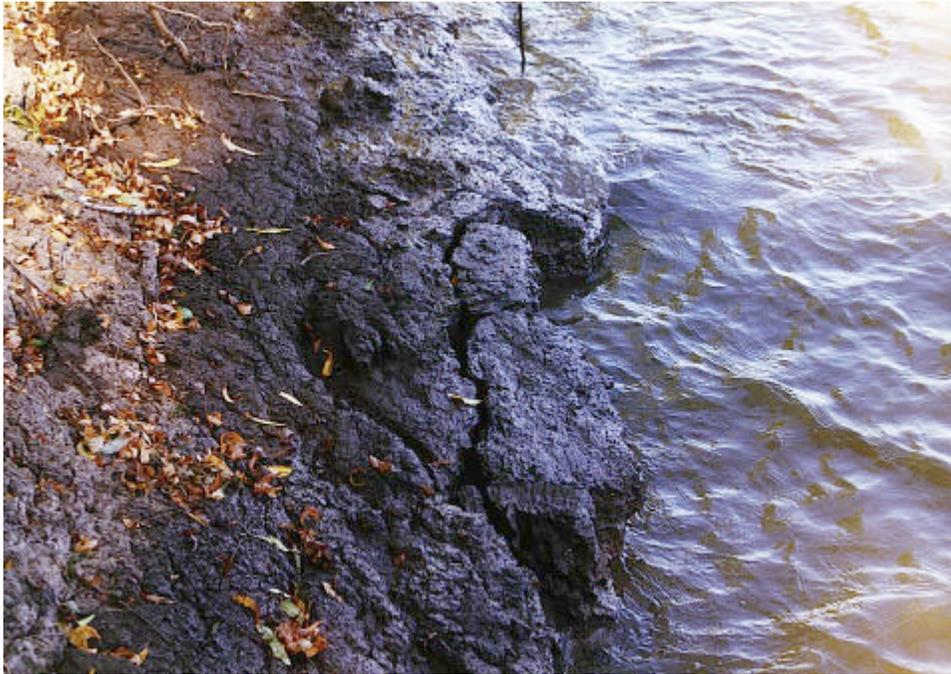
Photo 7-113 A close-up view of eroded bench at Site 40 downstream point

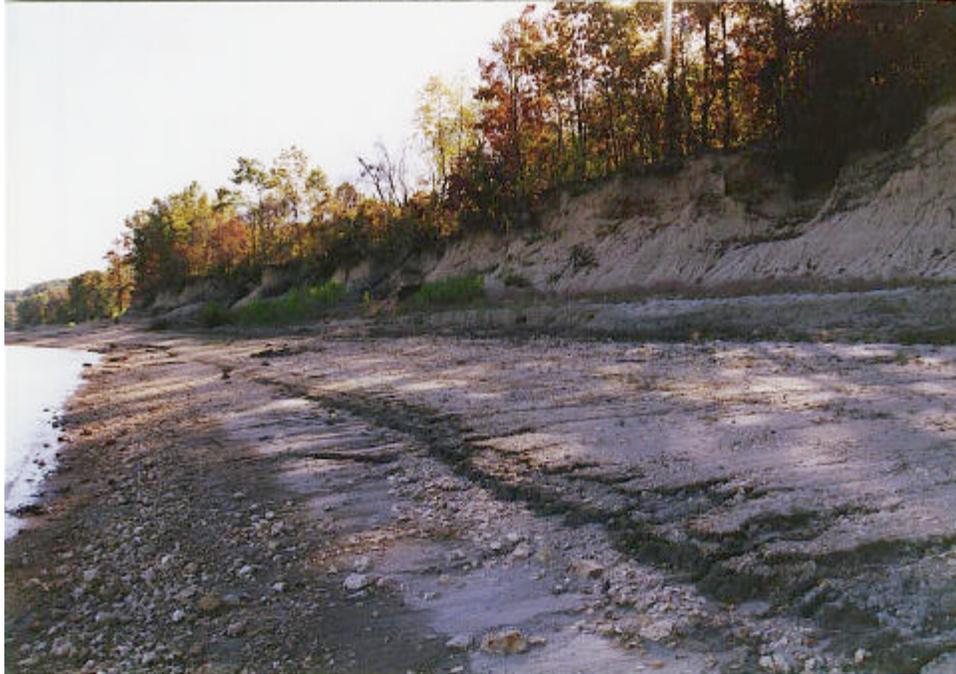
This right bank erosion site, shown in figure 129, is located on the outside of a mild bend across from Grand Tower Island, less than 0.5 mile downstream from a mid-channel island. Upstream and downstream views of the site are shown in Photos 7-114 and 7-115,

Photo 7-114 An upstream view of Site 41 midpoint

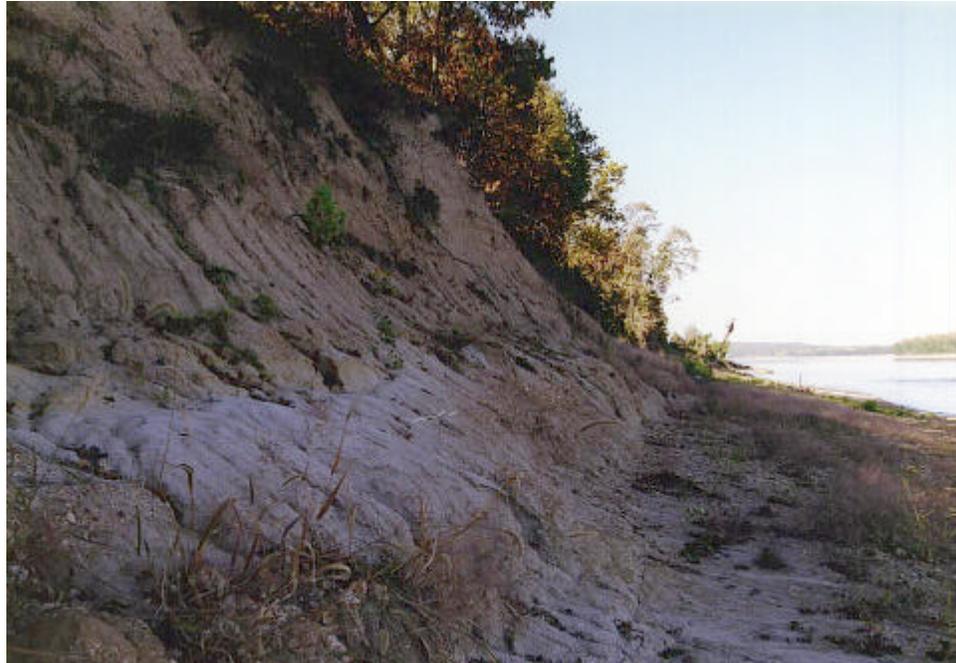
Photo 7-115 A downstream view of Site 41 midpoint

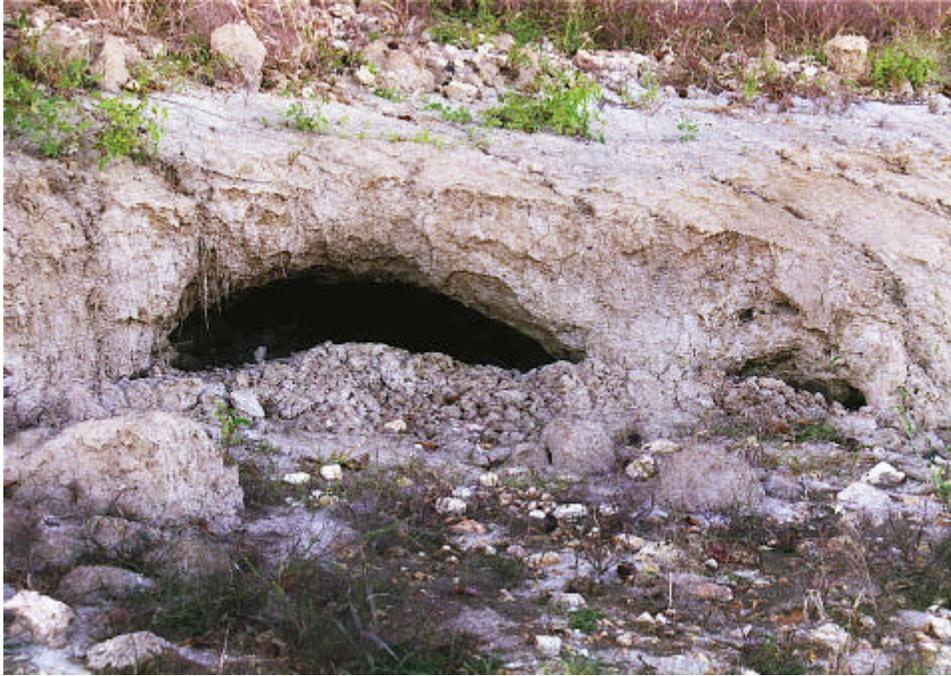
Photo 7-116 Piping features of Site 41 midpoint

forming layers and lenses. These deposits are over 25 ft thick. At the base of the scarp, where piping cavities were observed, deposits are silty. Photo 7-117 shows piping cavities.

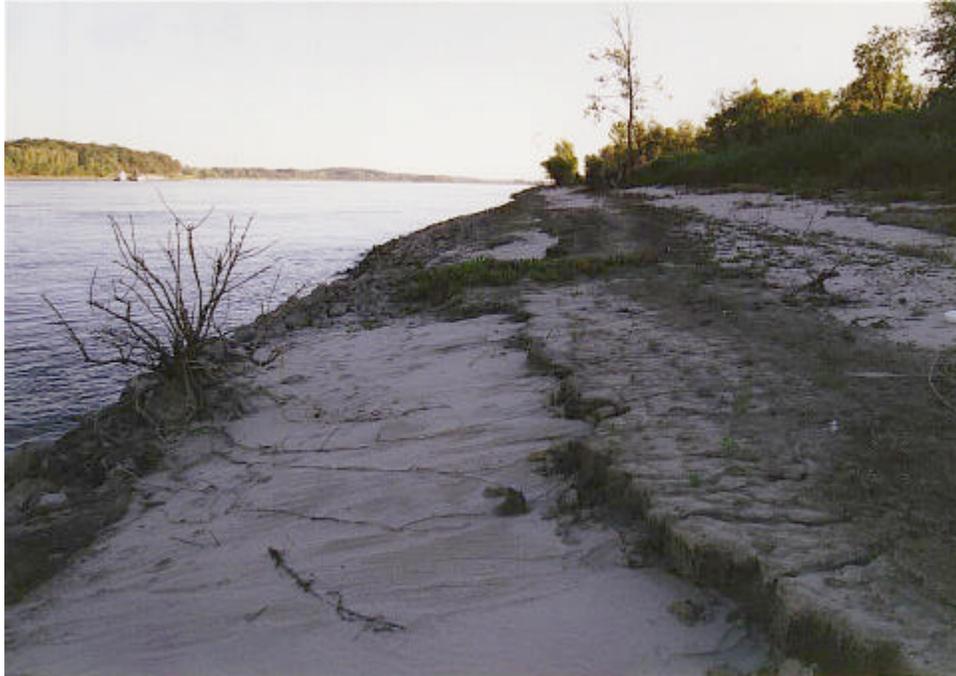
This left-bank erosion site, shown in figure 7-131, is located along the outside of a bend in the MR at Cape Girardeau. The river channel at this site is about 1,800 ft wide. Photo 7-117 shows an upstream view of the site and Photo 7-118 shows a close-up view of a revetment failure. Photo 7-119 shows a downstream view of the site. Photo 7-120 shows bank failure which was taking place. Undercut blocks fell onto the sandy lower bank. Three bank sections are shown in figures 7-132 through 7-134. The bank soils are primarily MST, FS, and VFS. This site is located within a failure of a hand-placed revetment. Piping features and failed soil blocks were observed at this site. Apparently, bank undercutting occurred and the toe of revetment was truncated, resulting in upslope launching of revetment stone. Once the revetment base, consisting of limestone gravel, is launched, waves or high water flows would erode the slope, resulting in further launching of upper revetment stone.

Photo 7-117 An upstream view of Site 42 midpoint

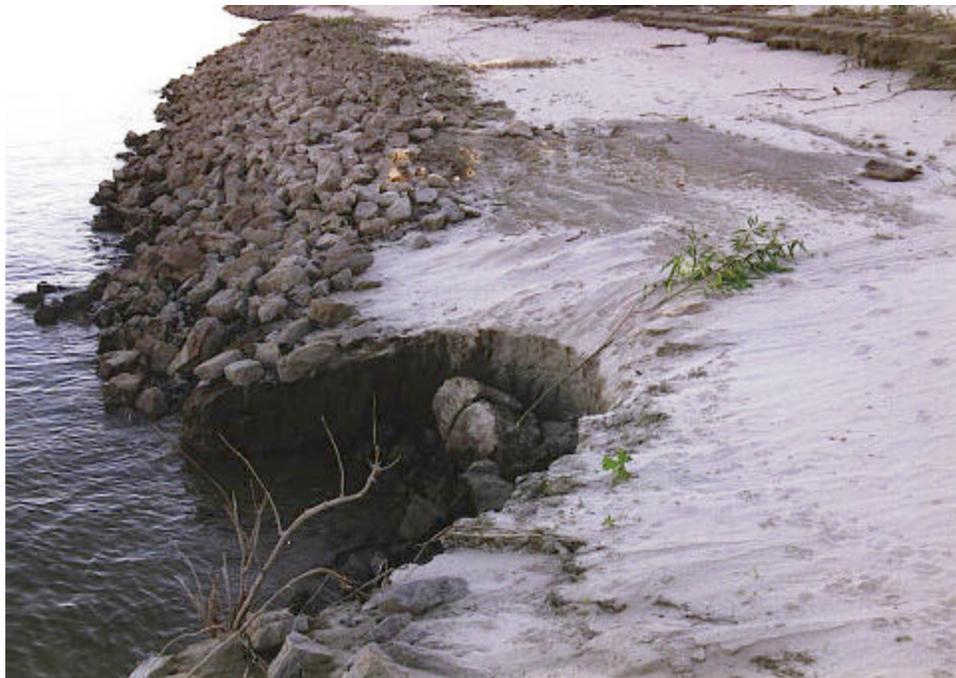
Photo 7-118 A close-up view of revetment failure at Site 42 midpoint

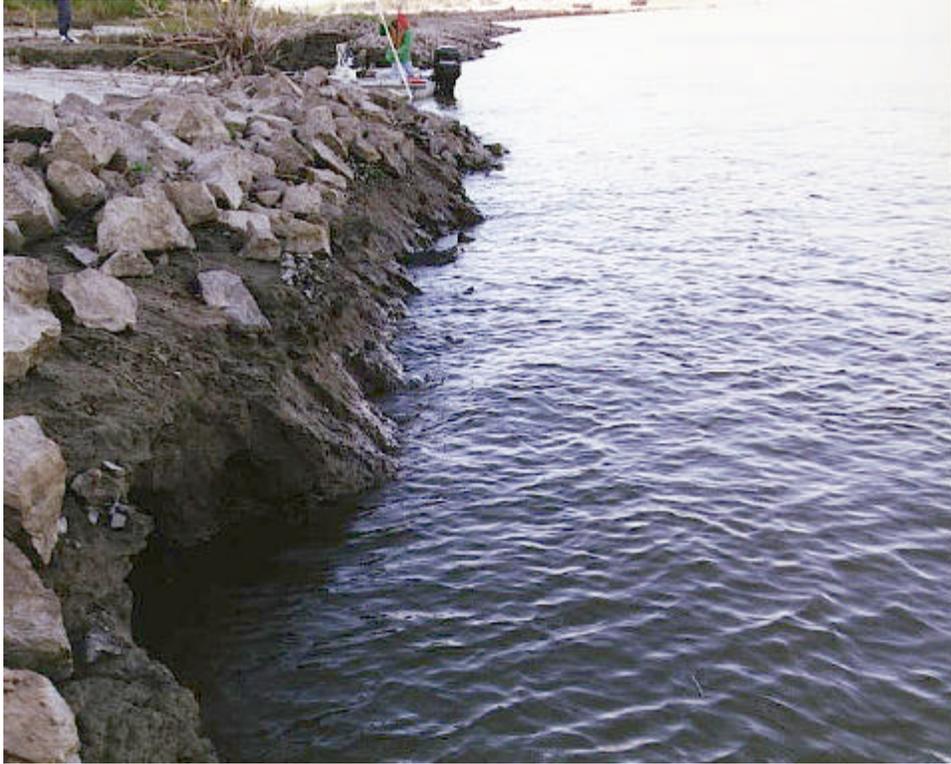
Photo 7-119 A downstream view of Site 42 midpoint

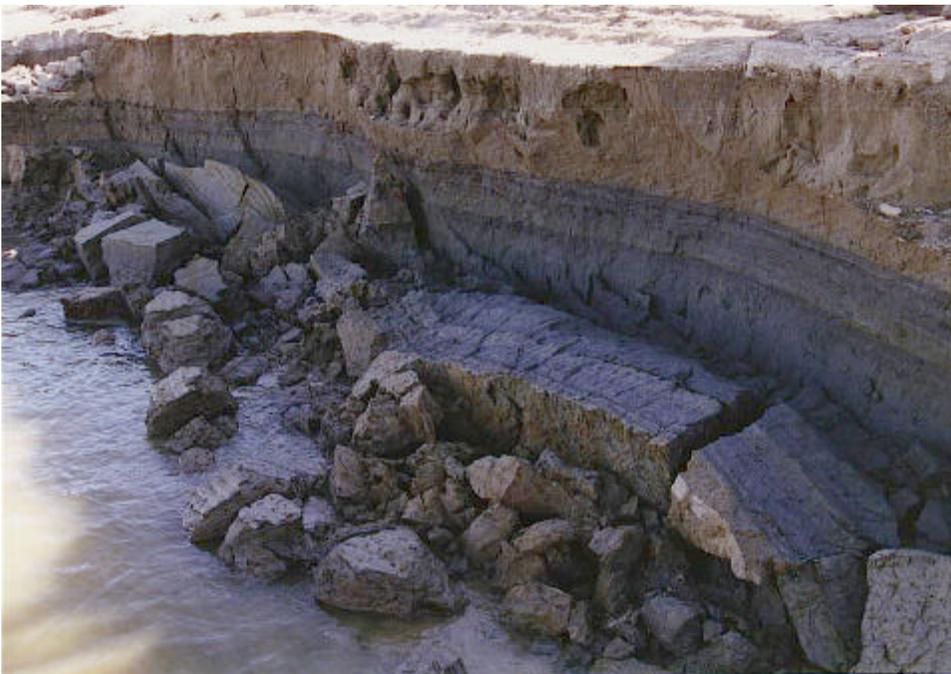
Photo 7-120 A close-up view of bank failure of Site 42 midpoint

Causative factors for bank retreat at this site include flood-flow erosion and oversteepening, recession and piping collapse, stone launching, and wave and rework-transport of failed soils and recently deposited sediments within berm and bench areas. Type A conditions best describe Site 42.

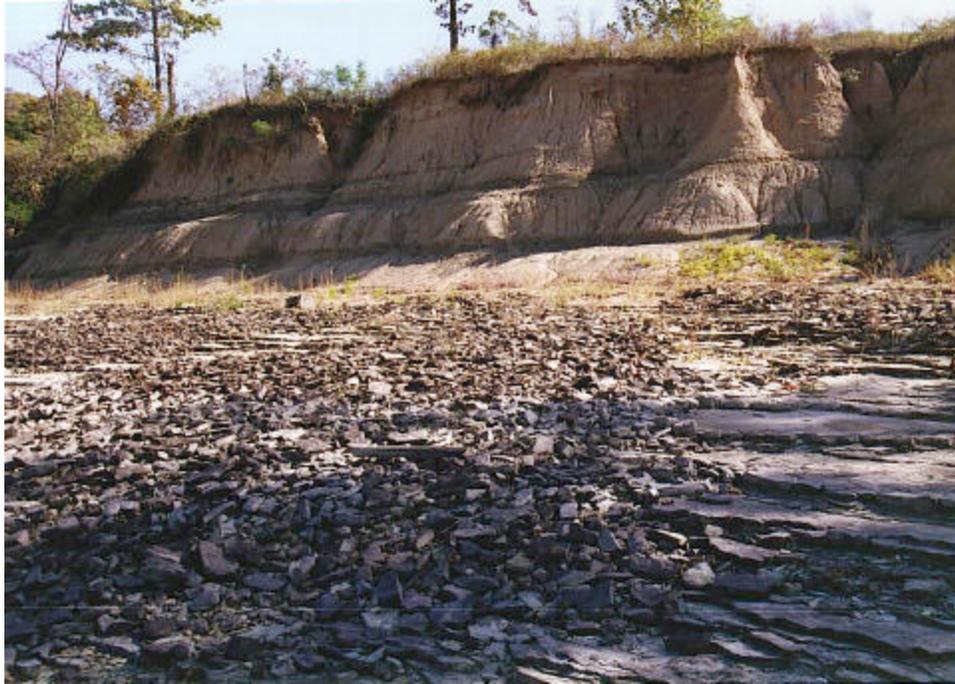
Photo 7-121 An upstream side view of Site 43 midpoint

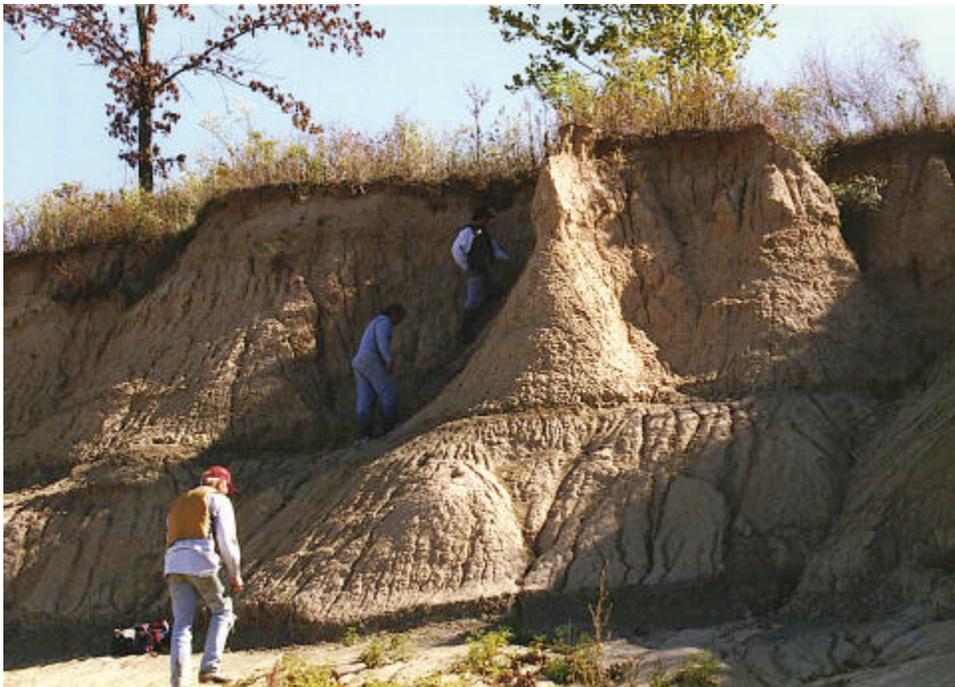
This left-bank site, shown in figure 7-135, is located in a narrow straight reach, immediately downstream from a sharp bend. The bank lies on a shaley siltstone, as depicted in Photo 7-121 and figure 7-136. Photo 7-122 shows a close-up view of the scarp which exposes medium silt (MST) and coarse clay (CC). Photo 7-123 shows the reddish brown bank soil when it was placed in water. The river cross section at Site 43 has a very peculiar shape, practically triangular, indicating a rather steep-slope bedrock-defined channel, with active erosion.

Photo 7-122 A close-up of scarp face of Site 43 midpoint

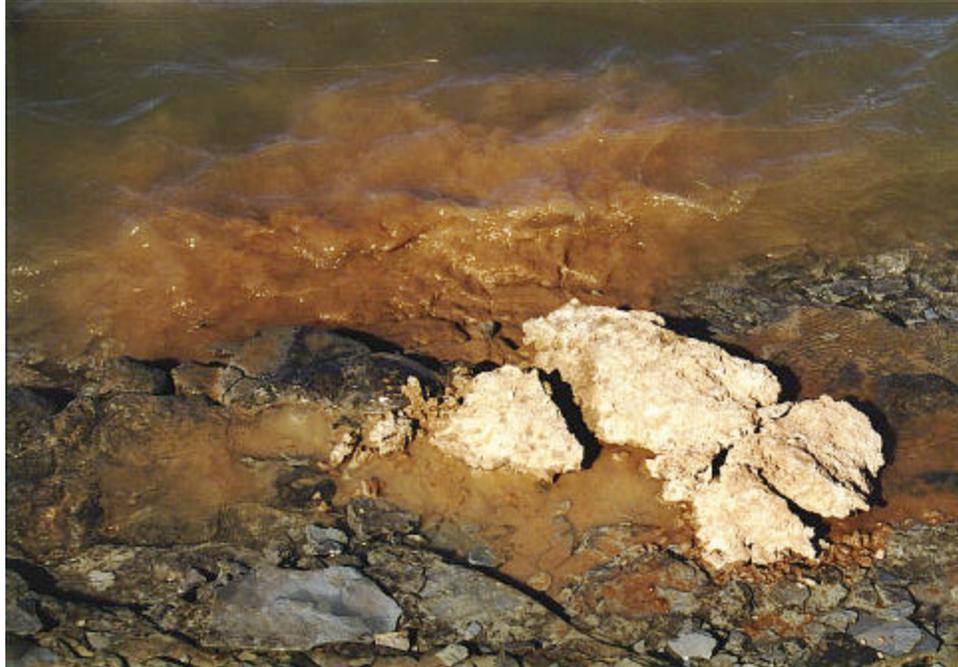
alluvium. A highly oxidized reddish brown loessal deposit (Loveland Loess-Sangamon) overlies shaley siltstone which outcrops at the toe of slope.

Photo 7-123 Reddish brown color of soil block in water at Site 43 midpoint

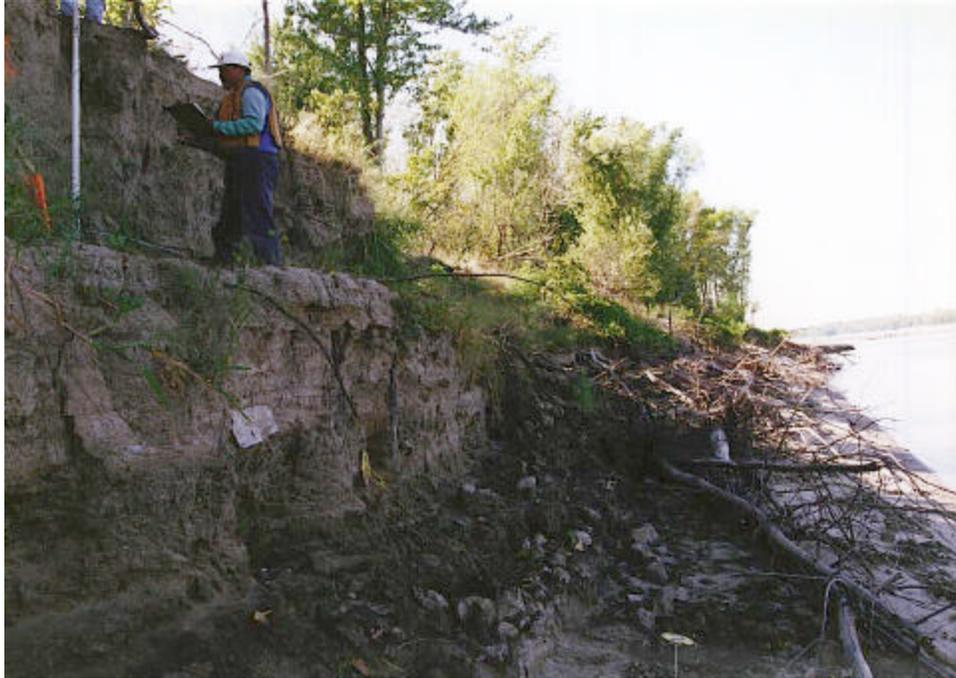
Photo 7-124 An upstream view of Site 44 midpoint

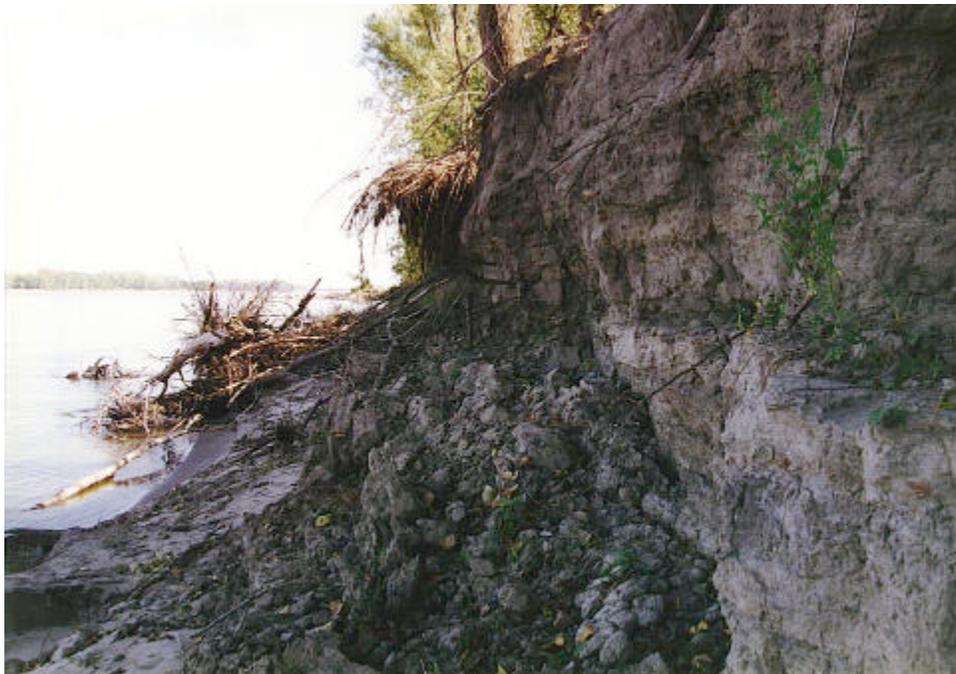
Photo 7-125 A downstream view of Site 44 midpoint

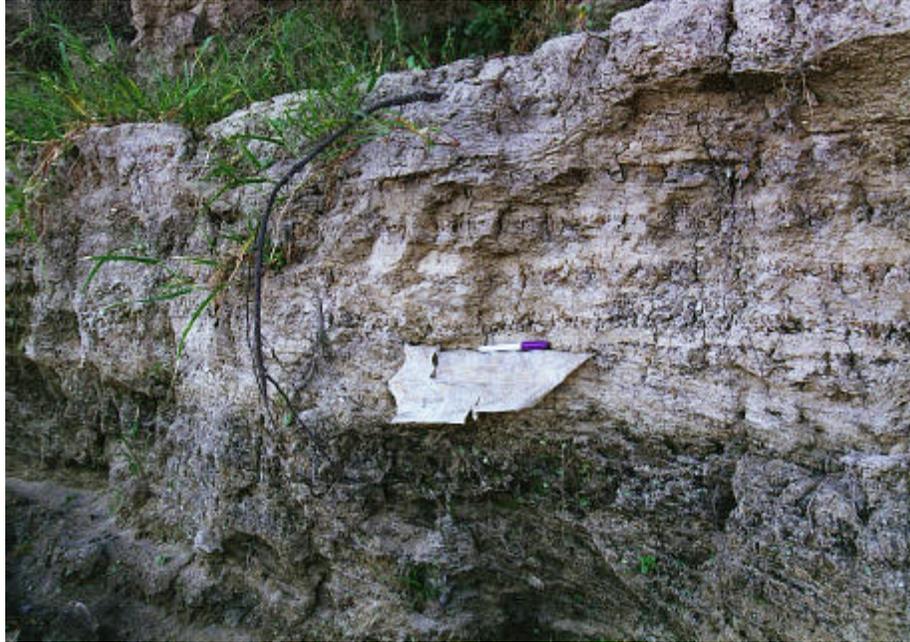
Photo 7-126 A close-up view of buried plastic sheet at Site 44 midpoint
(see Photo 7-124 for its relative location)
