## **Chapter 7. The Upper Mississippi River**

### **Introduction**

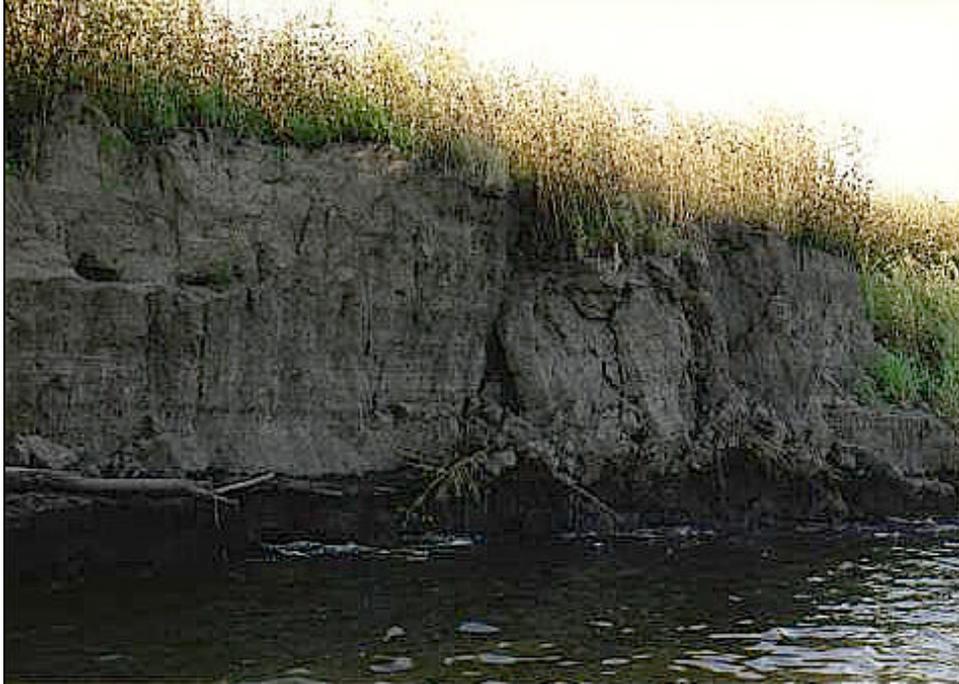
**Photo 7-1 Type A eroded-bank site (Site 28, RM 357.6)**

| Type | Principal Features |
|---|--|
| <b>Type A</b> | <ul style="list-style-type: none"> <li>• Primarily silty clay and clayey silt</li> <li>• Similar to TYPE B but without sand layers</li> <li>• Nearly vertical scarp face</li> <li>• Internal and external cracks</li> <li>• Large scale block failures</li> <li>• Near-bank and underwater berms may form from fallen soil blocks</li> <li>• Piping features seen at scarp faces</li> </ul> |

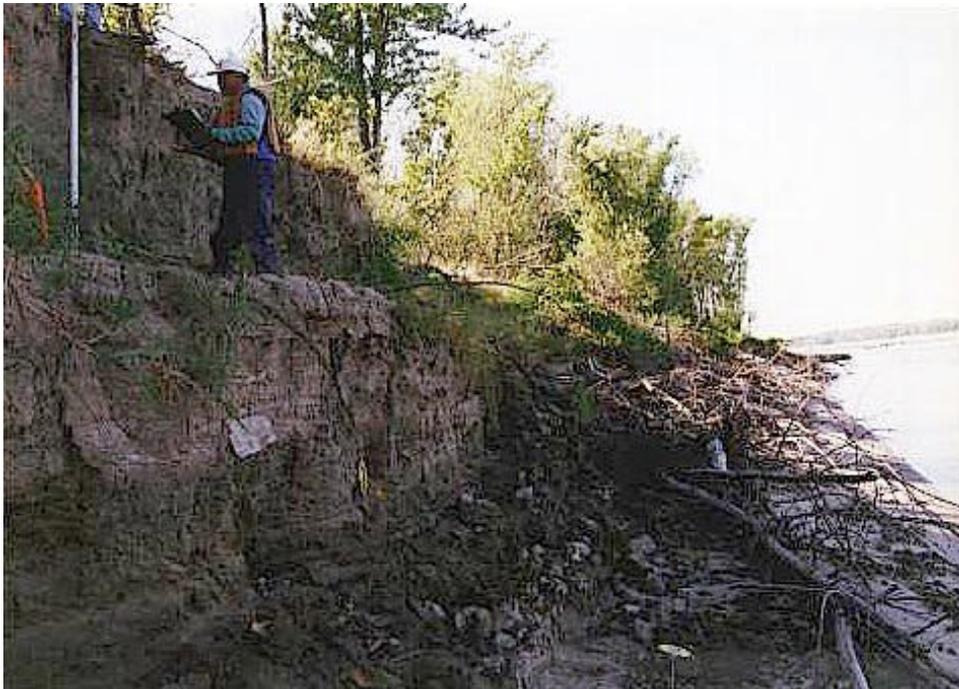
**Photo 7-2 Combination of Type A and Type B eroded-bank sites  
(Site 44, RM 26.0)**

| Type | Principal Features |
|---|--|
| <b>Type B</b> | <ul style="list-style-type: none"> <li>• Multiple layers of silty clay and clayey silt deposit with thin layers of silty-sand and sandy-silt lenses</li> <li>• Scarp faces nearly vertical</li> <li>• Terracette formation at each sandy layer</li> <li>• Fallen blocks frequently found in terraces at different levels</li> <li>• Piping features seen at different scarp faces</li> </ul> |

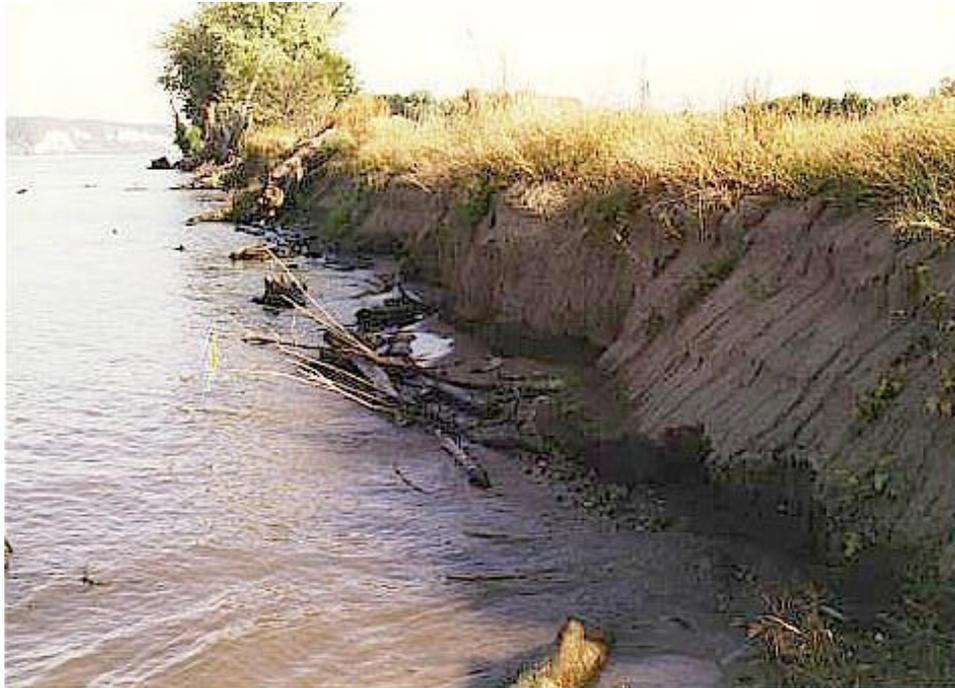
**Photo 7-3 Type C eroded-bank site (Site 36, RM 217.5)**

| Type | Principal Features |
|---|--|
| <b>Type C</b> | <ul style="list-style-type: none"> <li>• Upper layer of clayey silt and silty clay</li> <li>• Upper scarp face nearly vertical</li> <li>• Lower layer of sandy silt</li> <li>• Contains silty-sand and sandy-silt lenses</li> <li>• Berm structure with terracette formation</li> <li>• Piping features</li> </ul> |

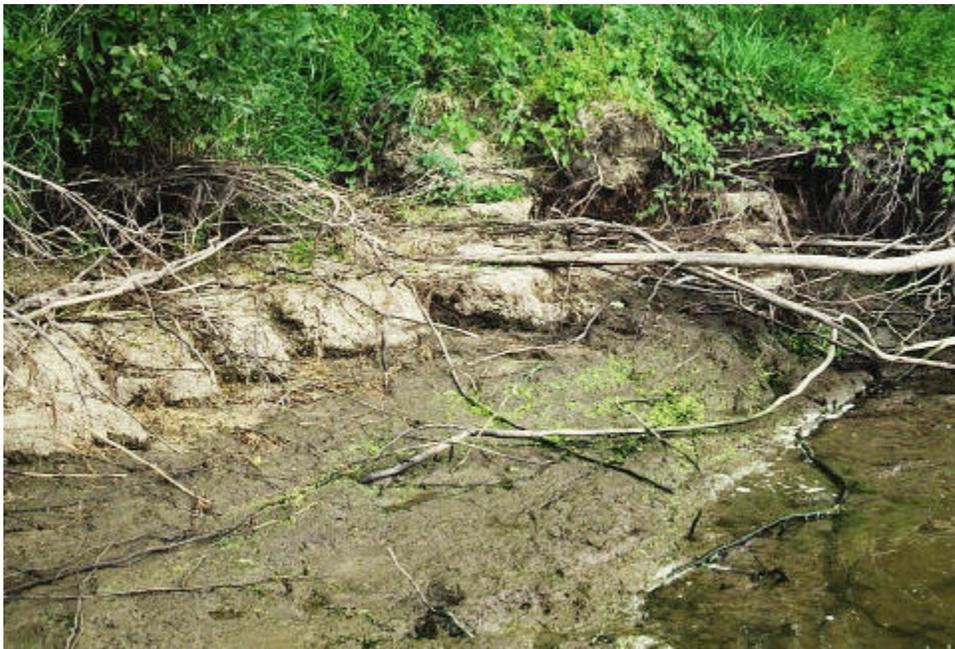
**Photo 7-4 A combination of Type D and Type E eroded-bank sites (Site 18, RM 432.3)**

| Type | Principal Features |
|---|--|
| <b>Type D</b> | <ul style="list-style-type: none"> <li>• Clayey silt and silty clay covered by layers of silty sand or sand</li> <li>• Bank with modest slope</li> <li>• No significant subaerial scarps</li> <li>• Severe near-shore subaqueous bank erosion</li> <li>• Typically found in fleeting area and outside of bend close to thalweg sailing line</li> </ul> |
| <b>Type E</b> | <ul style="list-style-type: none"> <li>• Primarily sand or silty sand characterized by bank with modest slope</li> <li>• Typically seen along small islands or downstream tips of large islands</li> <li>• Multiple miniature scarp faces affected by river-stage variations</li> </ul> |

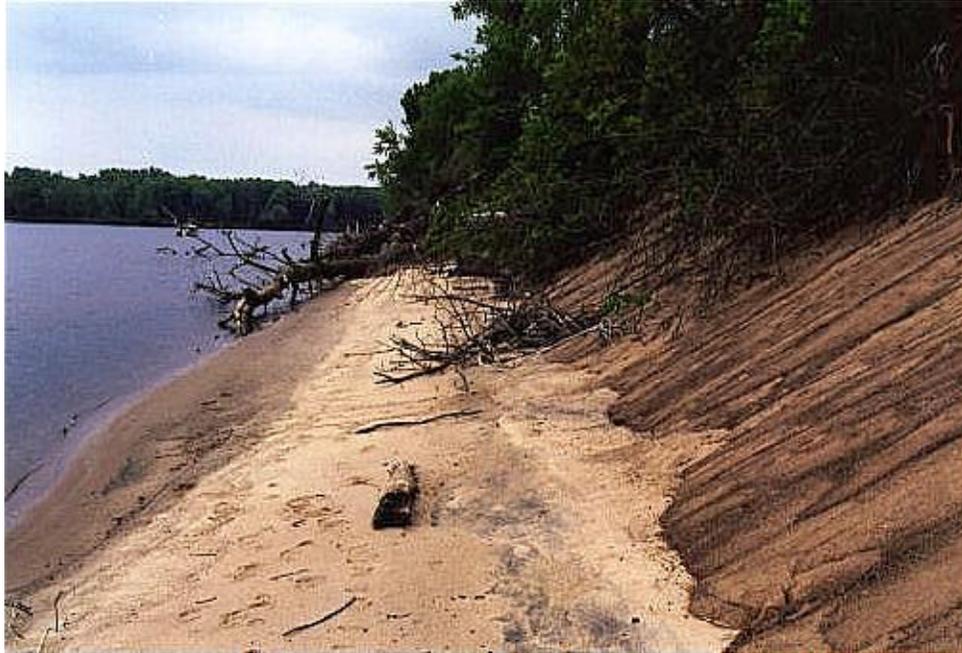
**Photo 7-5 Type F eroded-bank site (Site 3, RM 763.4)**

| Type | Principal Features |
|---|--|
| <b>Type F</b> | <ul style="list-style-type: none"> <li>• Noncohesive glacial deposit or dredge disposal material composed primarily of sand and gravel</li> <li>• On placement bank slope nearly equal to angle of repose</li> <li>• Typical along the Upper Mississippi River above St. Louis and along the Illinois Waterway</li> </ul> |

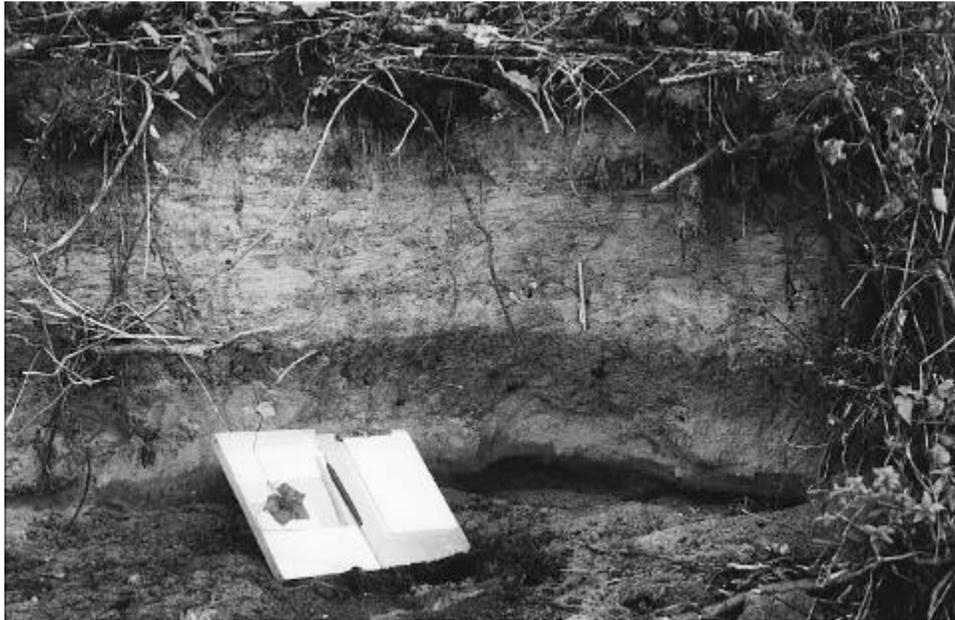
**Photo 7-6 Buried native soil below historical alluvium observed at Site 4, RM 751.1 (the lighter colored upper unit is the historical deposit)**

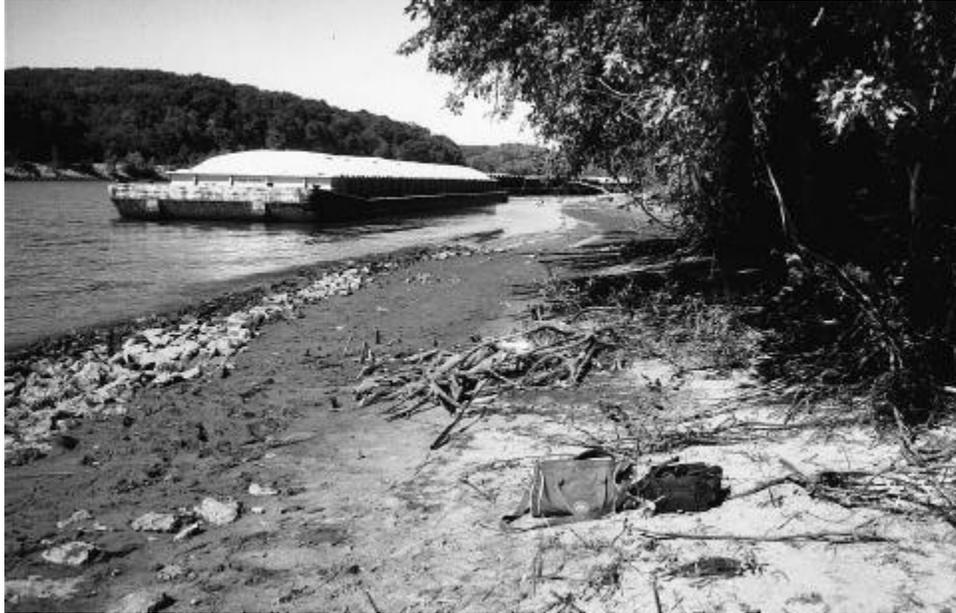
**Photo 7-7 Severe bank erosion at barge mooring area observed at Site 15, RM 576.0**

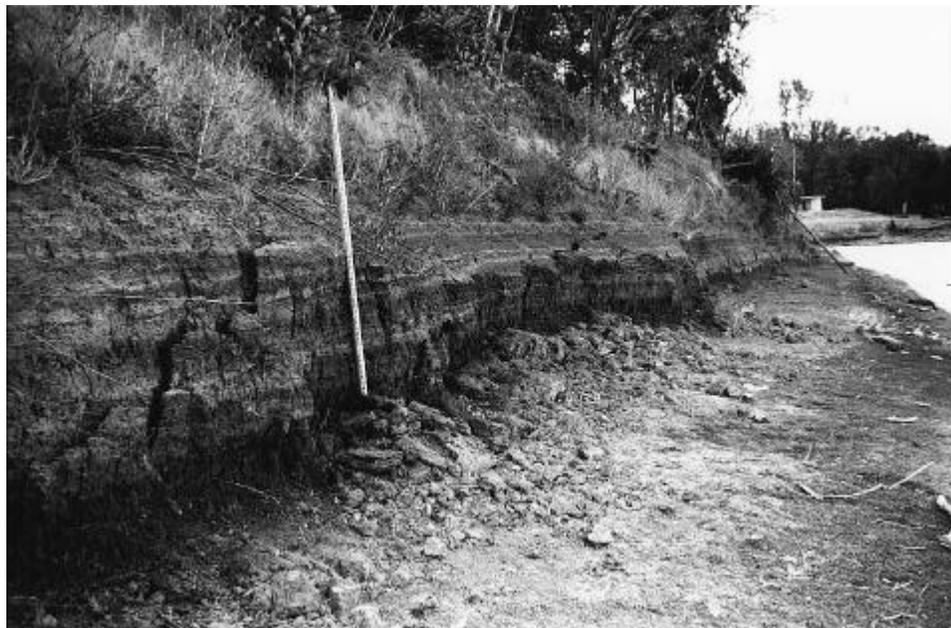
**Photo 7-8 Thick historical alluvium overlying the native soil observed at Observation Site, RM 194.0 (the bottom of stadia rod indicates the native soil surface)**

Below the confluences with the Illinois and Missouri Rivers, Holocene-aged surfaces along the channel margin all but disappear and are replaced by thick-bedded historical alluvium, as shown in Photo 7-8. With the exception of a few areas, a continuous levee

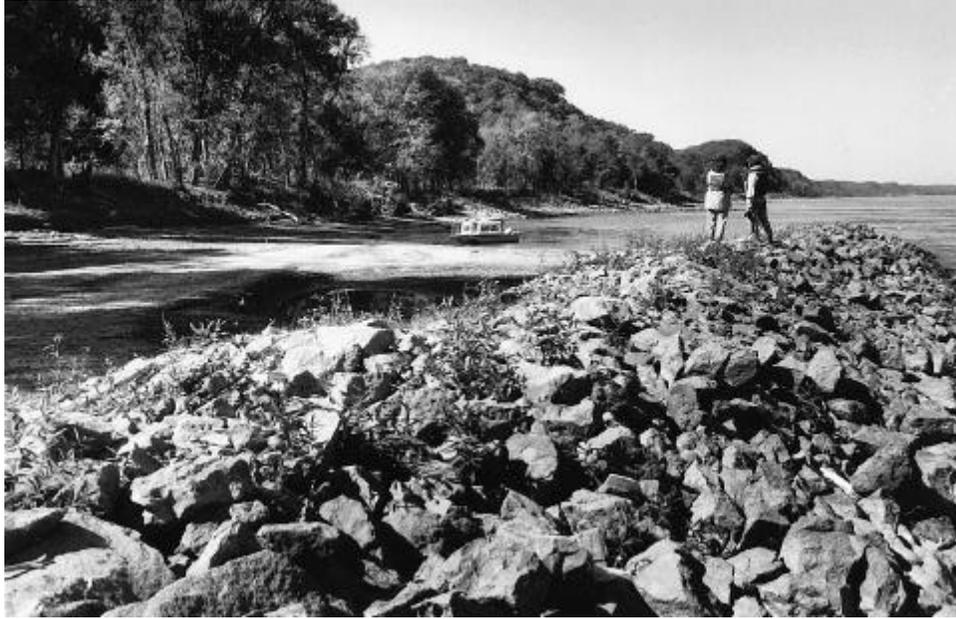
**Photo 7-9 Observation Site, RM 134.1 -- looking north upstream --  
(this photo shows study team members standing on CCC-placed  
riprap (ca. 1930s) About 150 ft of bank erosion has occurred  
westward to the left since riprap placement)**

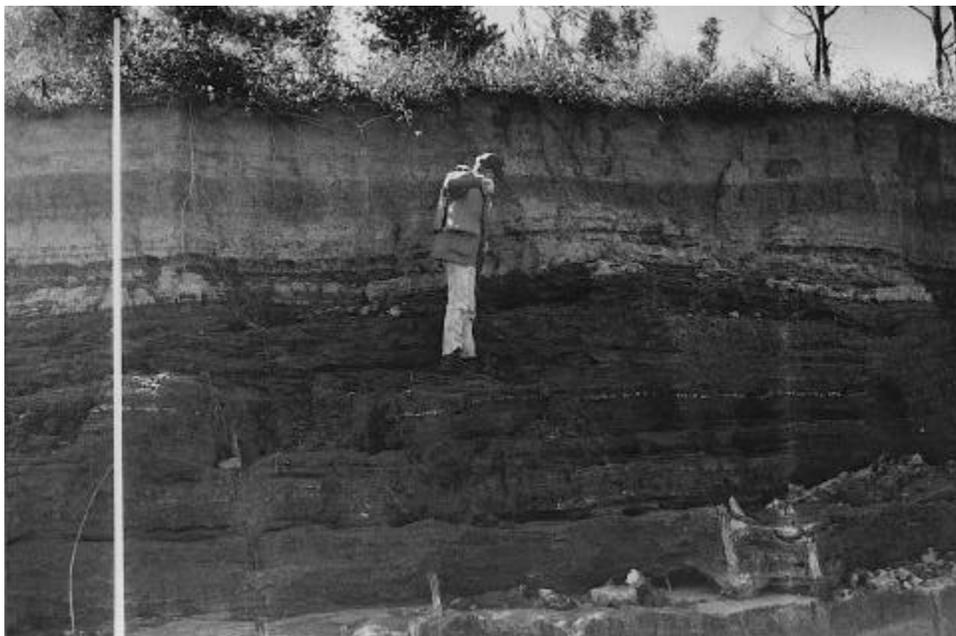
**Photo 7-10 Bank face showing a profile composed entirely of recent historical  
alluvium at Site 39, RM 112.4**

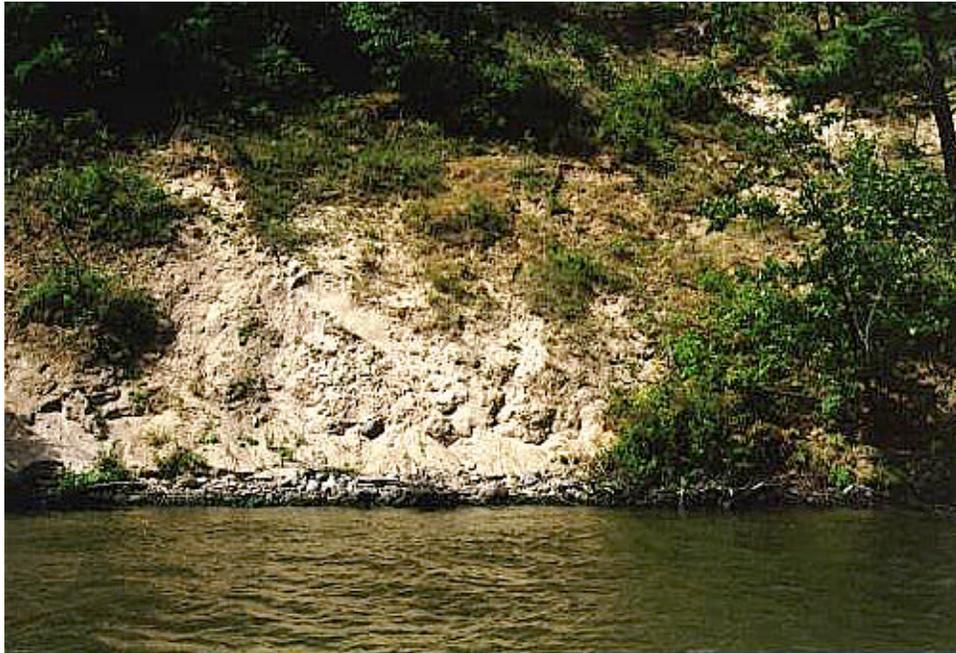
**Photo 7-11 A side view of Site 1 midpoint**

This right-bank site shown in figure 7-6 is located along the outer bank of a sharp river bend, and is very close to the thalweg sailing line. Side and upstream views of the site are shown in Photos 7-11 and 7-12, respectively. As can be seen in figure 7-7, the active steeply failing bank slope, approximately 90 ft high, consists primarily of glacial deposits.

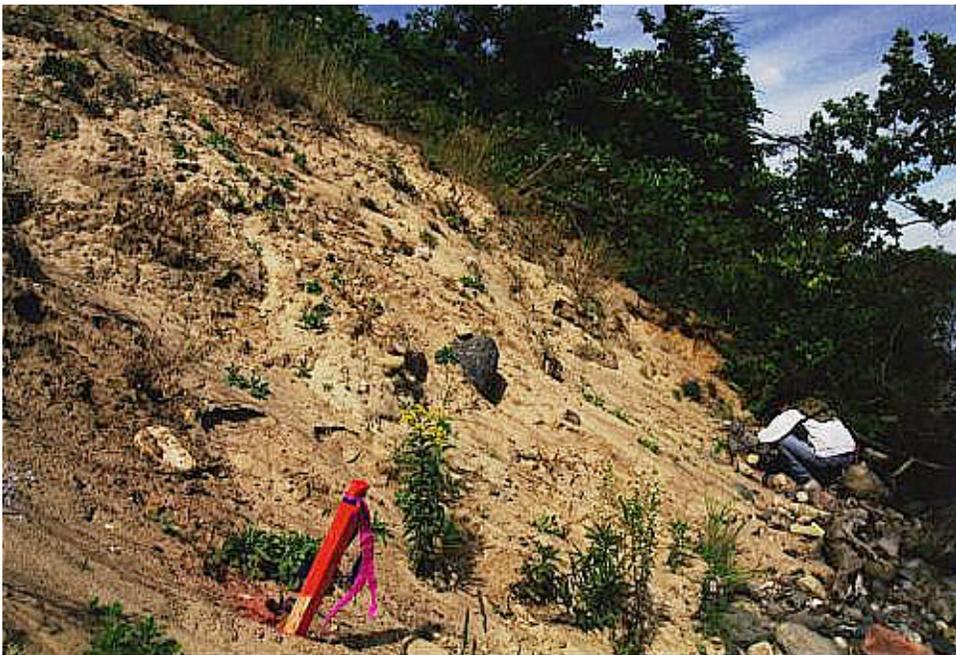
**Photo 7-12 An upstream view of Site 1 midpoint**
