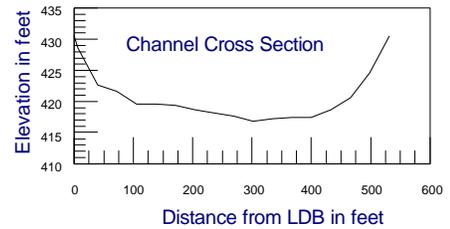
Figure 6-89. Bank sections at site 16 (concluded)

At the midsection, the d_{50} varied from 0.011 mm at the top surface of the bank to 0.005 mm at the upper portion of a core sample at a water depth of about 2 feet. The d_{50} of the lower portion of this core sample, 0.015 mm, is similar to that of other materials found on the bank. Gradation plots of bank soils and nearshore sediment are presented in appendix F. The detailed cross section and coordinates are shown in appendix G.

Bench slopes varied rapidly from 1V:7.0H at the upstream section to 1V:14.5H at the downstream section. The upstream section and midsections are classified as type 2, and the downstream section is classified as type 3 (figures 6-19, 6-20, and table 6-4). Rework and transport of bench materials occur at stages within the normal range of pool-level fluctuations. Erosion of in-place soils occurs at stage above OHW. Seepage and piping affect the extent of failure during recession periods when the river stages can drain.

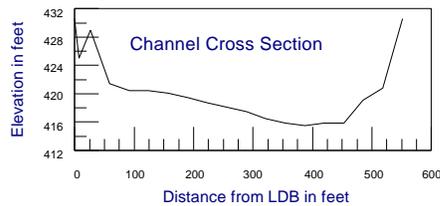
Figure 6-91. Bank sections at site 17

Figure 6-91 shows the three measured bank sections and two reduced cross sections. The OHW is 435.7 feet and NP is 429.9 feet above msl. There is a scarp near the water's edge and downslope from areas of seepage flows; the OHW elevation is above a zone of seasonal grasses. The OHW elevation corresponds well to the base of a scarp on the upper portion of the bank. Other stages and corresponding features are given in table 6-27.

At the midsection, the d_{50} varied from 0.005 mm at the top surface of the bank to 0.009 mm near the water's edge. Bank materials are similar. Gradation plots of bank soils and nearshore sediment are presented in appendix F. The detailed cross section and coordinates are shown in appendix G.

Bench slopes varied around 1V:4.0H. Both the upstream section and midsection are classified as type 5, and the downstream section is classified as type 4 (figures 6-21, 6-22, and table 6-4). Seepage at NP stages could weaken the bench materials and wave wash could create scarps on the bench. As at site 16, the subaerial bench was moist. Waves and currents at stages within the normal range of pool fluctuations cause erosion on bench and berm. These forces move failed soil or recent sediment away from the bank sections also.

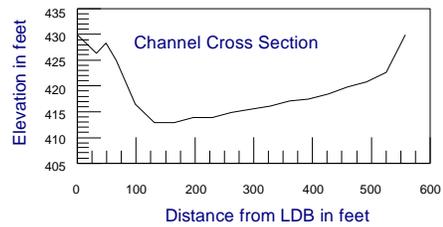
Figure 6-94. Bank sections at site 18 (concluded)

Figure 6-94 shows the three measured bank sections and a reduced cross section. All three sections were cut by a scarp, but scarp elevations were different. At this site, the OHW is 433.7 feet and the NP is 429.9 feet above msl. The scarp was above the OHW elevation at the upstream section, but the scarp elevations were lower for the midsection and downstream sections. The midsection and downstream section had small scarps in the stage range between the OHW and NP, but the upstream section did not have such scarps. Table 6-28 contains the stages with corresponding recurrence frequencies at this site.

At the midsection, the d_{50} varied from 0.016 mm at the top surface of the bank to 0.015 mm at the upper part of a core sample at a water depth of about 2 feet. Gradation plots of bank soils and nearshore sediment are presented in appendix F. The detailed river cross section and coordinates are shown in appendix G.

The bench slopes varied from 1V:7.4H at the upstream section to 1V:13.0 at the downstream sections. The subaqueous bench dropped off quickly at the midsection at this site. Both the upstream and downstream sections are classified as type 4, but the midsection is classified as a combination of types 2 and 4 (figures 6-19, 6-21, and table 6-4). The bank crest was covered by dense vegetation, and roots from that vegetation provided additional bonds to bank materials. The bank showed vertical cracks, which apparently were caused by basal scour. Sandy materials underneath the scarp seeped out after rapid stage recession. Waves and currents can rework and transport failed soils or recent sediments at stages within the normal range of pool-level fluctuations.

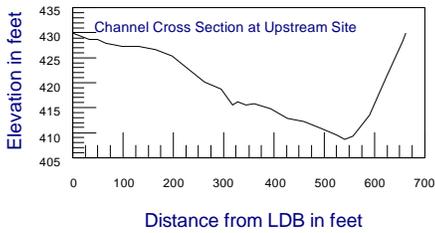
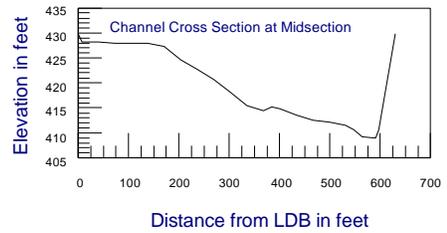
Figure 6-97. Bank sections at site 19

A scarp approximately 4 to 6 feet high was present. The lower bank and berm area contained several scarps and a moist soil layer at the toe. Some sand deposition was found on the narrow bench area. Figure 6-97 shows the three measured bank sections and a reduced cross section. The upstream bank section was extended approximately 160 feet to include the top of the embankment for the Chicago Burlington & Quincy Railroad. The OHW is 433.3 feet and NP is 429.9 feet above msl. The OHW elevation is at the base of the large scarp. The stage at the time of the field visit was at NP level.

At the midsection, the d_{50} varied from 0.027 mm at the top surface of the bank to 0.014 mm at the upper part of a core sample at a water depth of about 2 feet. Gradation plots of bank soils and nearshore sediment are presented in appendix F. The detailed river cross section and coordinates are shown in appendix G.

Bench slopes varied from 1V:4.8H at the upstream section to 1V:10H at the downstream section. This site is classified as a combination of types 2 and 4 (figures 6-19, 6-21, and table 6-4). Seepage initiated bank failure, rework and transport of failed soils occurred at stages within the normal pool-level fluctuations. Traffic-induced disturbances should be considered because the closeness to the barge terminal. Rapid drop of depth at mid- and downstream sections may reflect such a factor.
