**8. Site 8 at RM 677.5 RDB (Pool 9)**

**9. Site 9 at RM 677.5 LDB (Pool 9)**

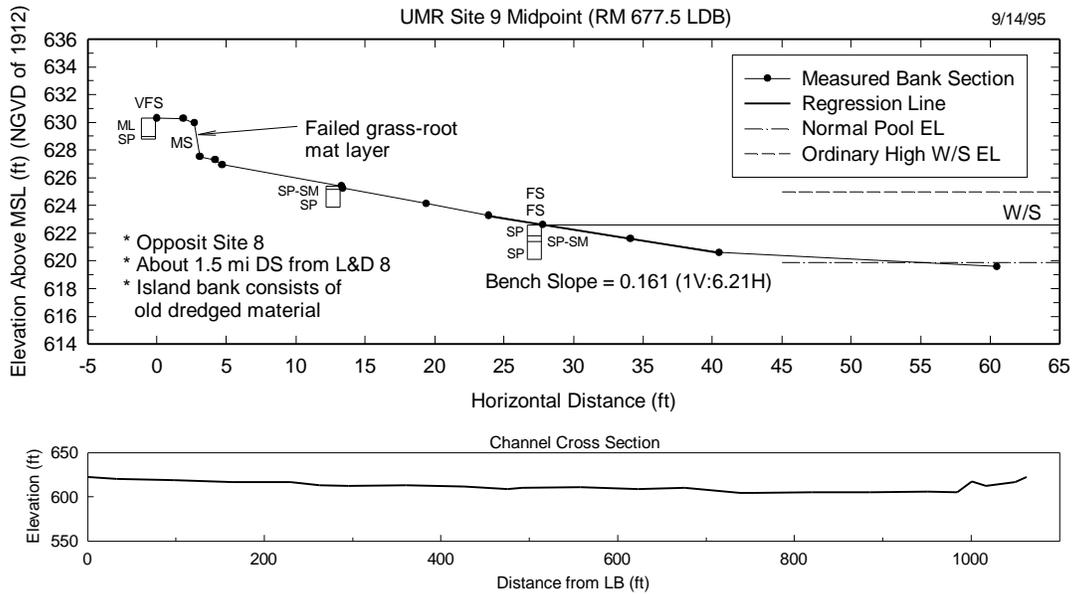
**Figure 7-33 Bank section and channel cross section measured at Site 9 midpoint**

This left-bank site on the inside of a slight bend, shown in figure 7-29, is located opposite Site 8. An upstream view of the site is shown in Photo 7-25. On the other side of this island is Thief Slough. Site 9 is located within a wing-dam field. Bank retreat at this site since 1984 is apparent in figure 7-29. The bank section is shown in figure 7-33, and the bank soils are old dredged material (VFS-MS). A small scarp was covered by a layer of failed grass-root mat.

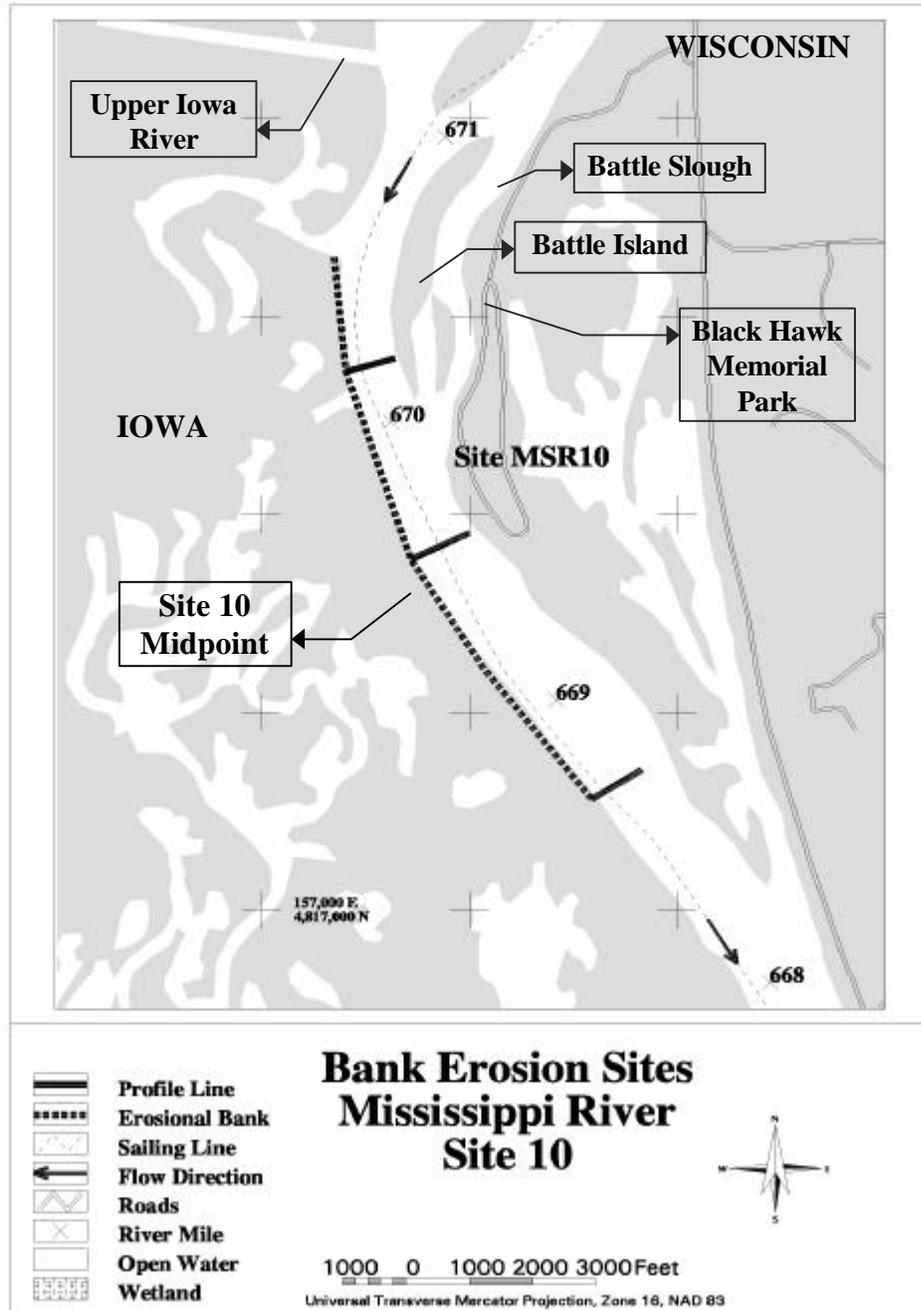
Figure 7-34 A site map showing Mississippi River Site 10

This right-bank site on the outside of a mild bend, shown in figure 7-34, is located only about 1.5 miles downstream from the mouth of the Upper Iowa River. The bank is covered by fine silt (FST) and sand (VFS-MS), and subaqueous soil is silt (FST-CST). A downstream view of the site is shown in Photo 7-26, and a close-up view of the scarp is shown in Photo 7-27. Three bank sections are shown in figures 7-35 through 7-37. Numerous fresh, fallen silty soil blocks, 6 in. to 2 ft high, were found along the sand

bench, which indicates that Site 10 is an active bank failure and erosion location. At the upstream section, a rocky bottom was observed about 30 ft from the water's edge (see figure 7-35).

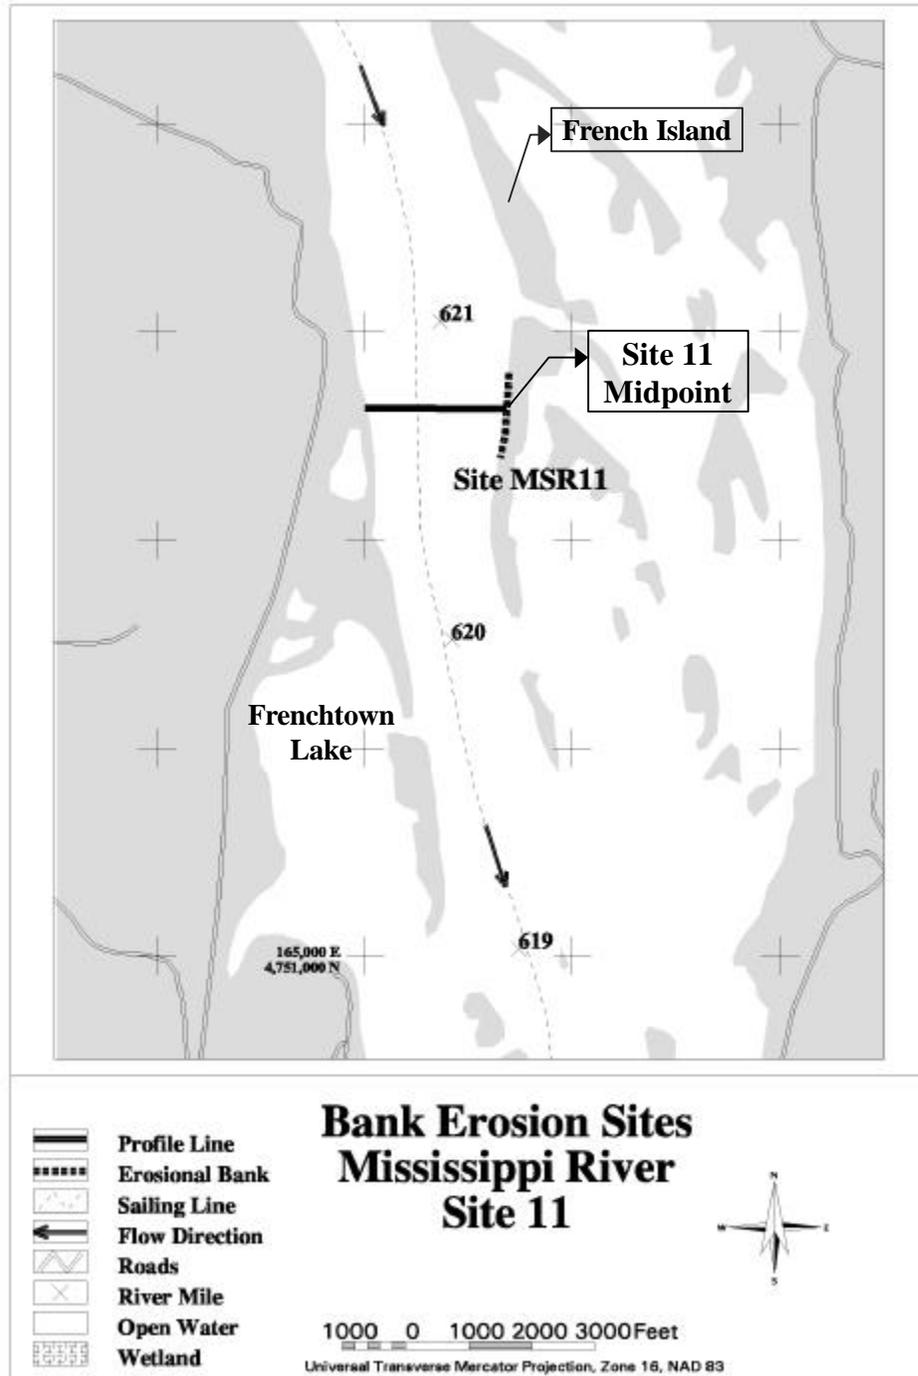
Figure 7-38 A site map showing Mississippi River Site 11

This island site, shown in figure 7-38, is located within a relatively narrow section of the valley, about 5.5 miles upstream from Lock & Dam No. 10, in the crossover reach between two mild bends. Upstream and downstream views of this site are shown by Photos 7-28 (see undercutting) and 7-29, respectively. Three bank sections are shown in figures 7-39 through 41. There are two wing dams, the upstream wing dam extends about 700 ft, and the downstream wing dam extends approximately 1,000 ft from the island. The midpoint section is just upstream from the longer downstream wing dam. The river
