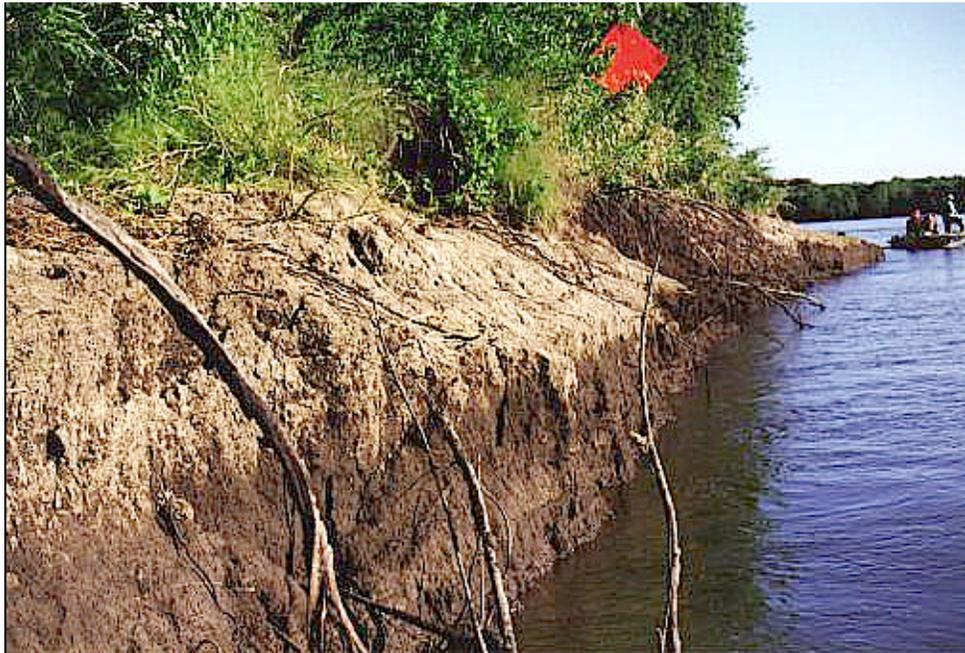
Photo 7-44 A close-up view of Site 16 midpoint

Both at the upstream section and the midpoint section, the scarp contained piping features, and fallen soil blocks were found in the water. Causative factors for bank retreat at this site include flood-flow related oversteepening and recessional slumping, lower-bank piping-related cantilever and block failures, wave and flow rework-transport actions, and secondary currents. Type C characterizes Site 16.

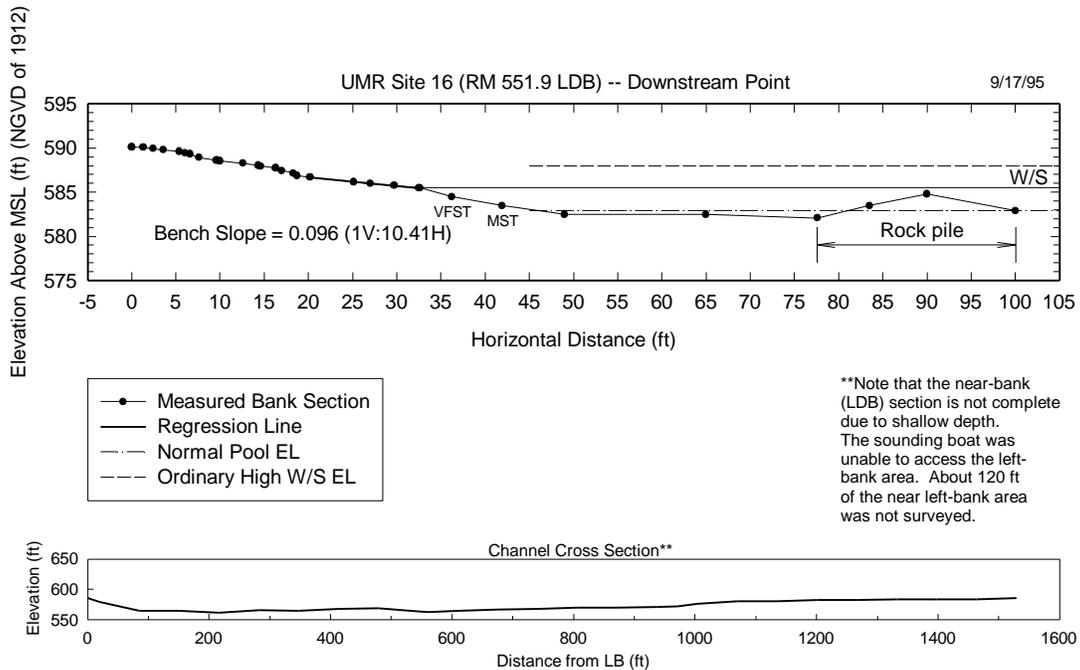
Figure 7-58 Bank section and channel cross section measured at Site 16 downstream point

and subaqueous sediments are silt (VFST-MST). The site is very close to the thalweg and evidence of severe flood-related channel erosion was visible. The near-bank flow velocity was estimated to be about 3 ft/s, at the time of the field study. At the downstream point, a rock pile was found, about 60 ft off the water's edge.

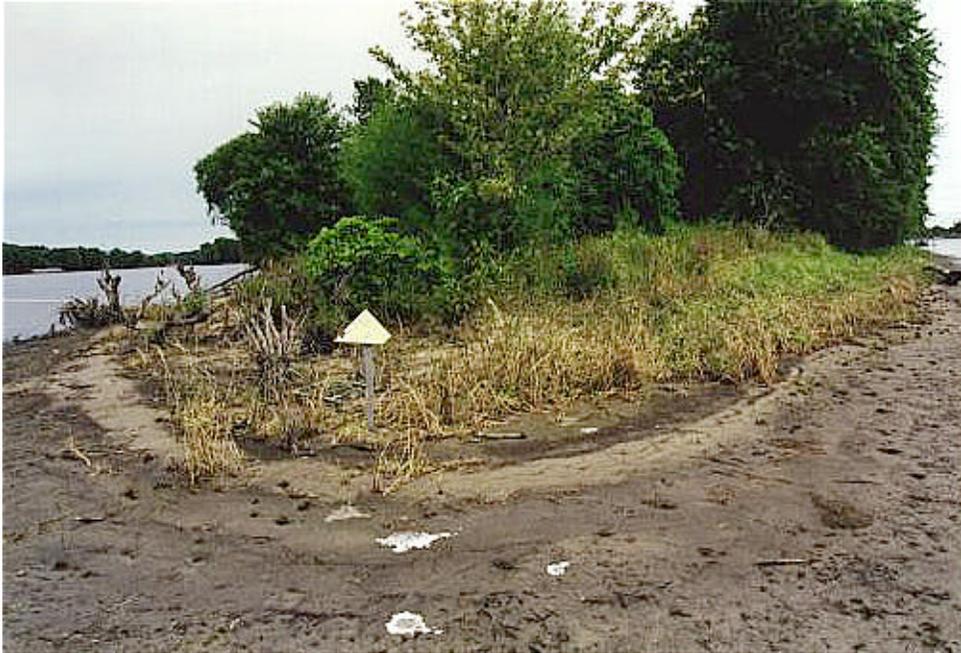
Photo 7-47 An upstream view of toe of island of Site 17

This site is a mid-channel island site in a rather straight river reach, 9.8 miles downstream from Lock & Dam No. 14, as shown in figure 7-59. Upstream and downstream views of the midpoint site are shown in Photos 7-45 and 7-46, respectively. Photo 7-47 shows an upstream view of the toe of the island, and Photo 7-48 shows wave removal of sand from the bench cover near the toe of the island. Substantial downstream accretion of the island since 1984 can be seen in figure 7-59. In order to investigate bank erosion characteristics on the island, five bank sections were taken along the channel side and two sections were taken along the back channel (see figures 7-60 through 7-66). The bench area cover is primarily sand with recently deposited silt. Subaqueous sediments are medium sand (MS) at the upstream limit, coarse silt (CST) at the midpoint section, and CST on top of FS at the downstream limit, indicating the reduction in bed-material particle size along the island. The island is located within two large wing dams which extend toward the main channel from the left bank approximately 1,700 ft, and immediately downstream from Beaver Slough along the right bank. Beaver Slough is heavily used by barge traffic, and the area across from this island site is a busy fleeting site. The upstream tip of this island is eroded and the toe of the island appears to be extending downstream, indicating that the island is shifting downstream.

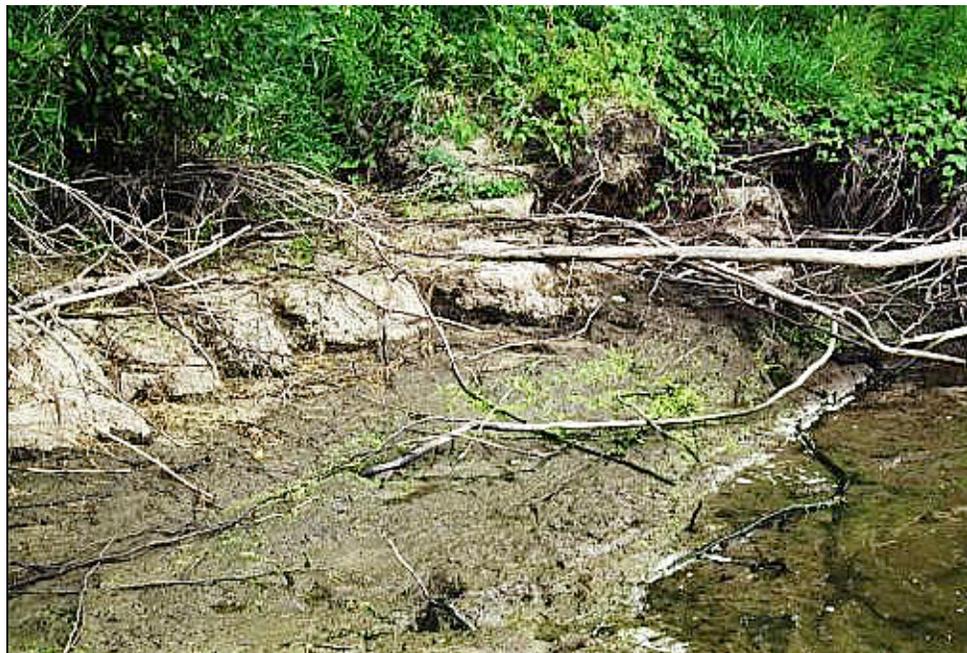
Photo 7-50 A close-up view of Site 18 midpoint

an upstream view of the site, and Photo 7-50 shows a close-up view of the bankline. Three bank sections were taken at this site and they are shown in figure 7-68 through 7-70. No bank erosion was visible; however, very steep subaqueous bed slopes indicate severe channel erosion at this site.

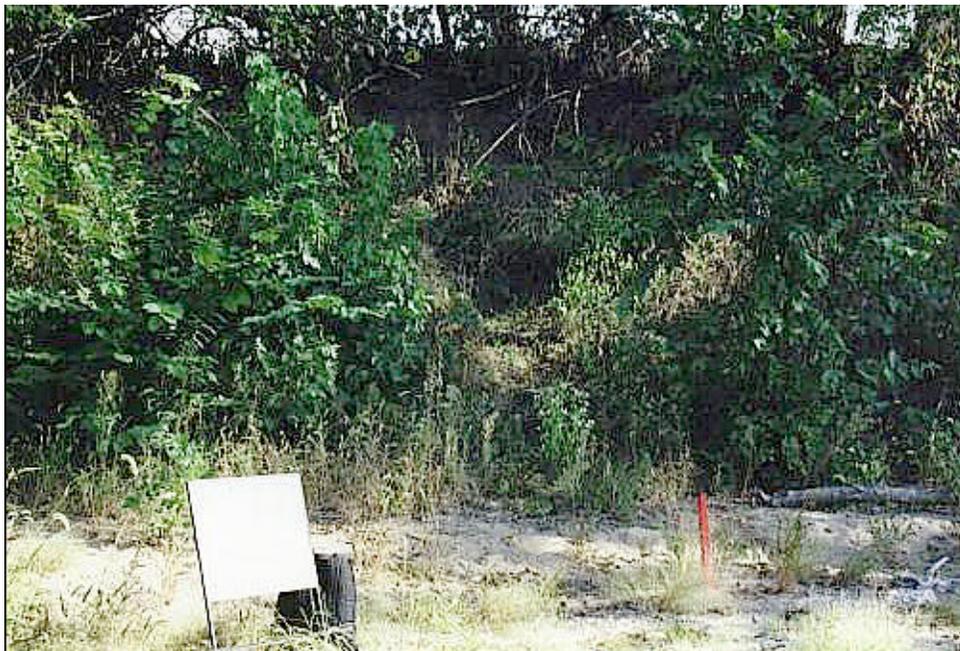
Photo 7-52 A perpendicular view of Site 19 midpoint

Photo 7-51 shows an upstream view of the site. The bank face was covered by tall weeds and shrubs, as can be seen in Photo 7-52. Two bank sections were taken at this site and

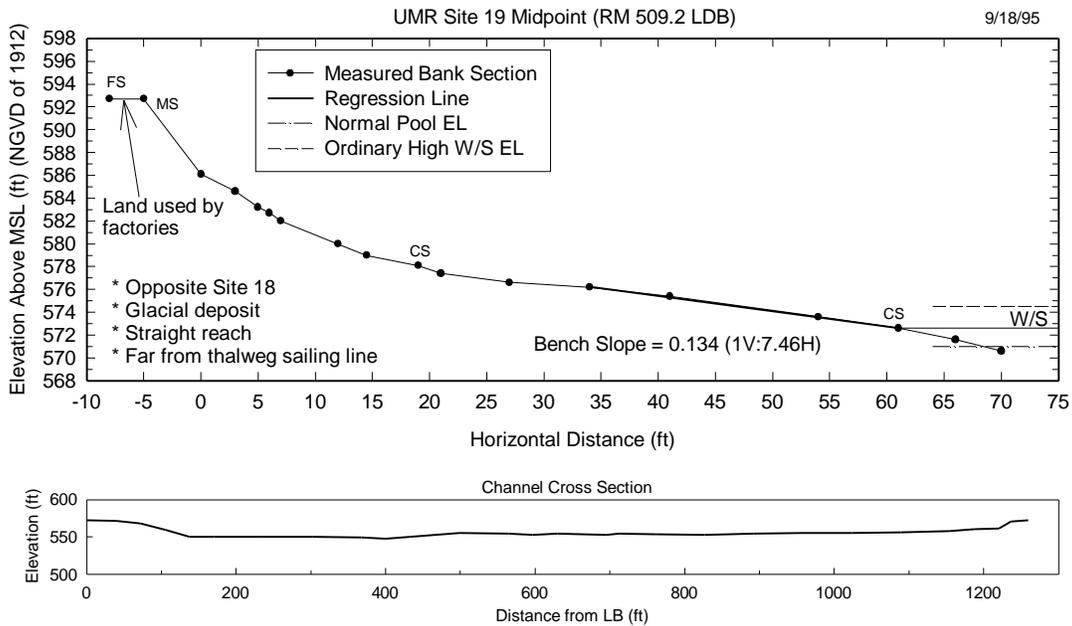
Figure 7-71 Bank section and channel cross section measured at Site 19 midpoint

are shown in figures 7-71 and 7-72. The bank soils are primarily sand, ranging from FS to CS.
