**Table 7-5a A summary of bank-erosion study sites and their characteristics**

### 3. Site 3 at RM 763.4 LDB (Pool 4)

#### ***4. Site 4 at RM 751.1 LDB (Pool 5)***

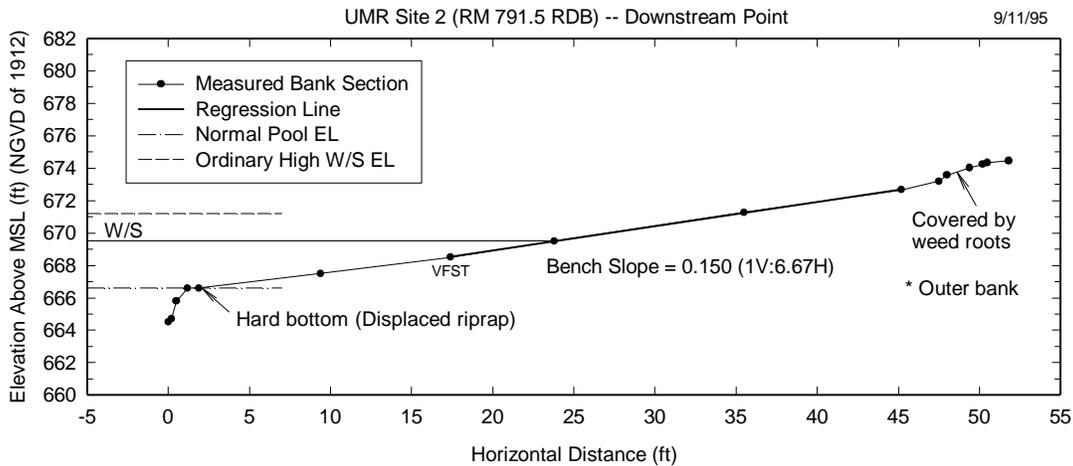
**Figure 7-11 Bank section measured at Site 2 downstream point**

Causative factors for bank retreat at this site include wave and rework-transport of failed soil, and flood-period failure and erosion. Sandy sediment mantles the bench. This site can be classified as Type E.

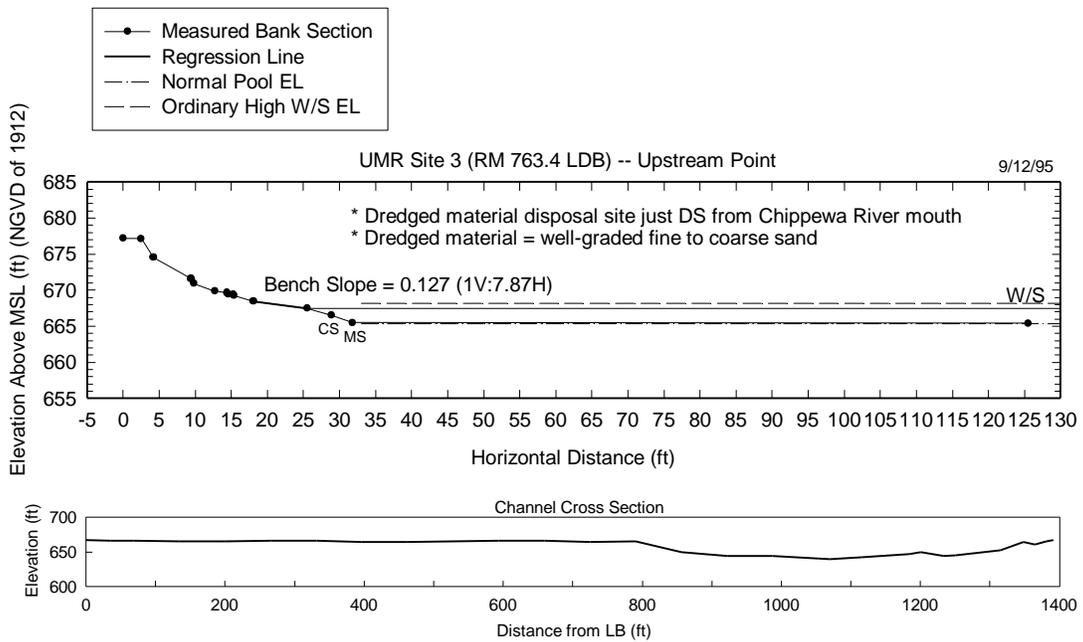
**Figure 7-13 Bank section and channel cross section measured at Site 3 upstream point**

Because there is no erosion protection at this site, dredged material was reworked and transported to the river. The bank-section bench area can be seen clearly in figure 7-14 at the midpoint section. Dredged material at this site is prone to current and wave erosion. The bank sections at the upstream and downstream points are classified as a combination of bank Type E and Type F, and the midpoint section as Type F.

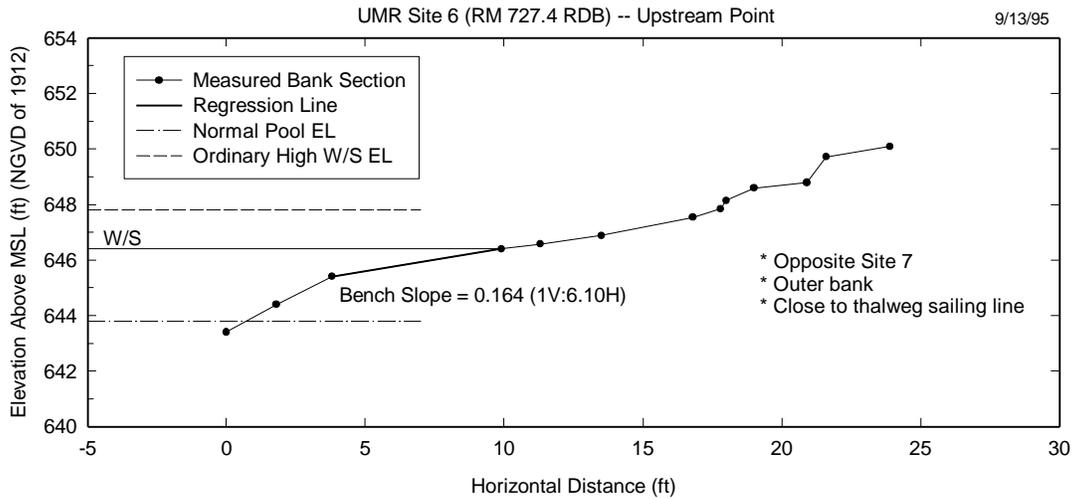
**Figure 7-25 Bank section measured at Site 6 upstream point**

Primary causative factors for bank retreat at this site include flood-flow erosion and rapid recessional loading and failure, wave and rework-transport of failed soils and recently deposited sediments, and minor piping. Wave erosion of sand cover occurs within bench areas at this site. This site is classified as Type E.

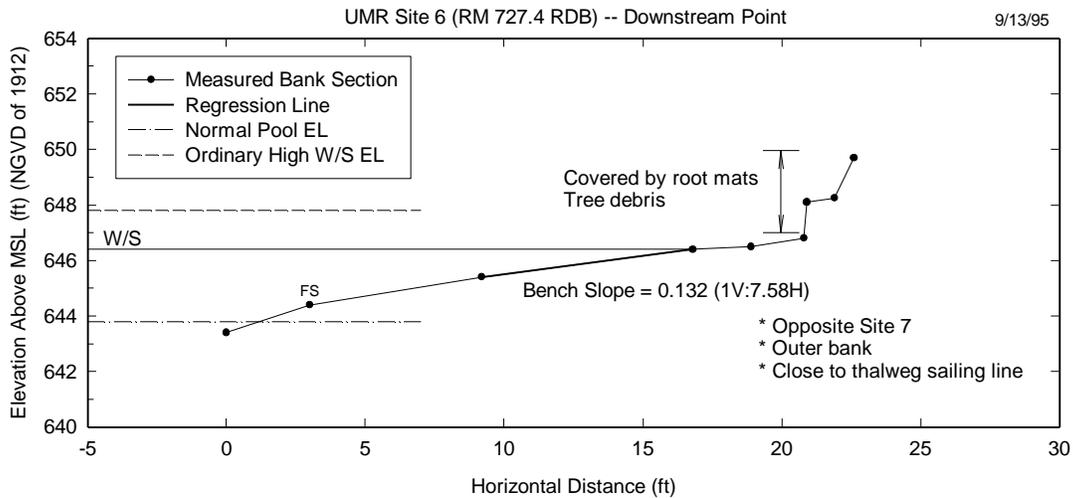
**Figure 7-27 Bank section measured at Site 6 downstream point**

Observations indicate lateral bank erosion with minor surface erosion. No historical deposits were found in the core sample. Three paleosols were observed in the profile, developed in levee deposits, and they appear to be of late Holocene age. It should be noted that the buried soils occur in a MR natural levee deposit. Because of the buried soils and location in the upper pool, there is potential for buried archaeological material although there are no recorded archaeological sites nearby.
