US Army Corps
of Engineers
St. Paul District

Photo A.1: Weaver Bottoms Constructed 1986 Swan & Mallard Island, Whitewater River

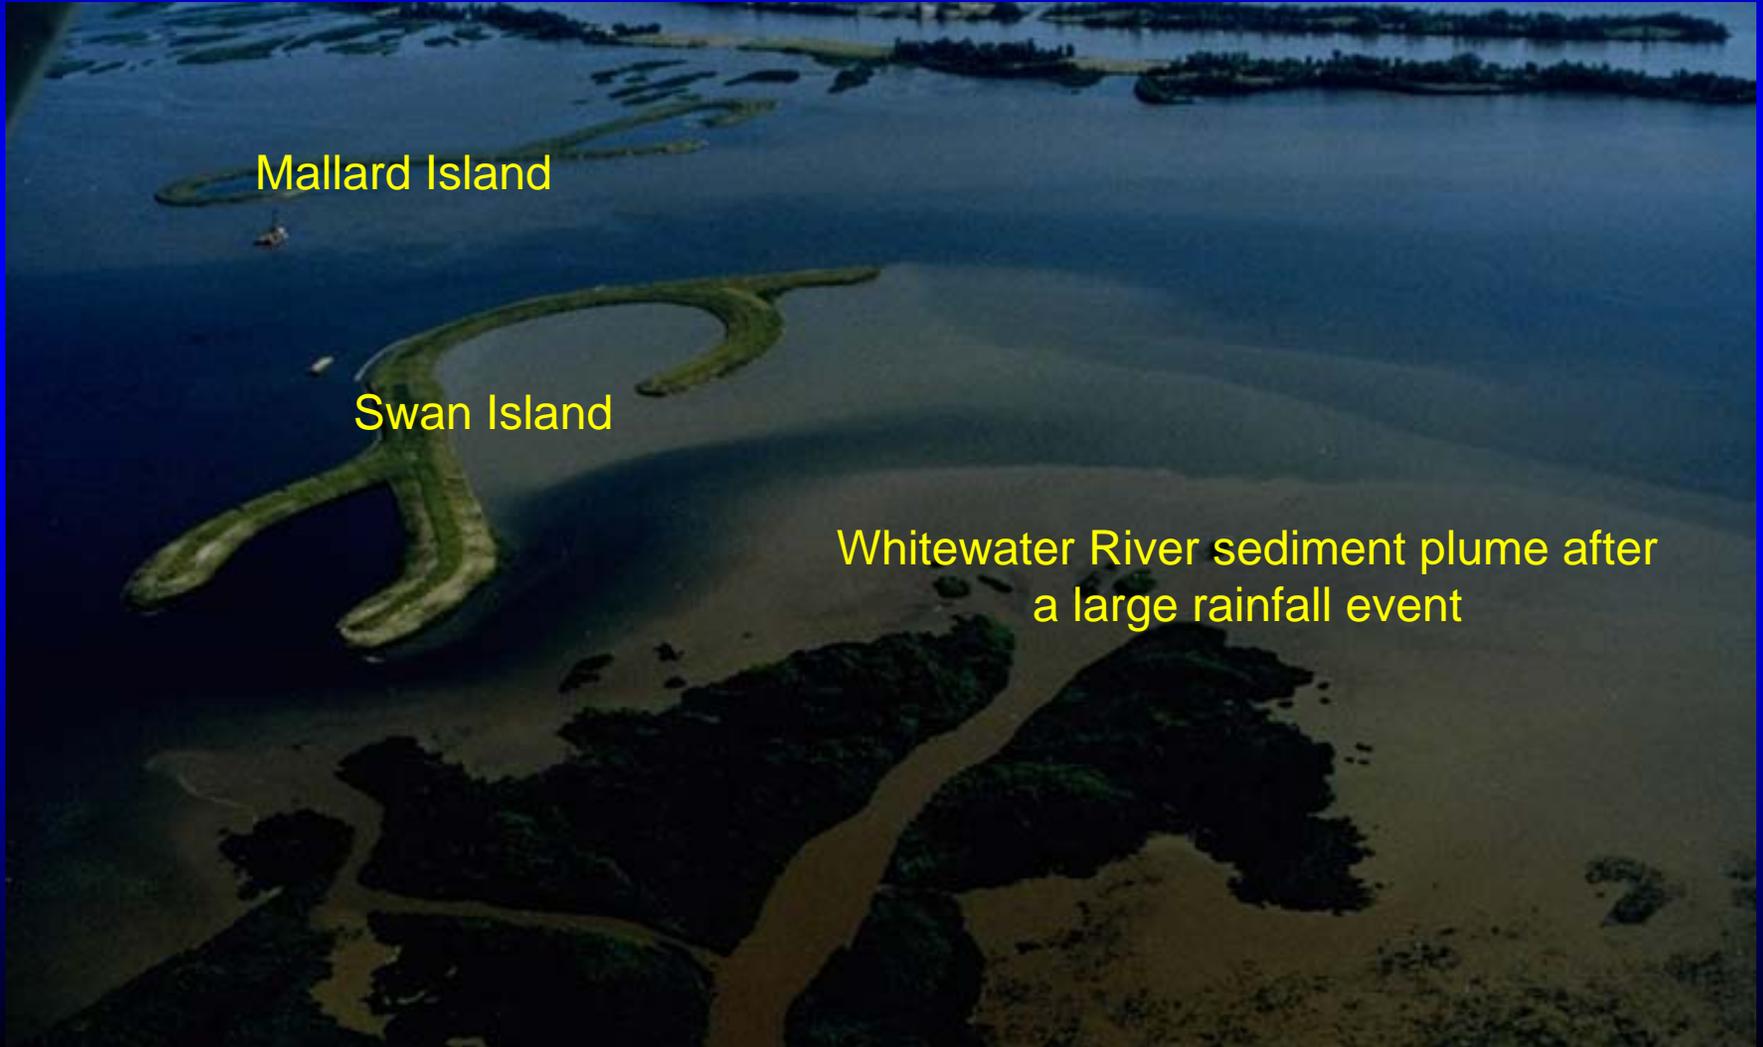
Whitewater River sediment plume after
a large rainfall event

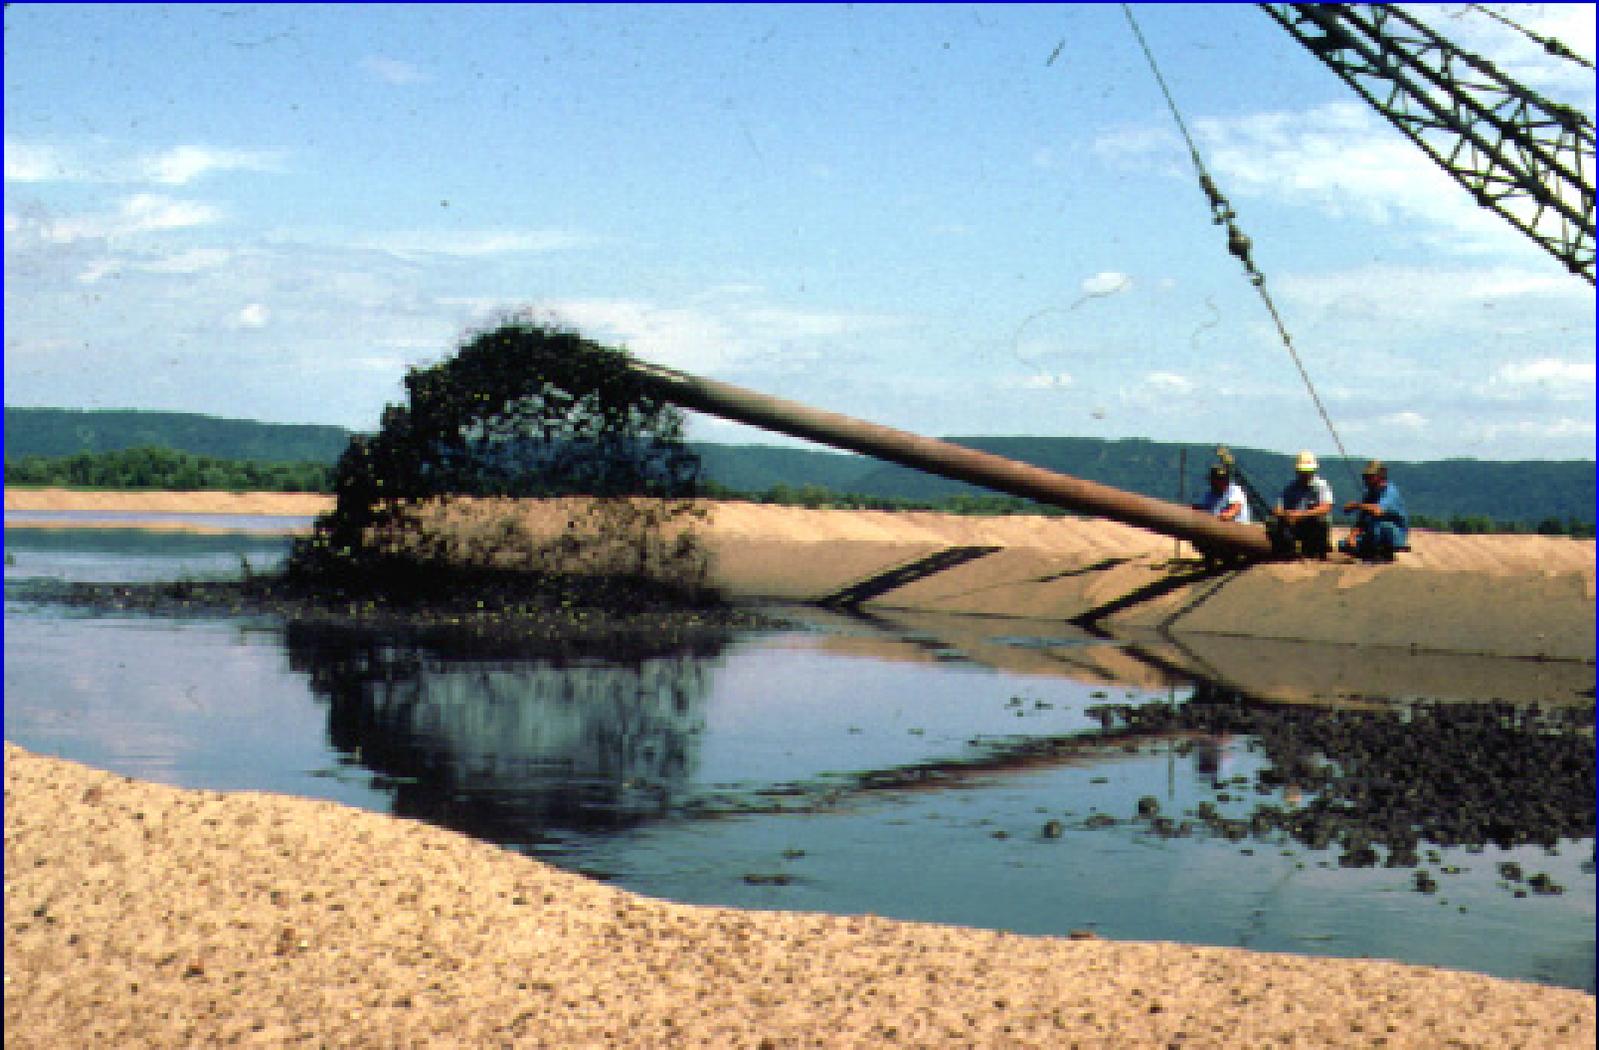
Photo A.2: Weaver Bottoms Hydraulic dredging of fine sediments into a containment cell constructed on Swan Island

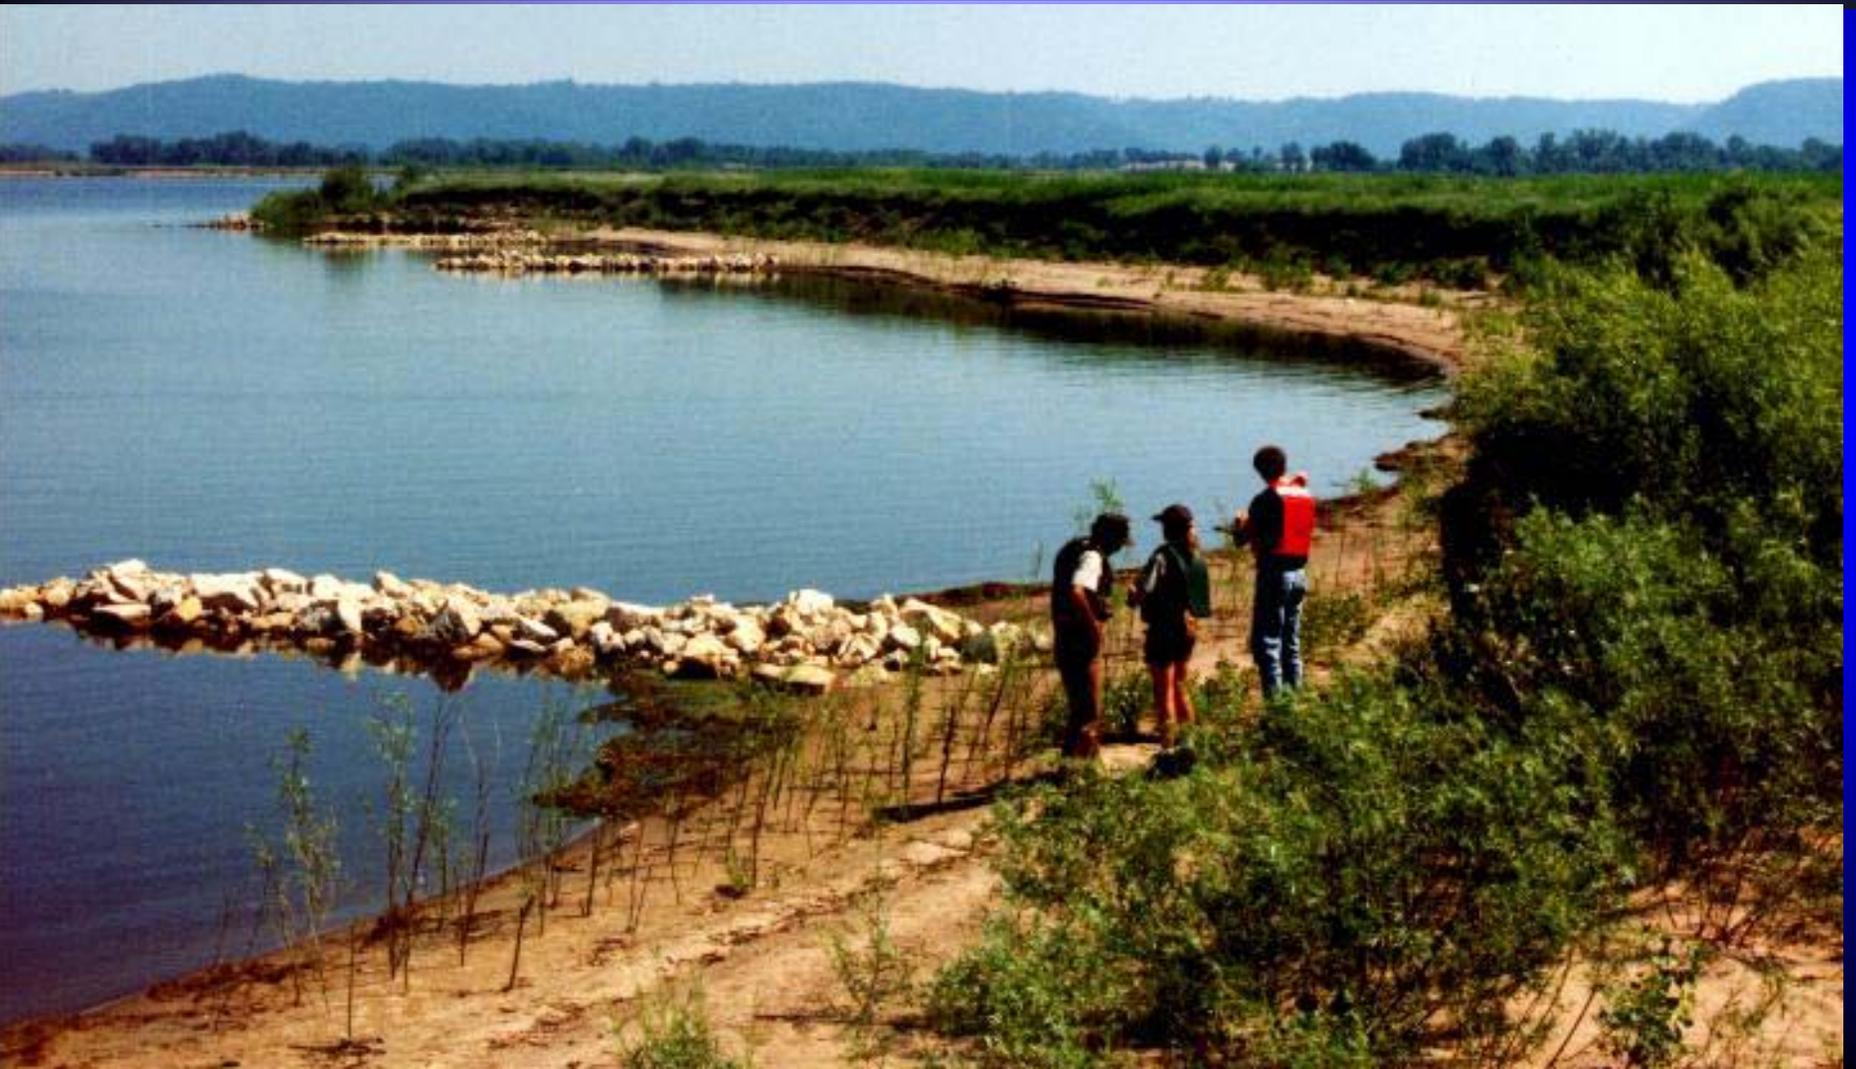
Photo A.4: Weaver Bottoms Groins on north side of Swan Island

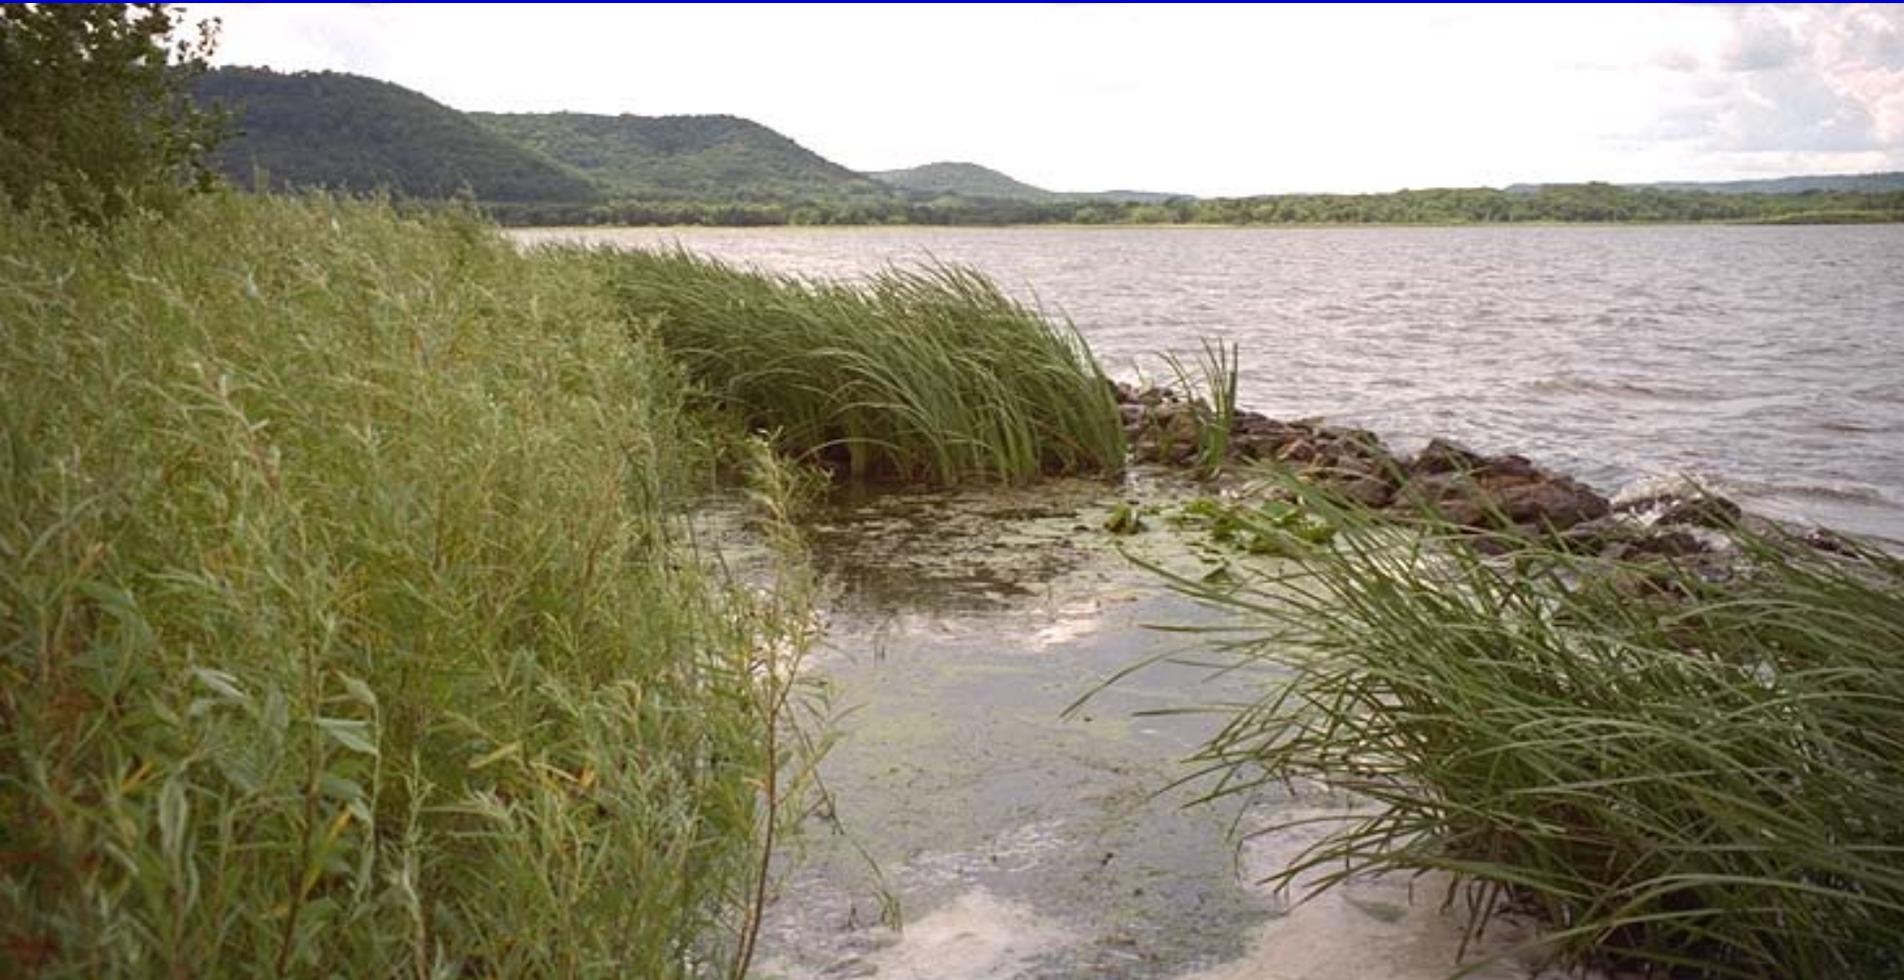
Photo A.5: Weaver Bottoms Offshore rock mound, Swan Island

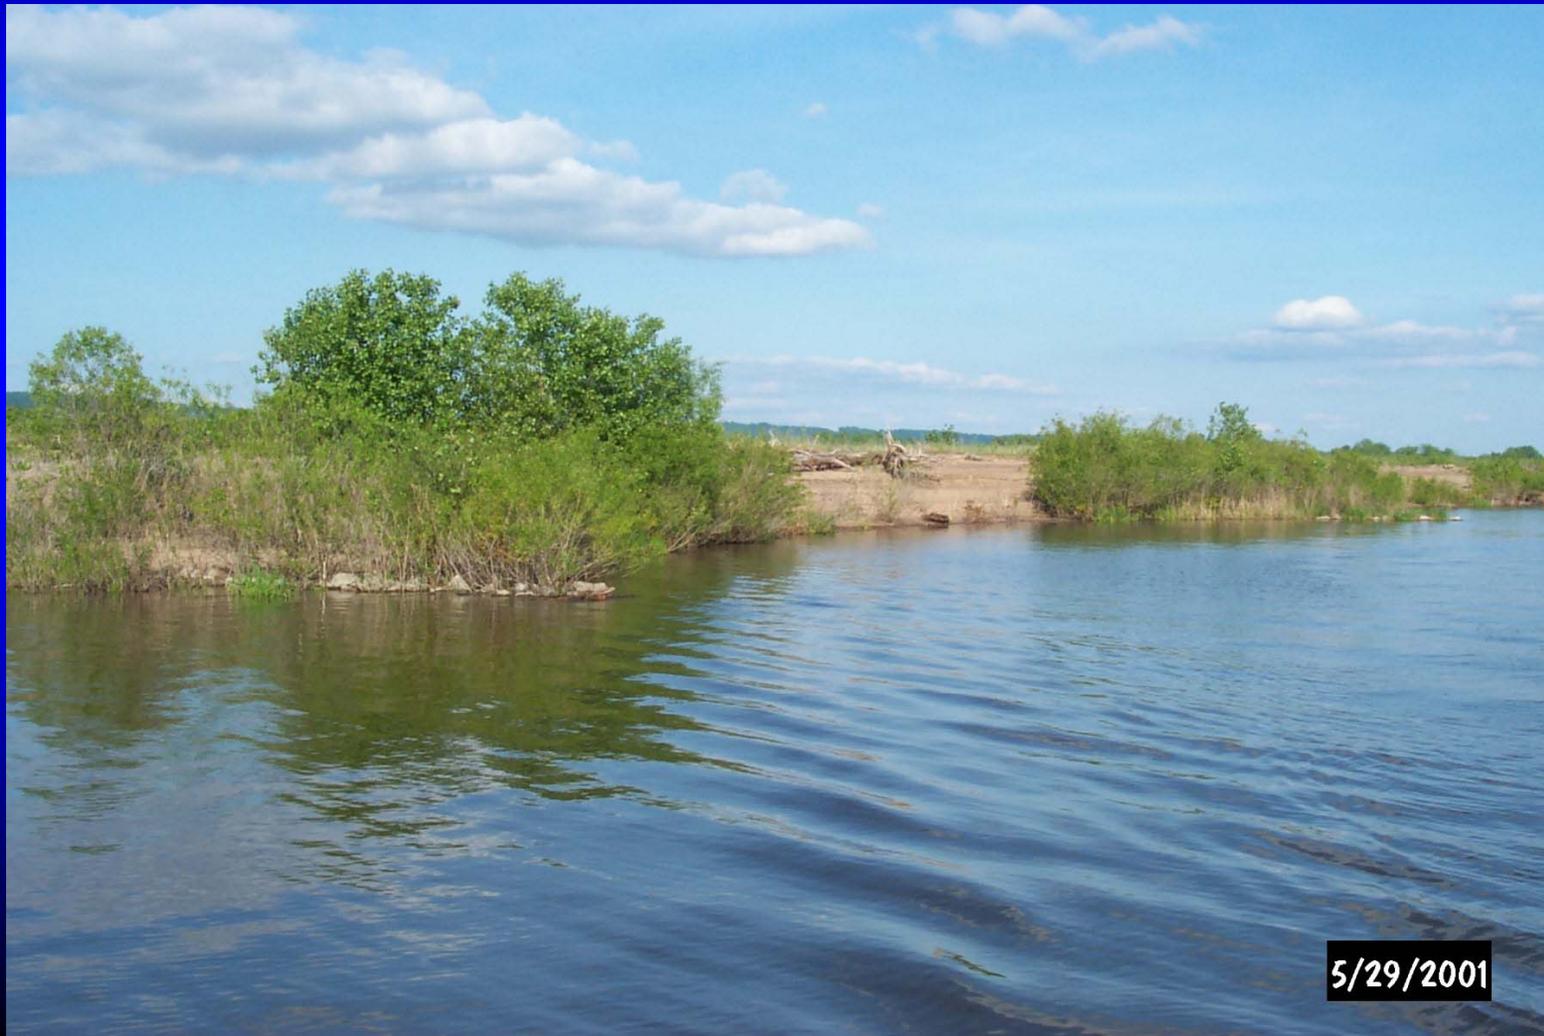
Photo A.6: Weaver Bottoms Mallard Island Shoreline

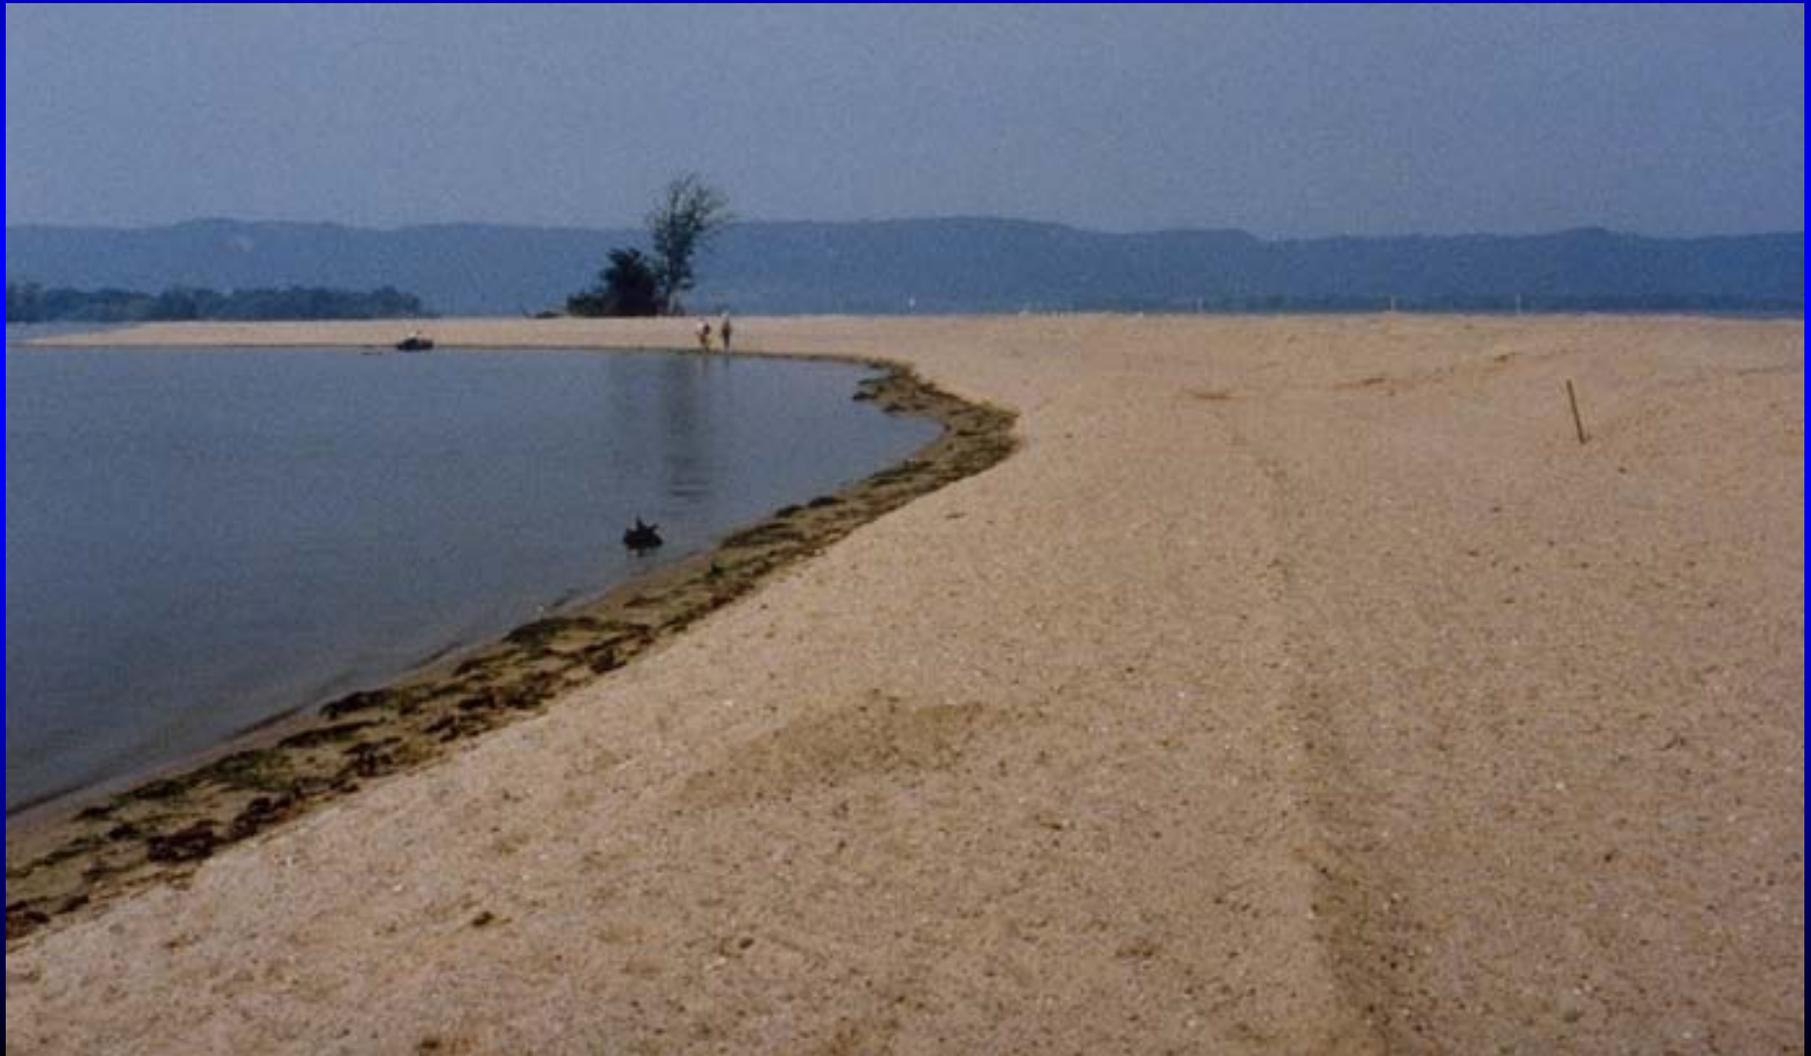
Photo B.2: Lake Onalaska Comorant Island before topsoil

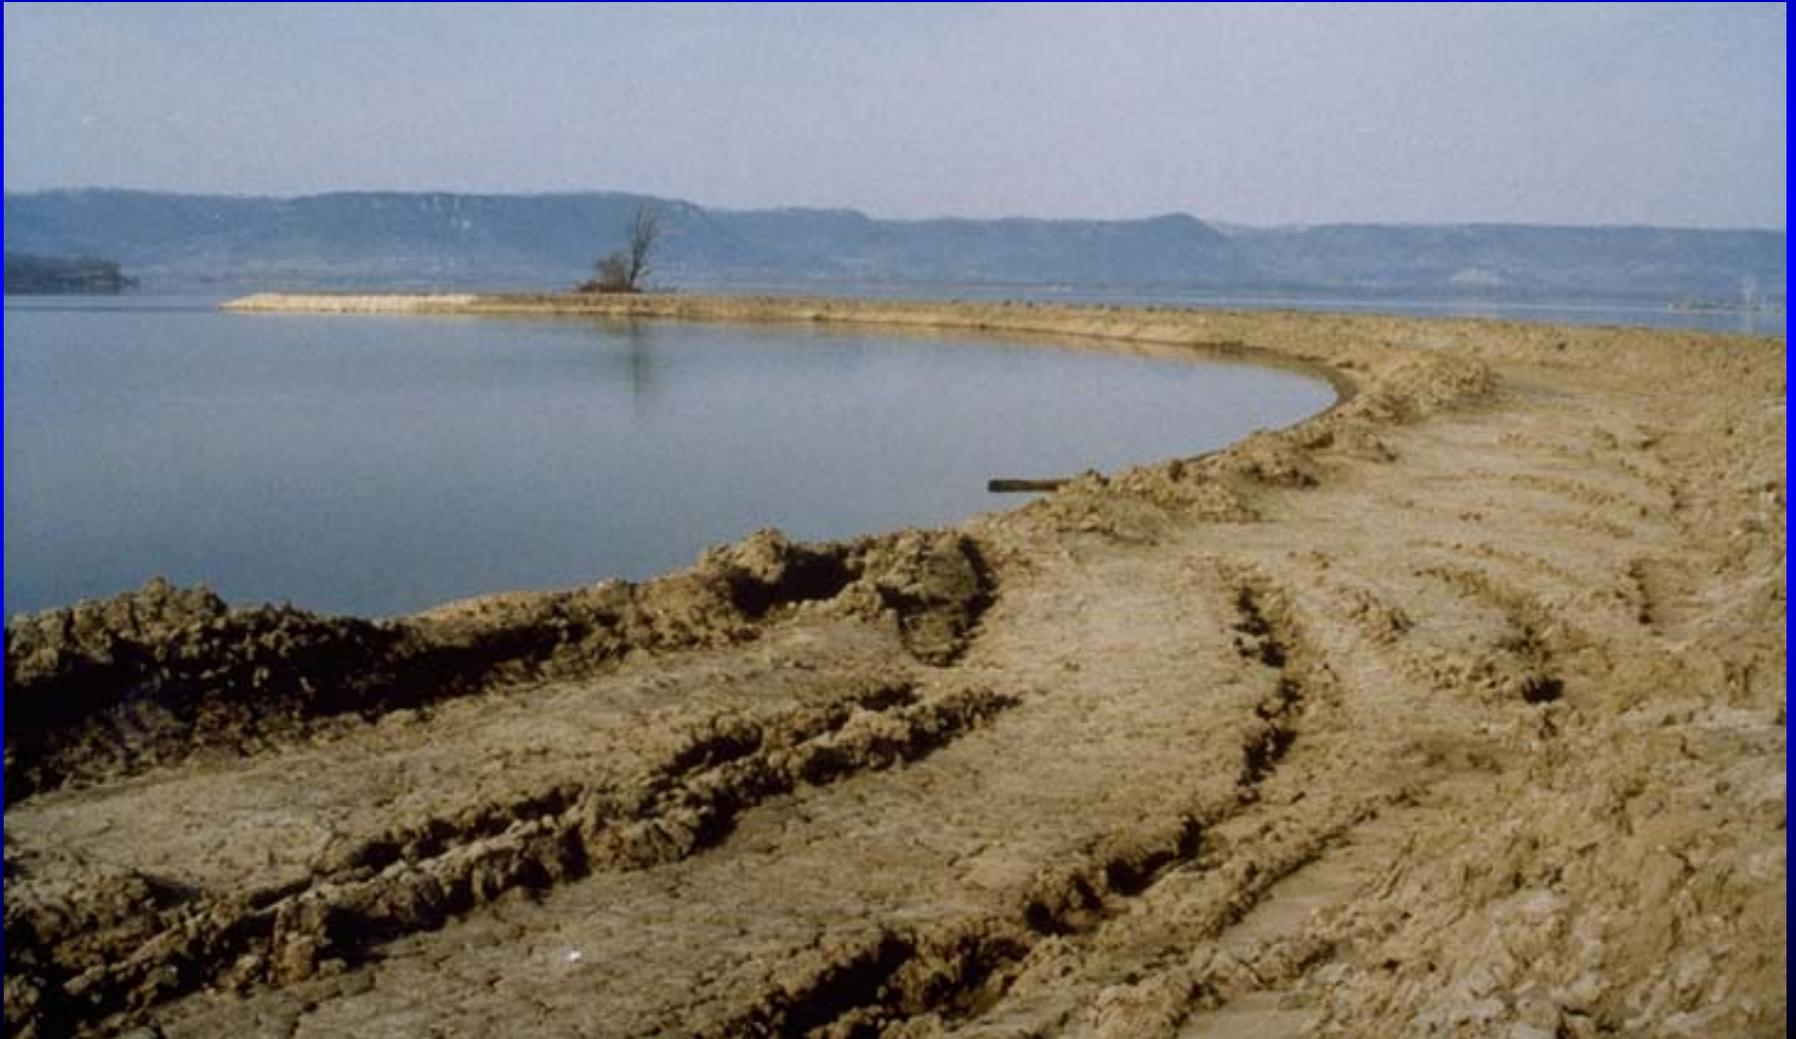
Photo B.3: Lake Onalaska Comorant Island before vegetation

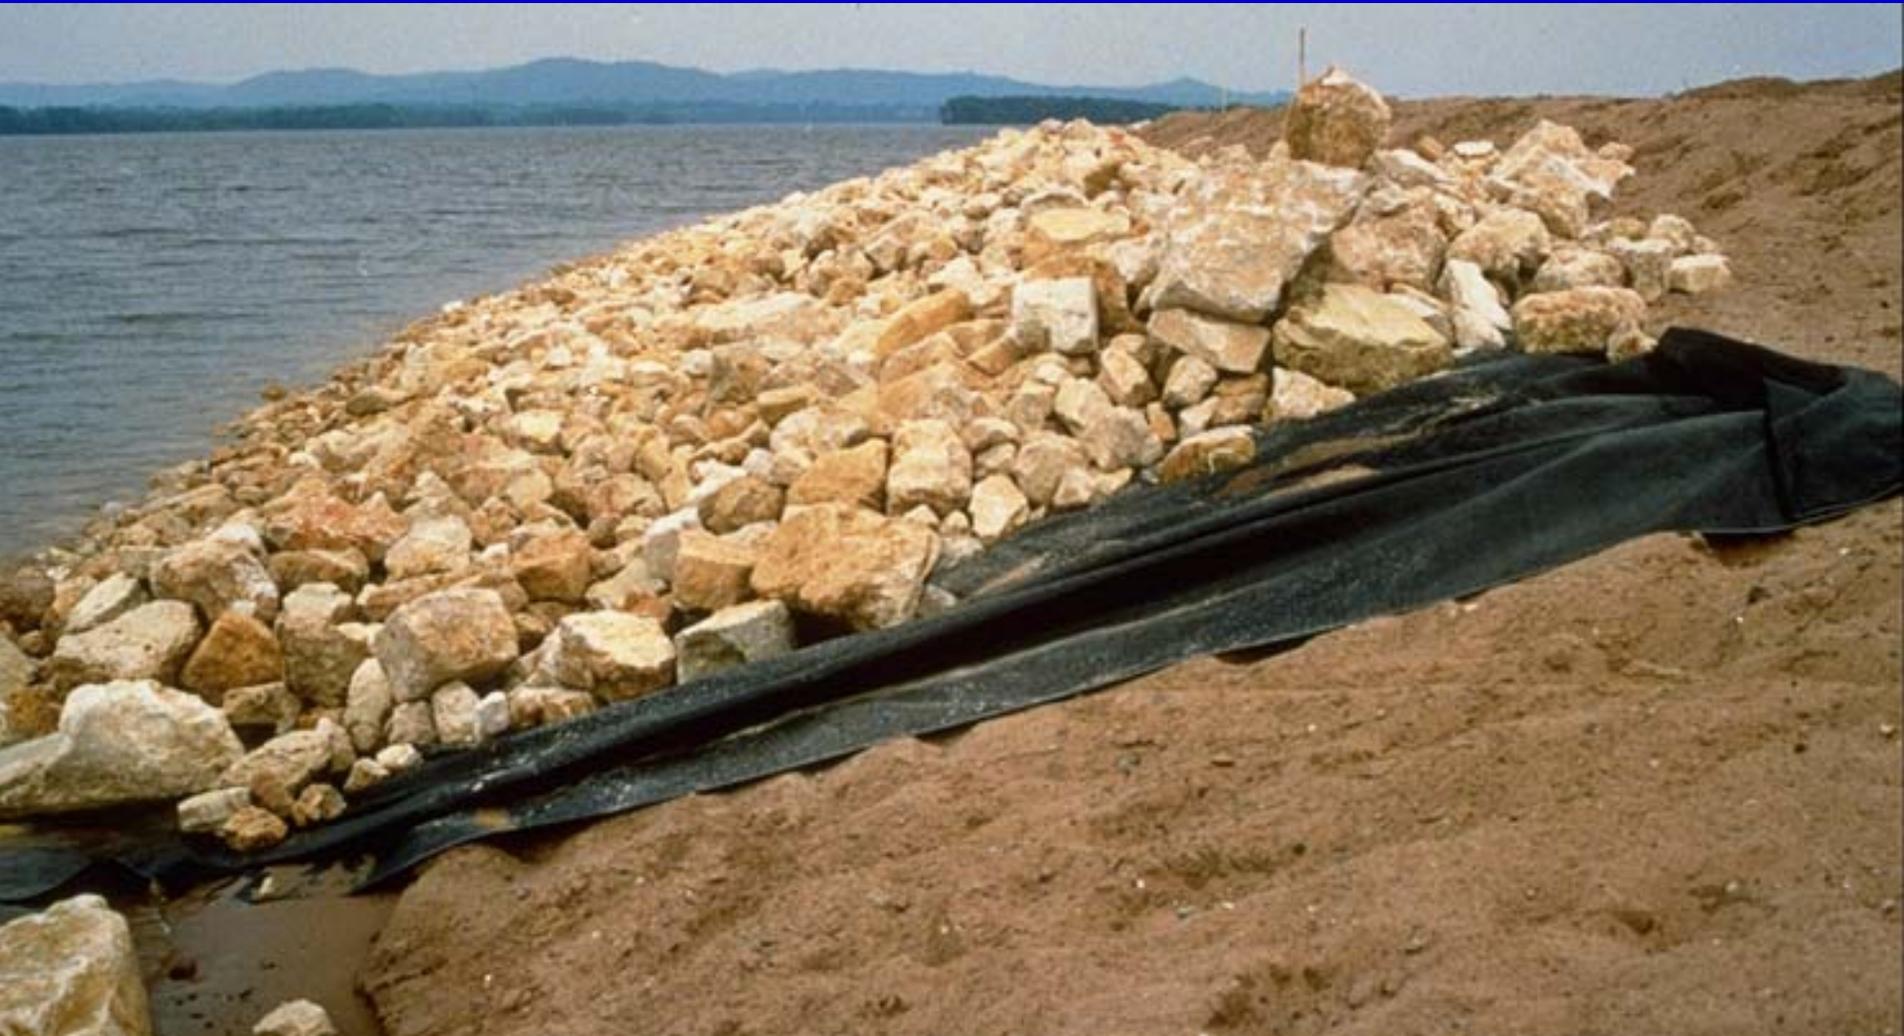
Photo B.5: Lake Onalaska Riprap and Geotextile

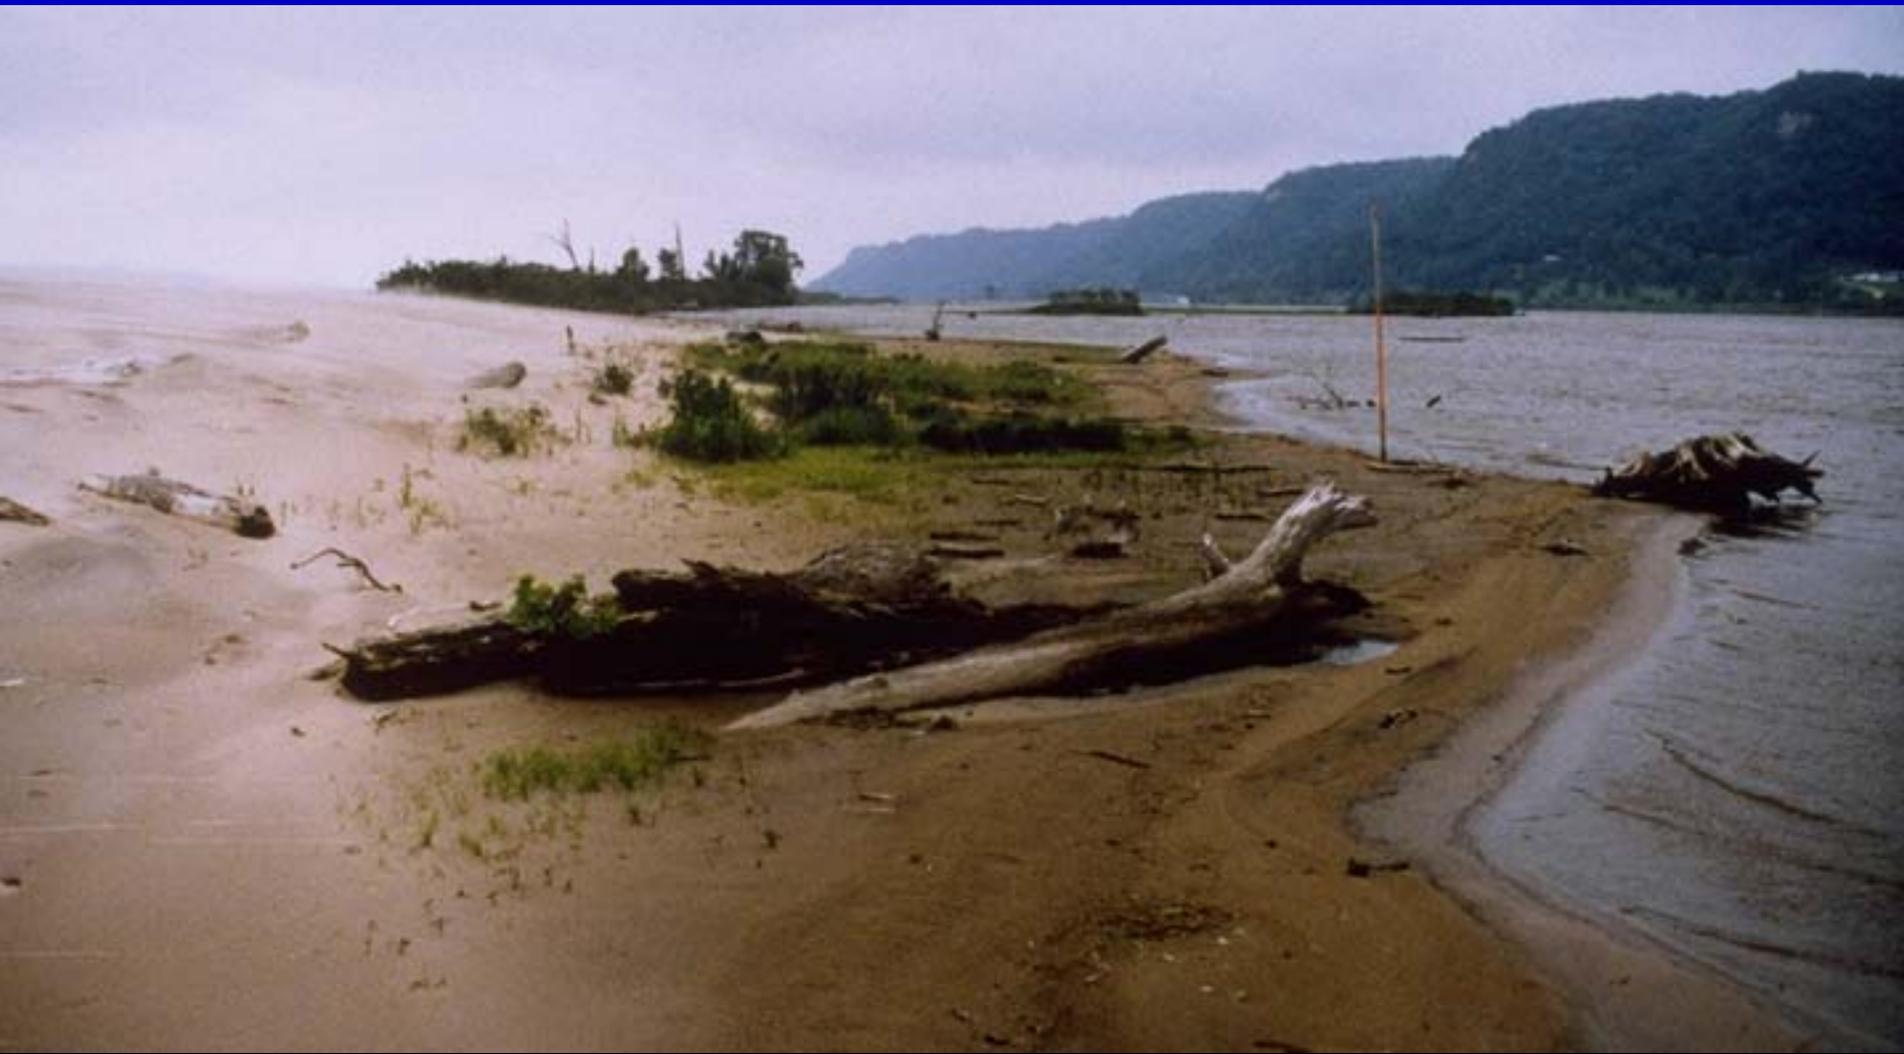
Photo C.2: Pool 8, Phase I, Stage I Horseshoe Island stable shoreline

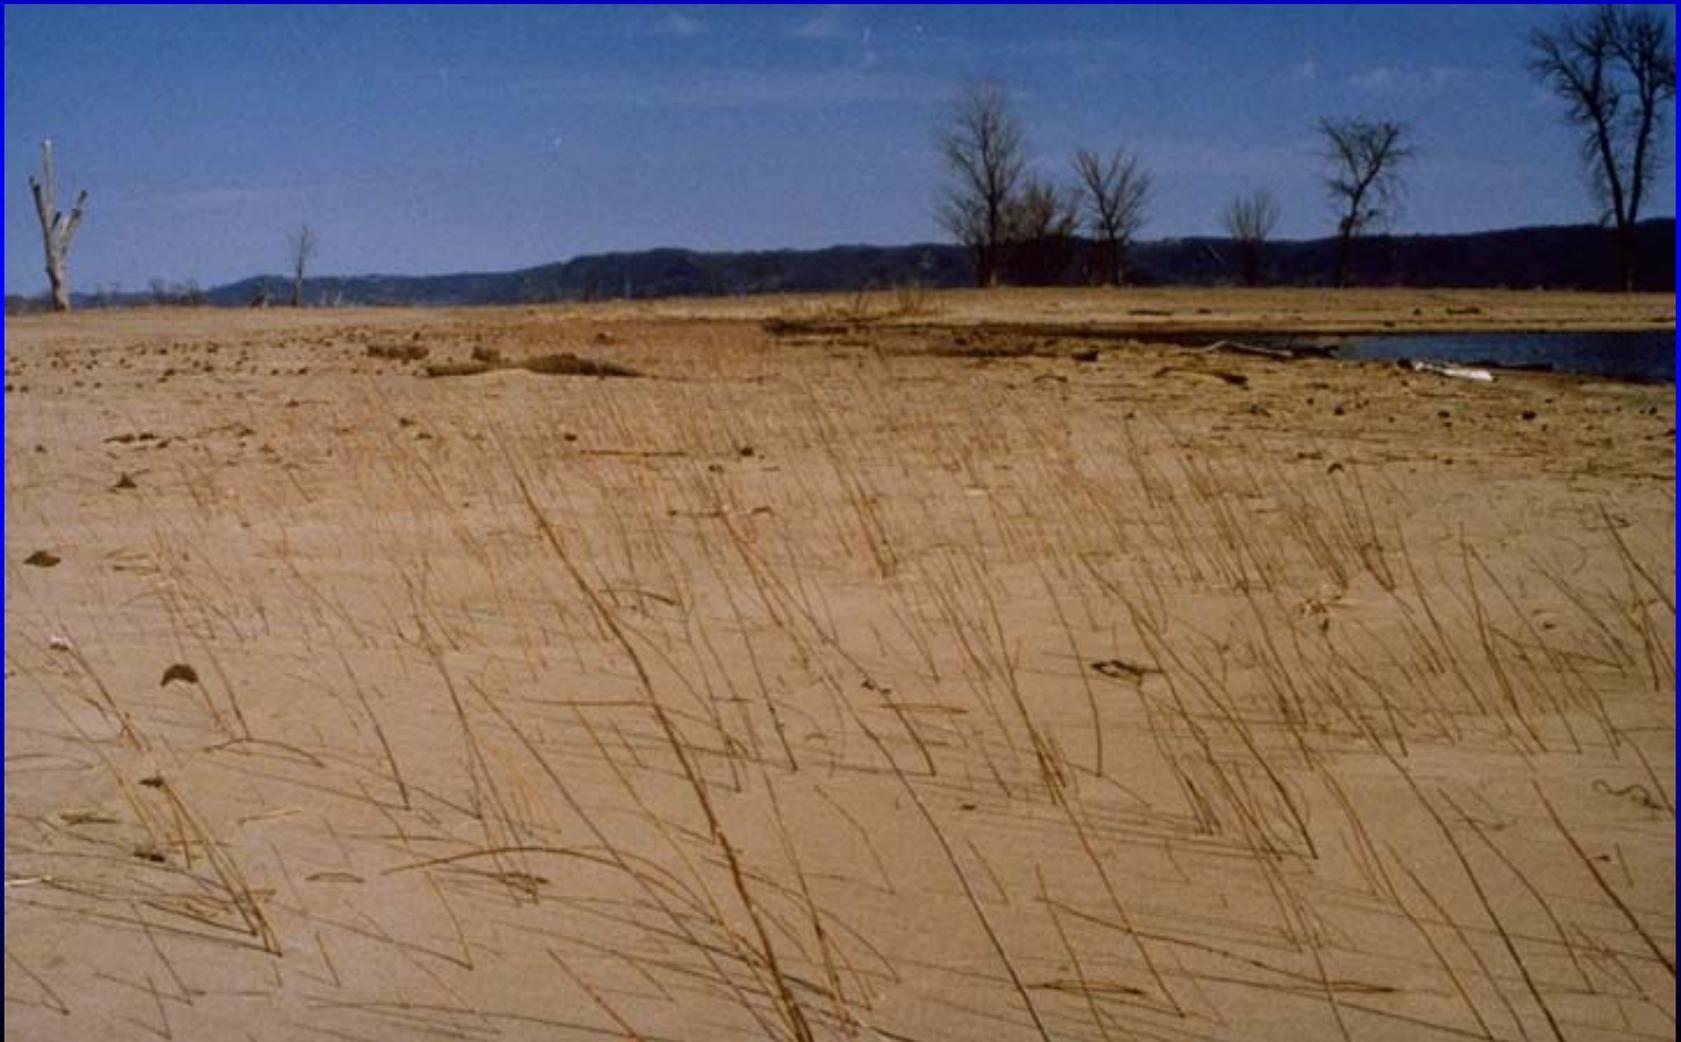
Photo C.3: Pool 8, Phase I, Stage I Willow growth on sand berm less than one year after construction

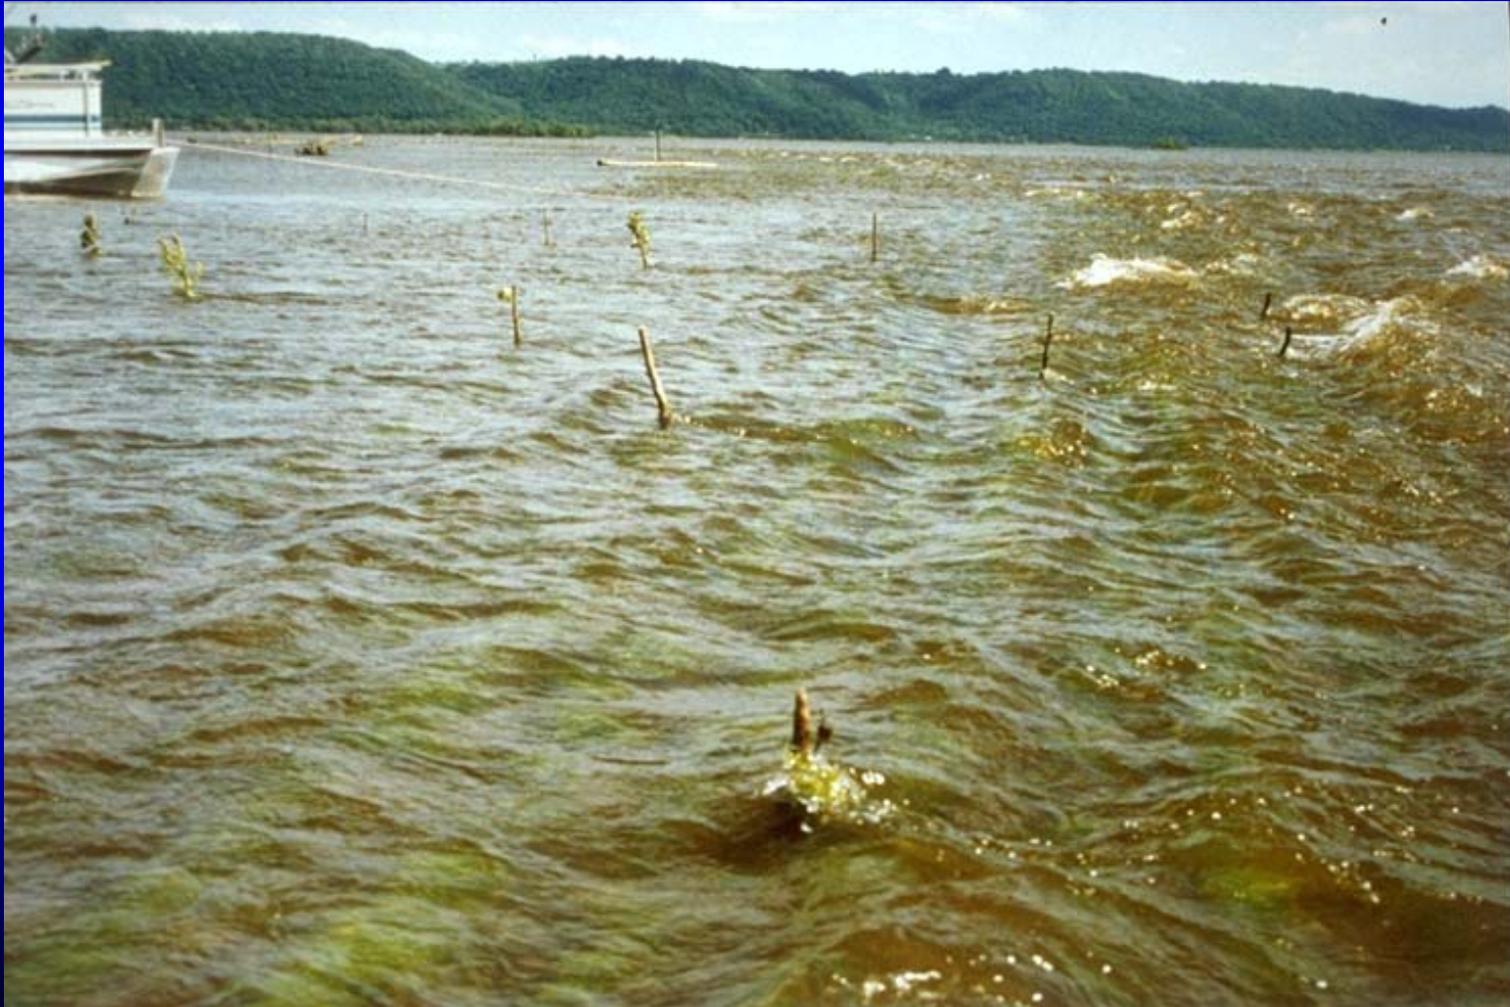
Photo D.5: Pool 8, Phase I, Stage II Stable during 1993 flood Note green rows of grass beneath water

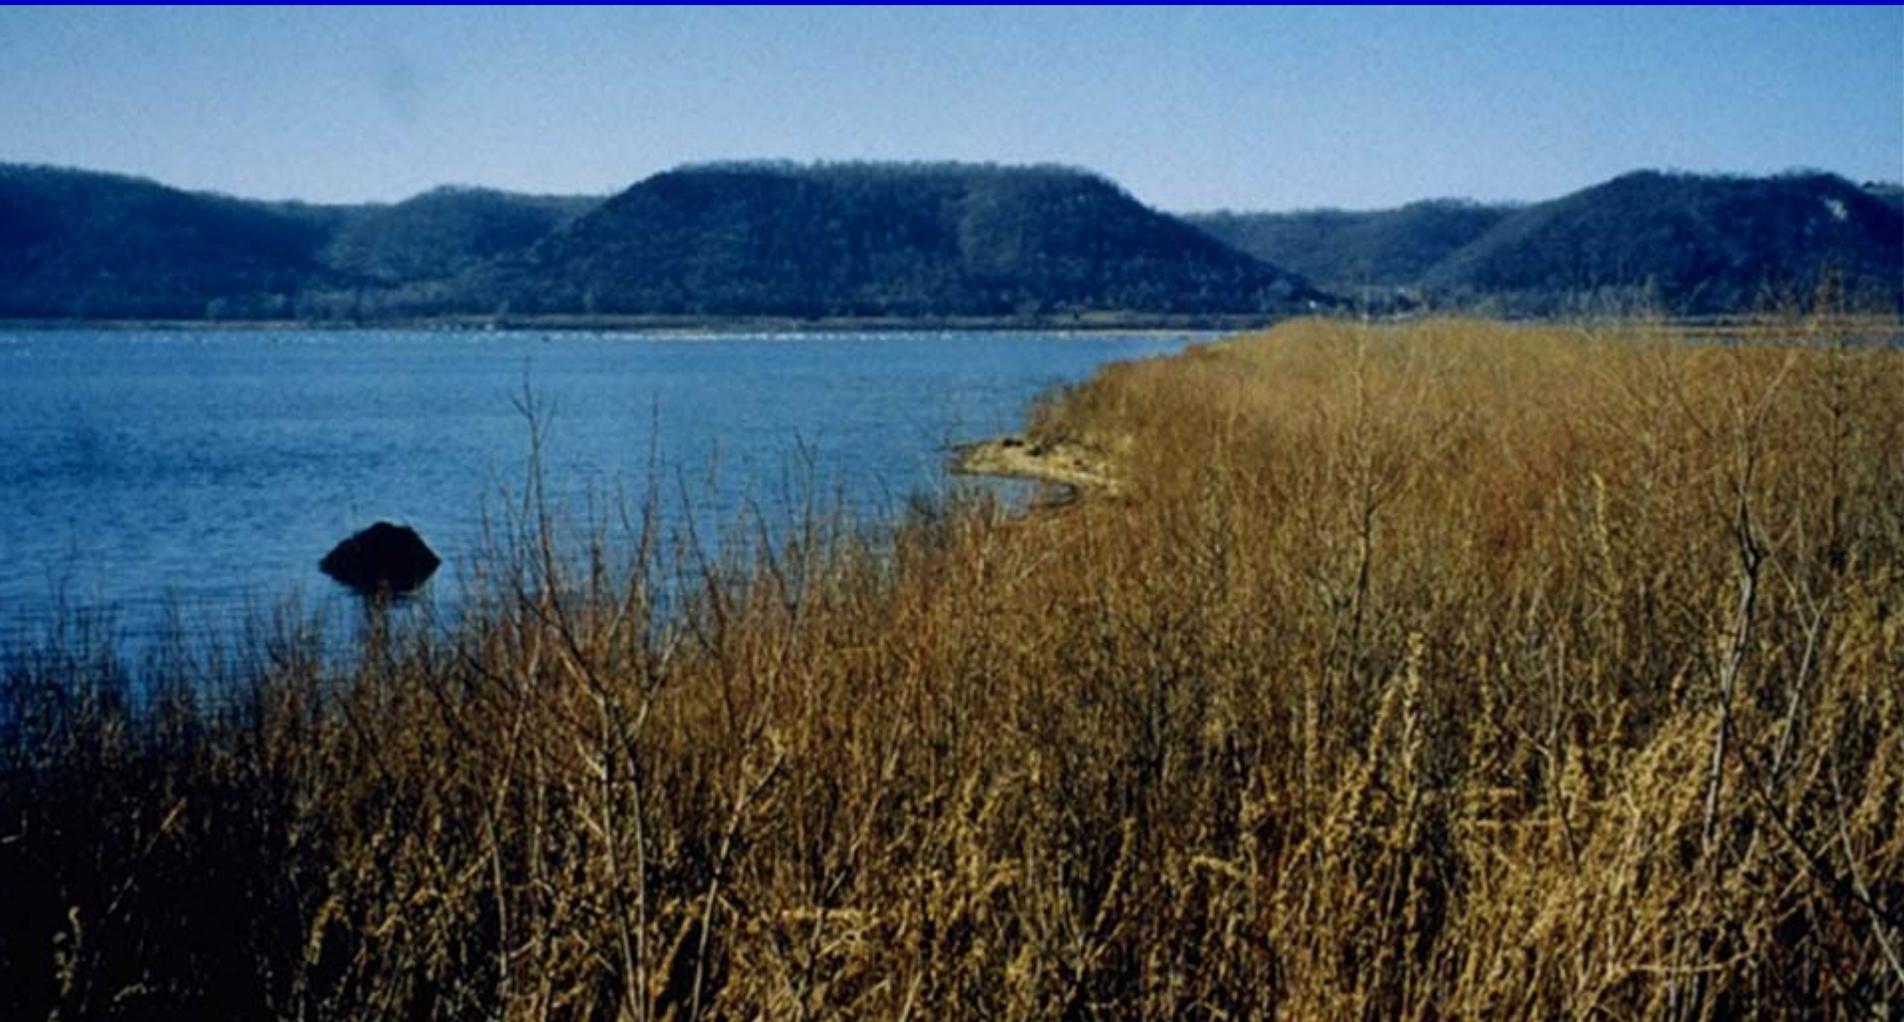
Photo D.6: Pool 8, Phase I, Stage II Vegetative stabilization on Boomerang Island
