US Army Corps
of Engineers
St. Paul District

Photo A.1: Weaver Bottoms Constructed 1986 Swan & Mallard Island, Whitewater River

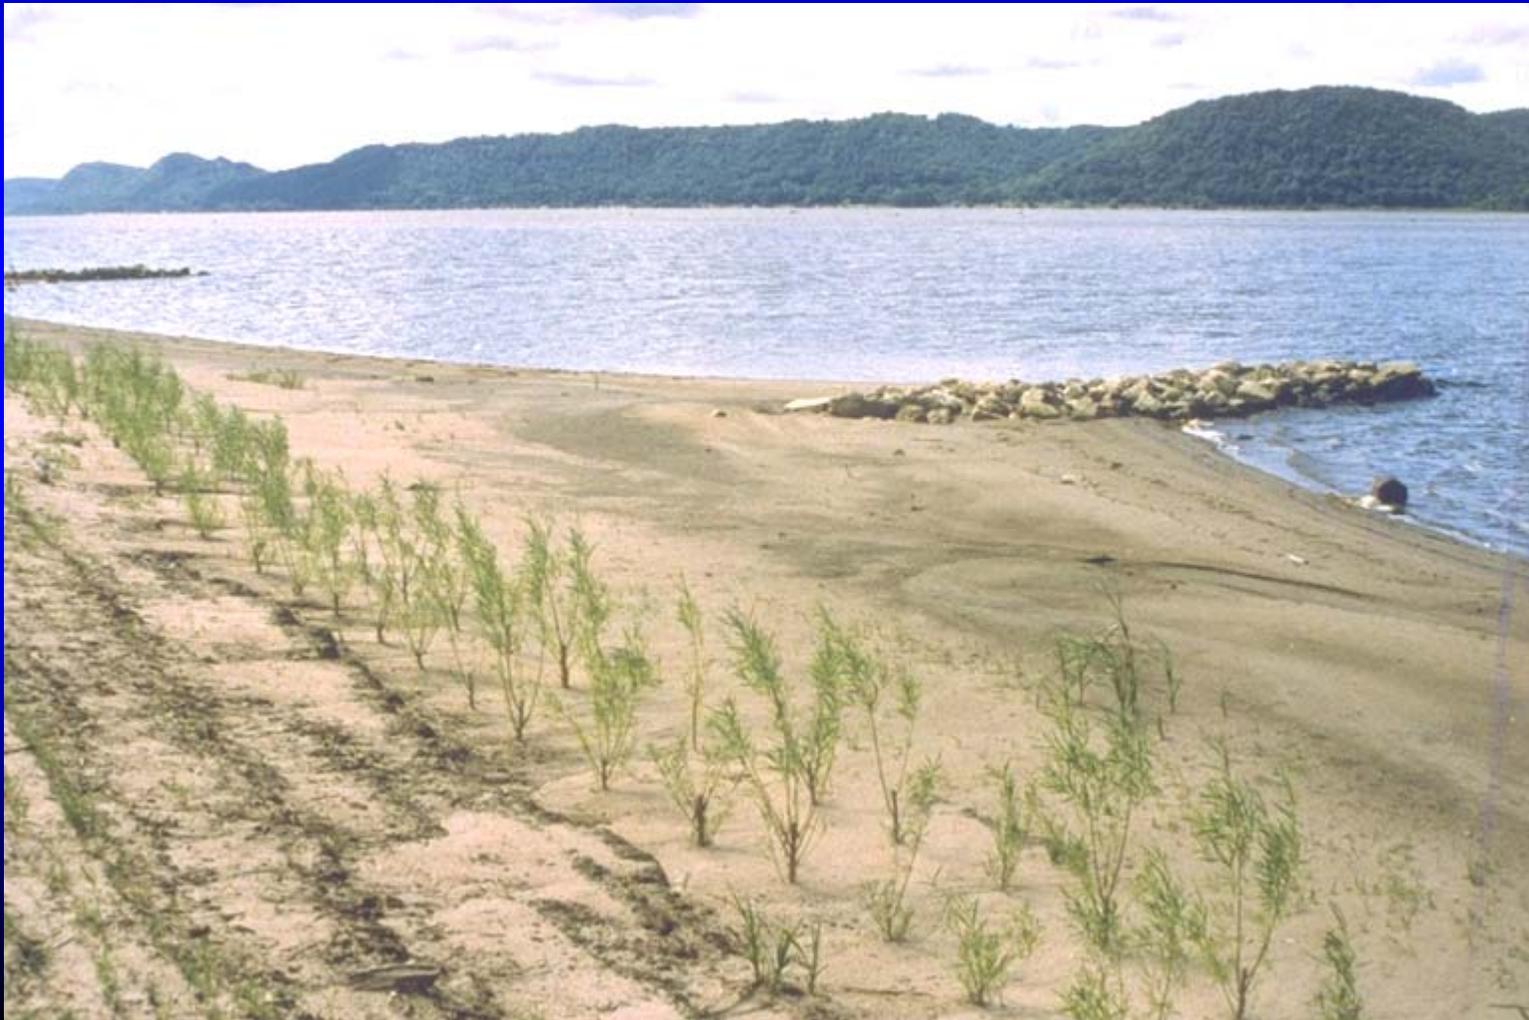
Photo D.9: Pool 8, Phase I, Stage II Biotechnical stabilization consisting of groins, sand berm, and willows

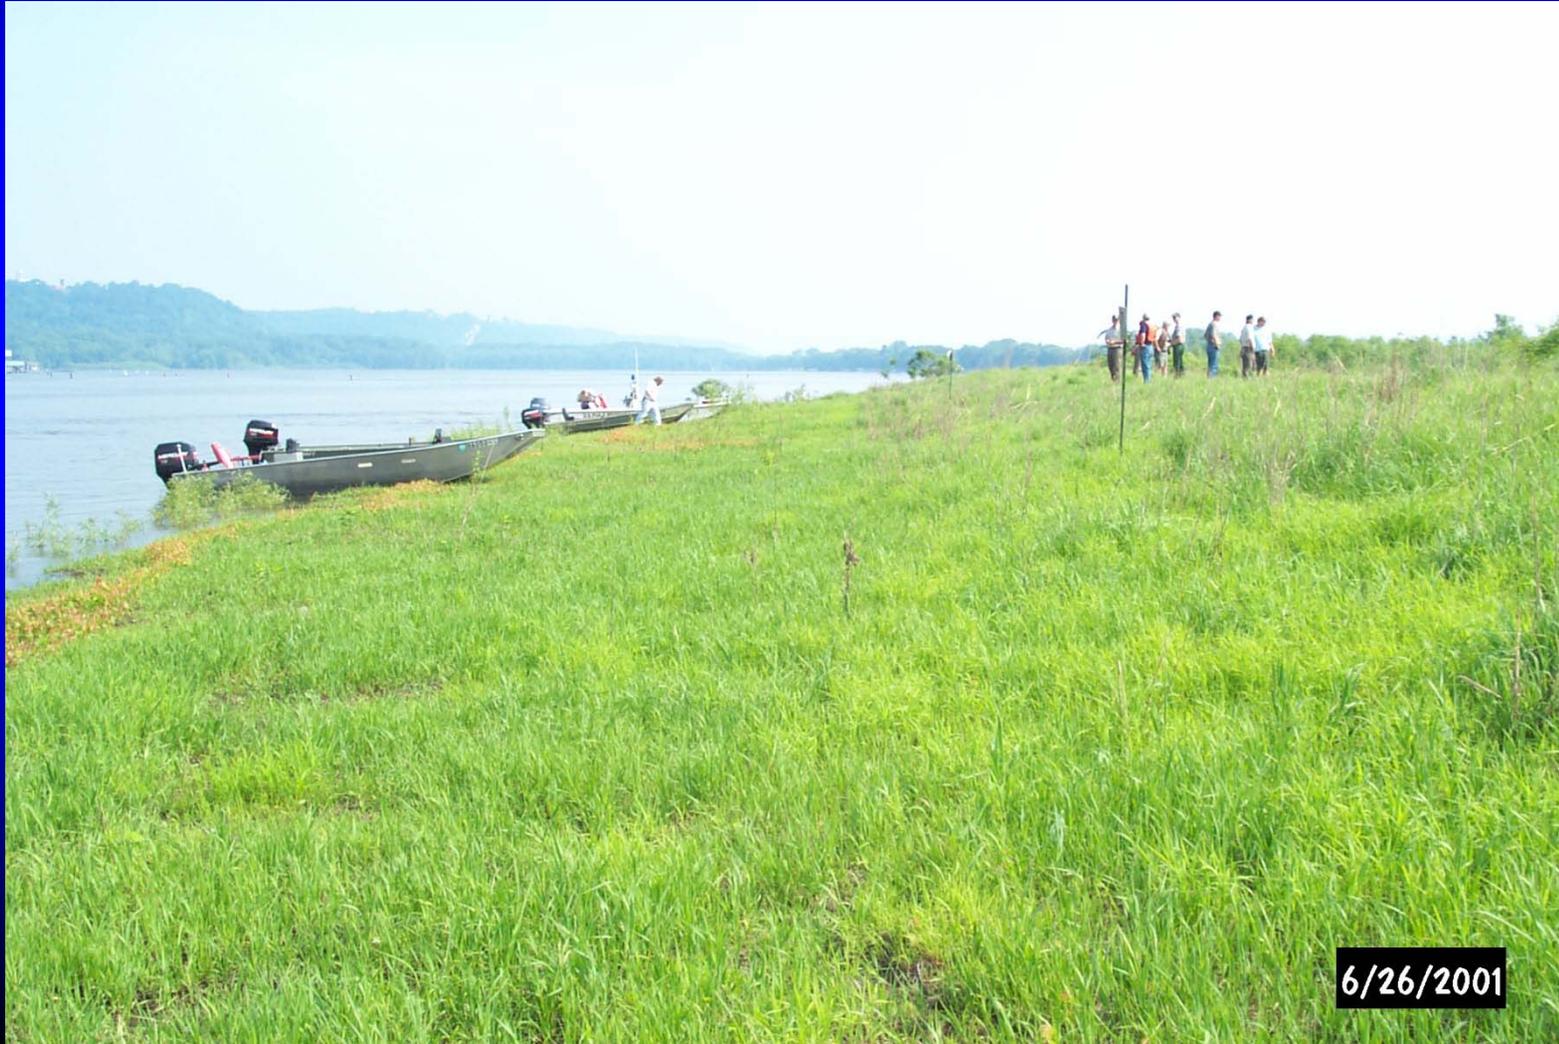
Photo G.2: Willow Island Berm

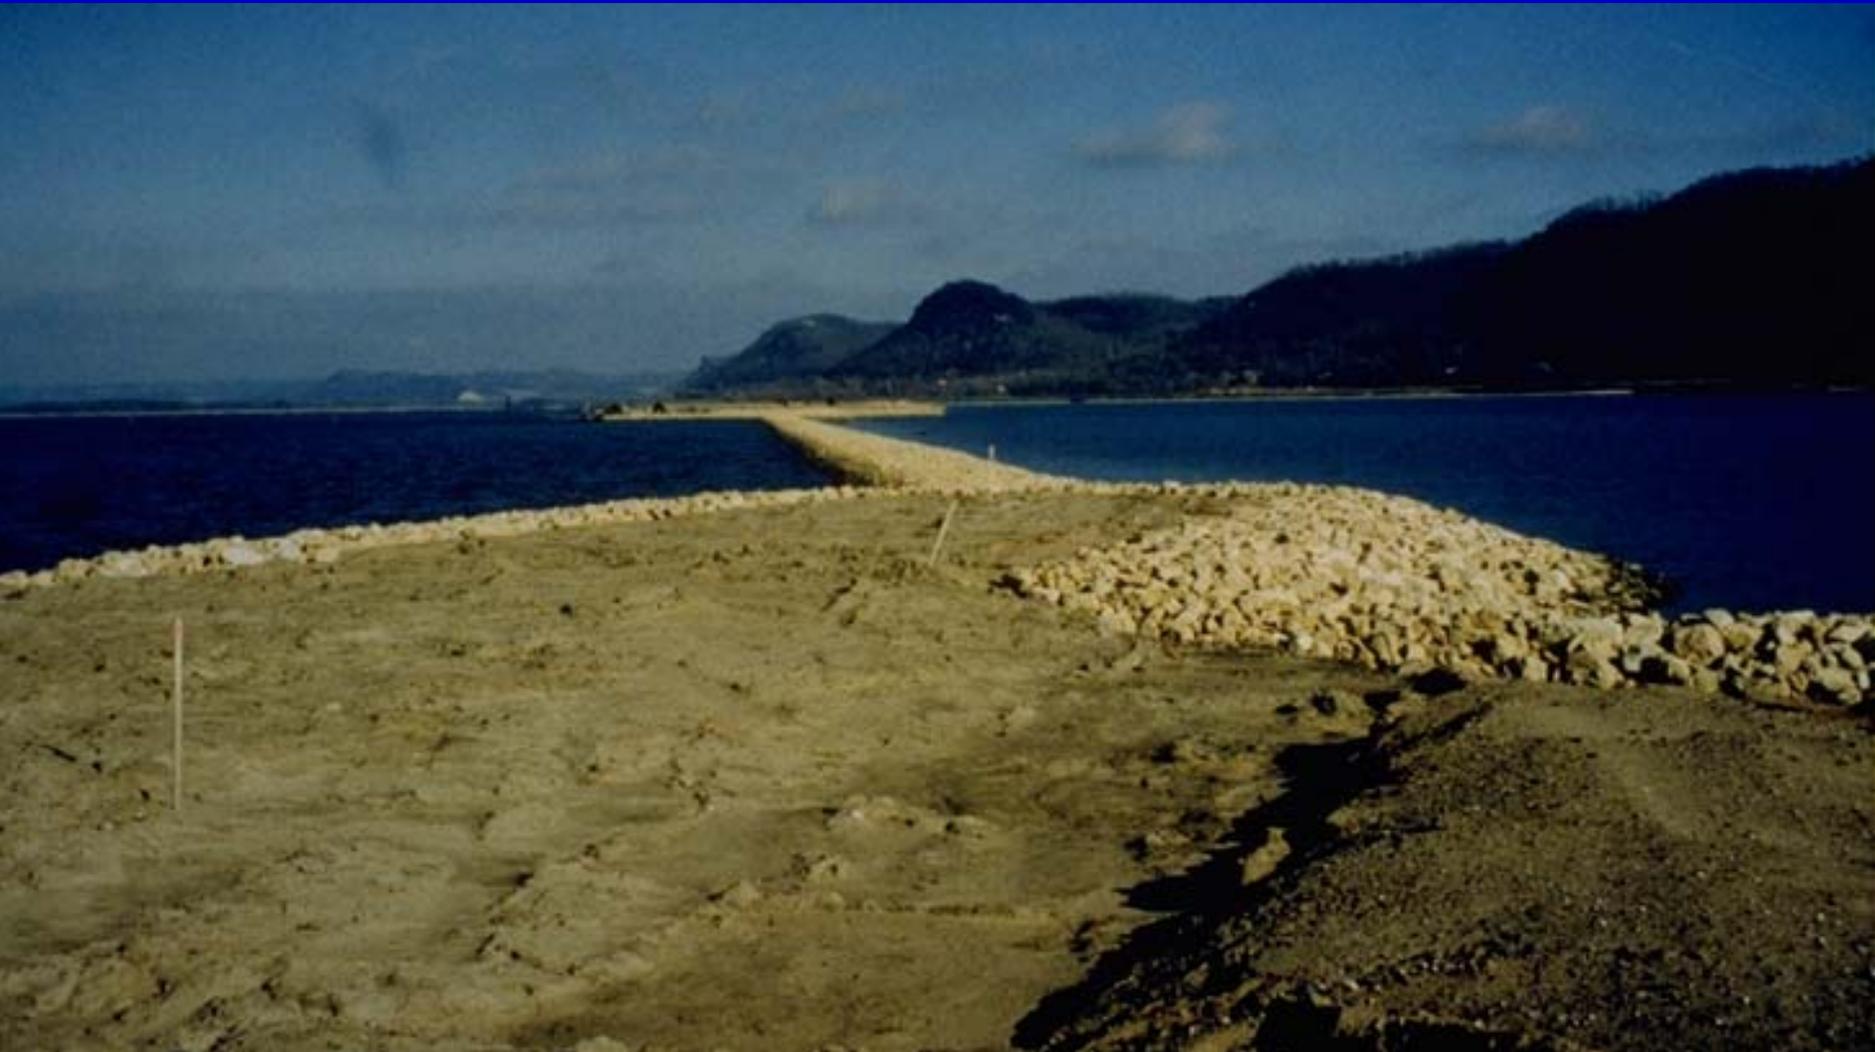
Photo H.5: Rock Sill B Stoddard Bay

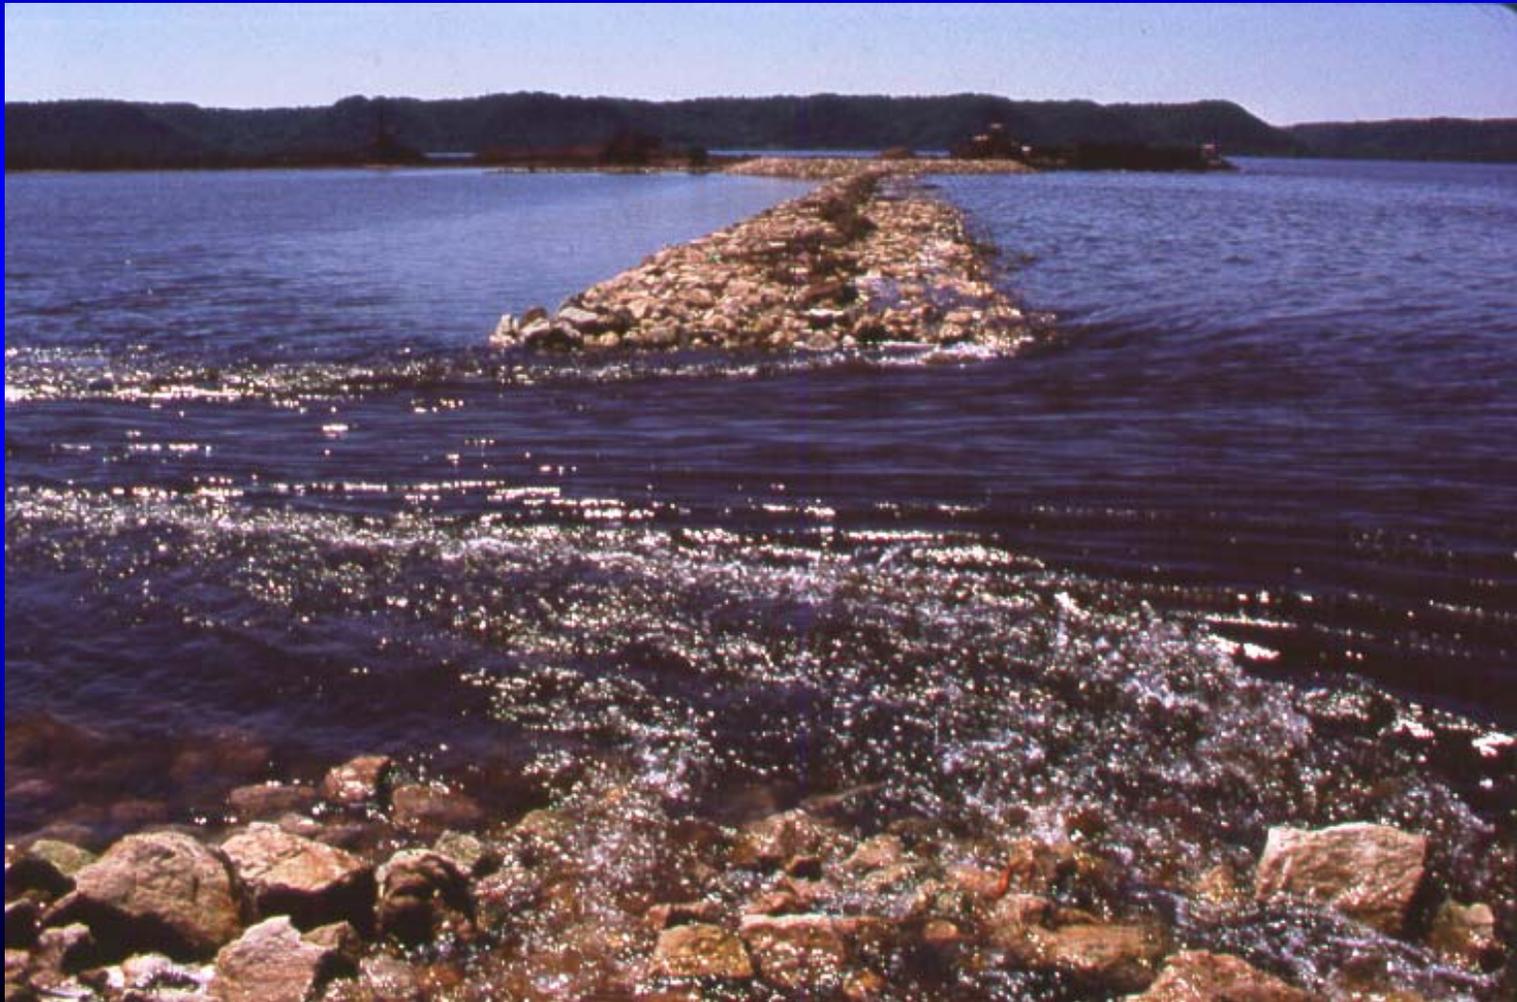
Photo H.7: Notch in Rock Sill A

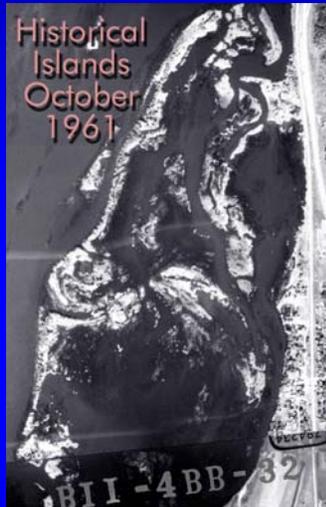
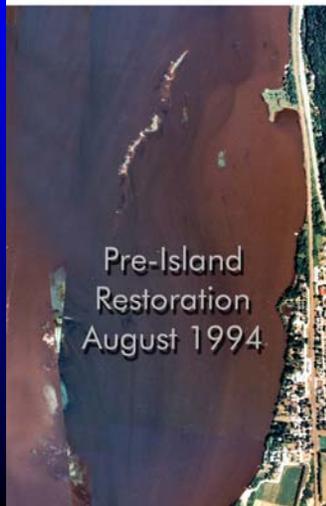
Photo H.8: Vegetative response in Stoddard Bay

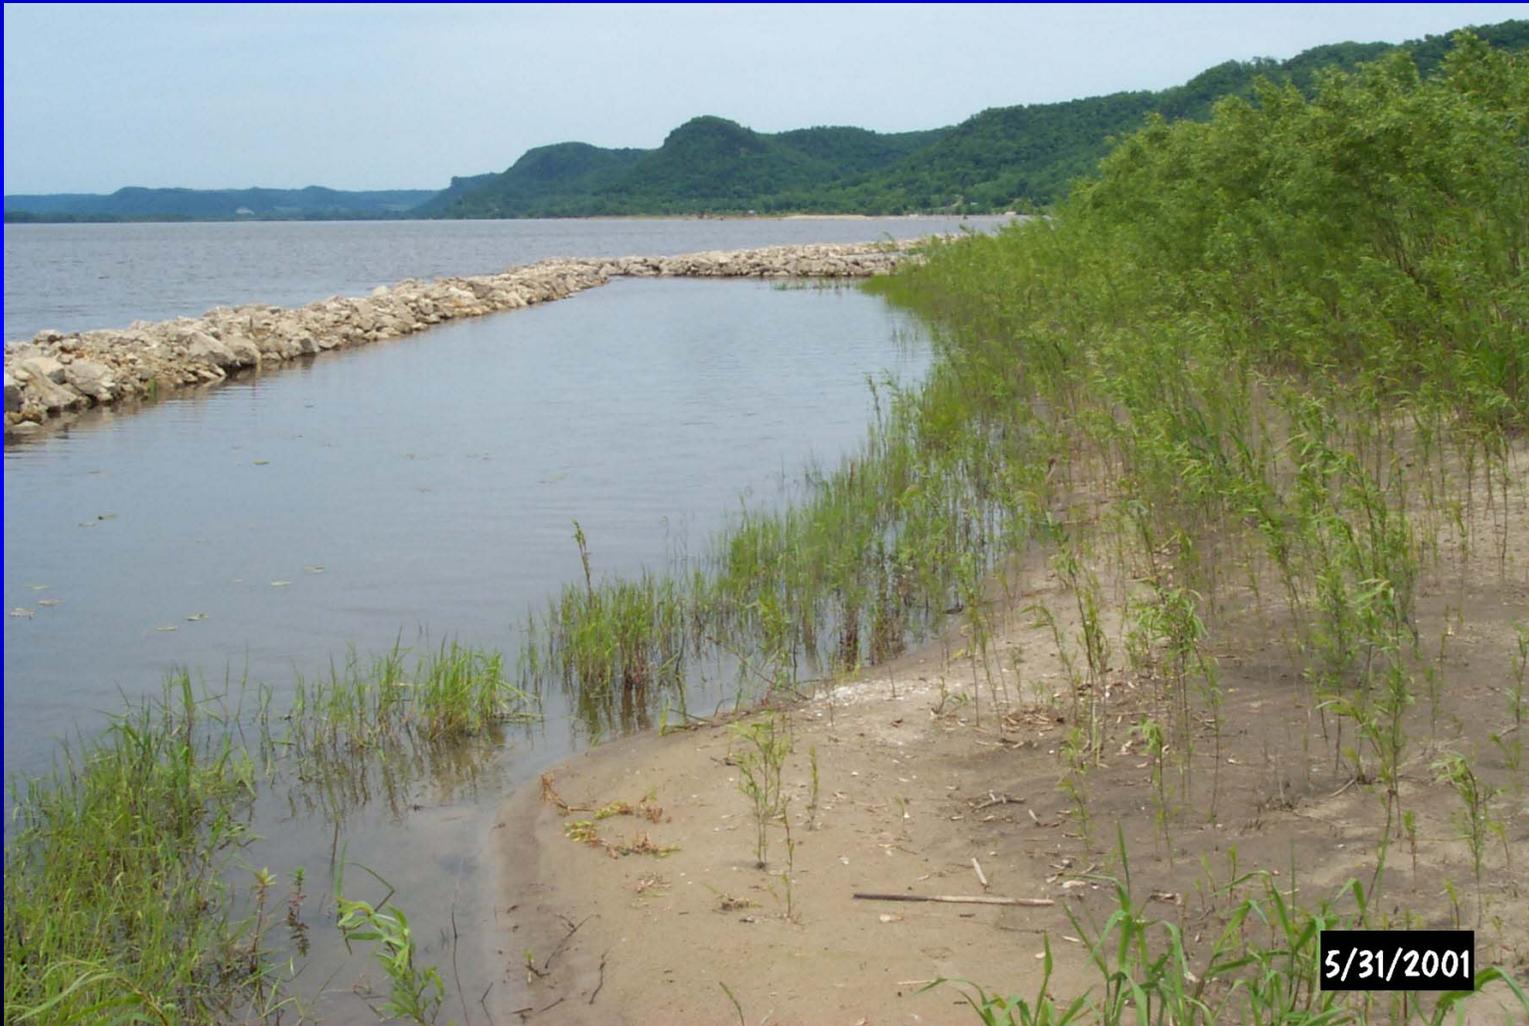
Photo H.11: Rock Mound

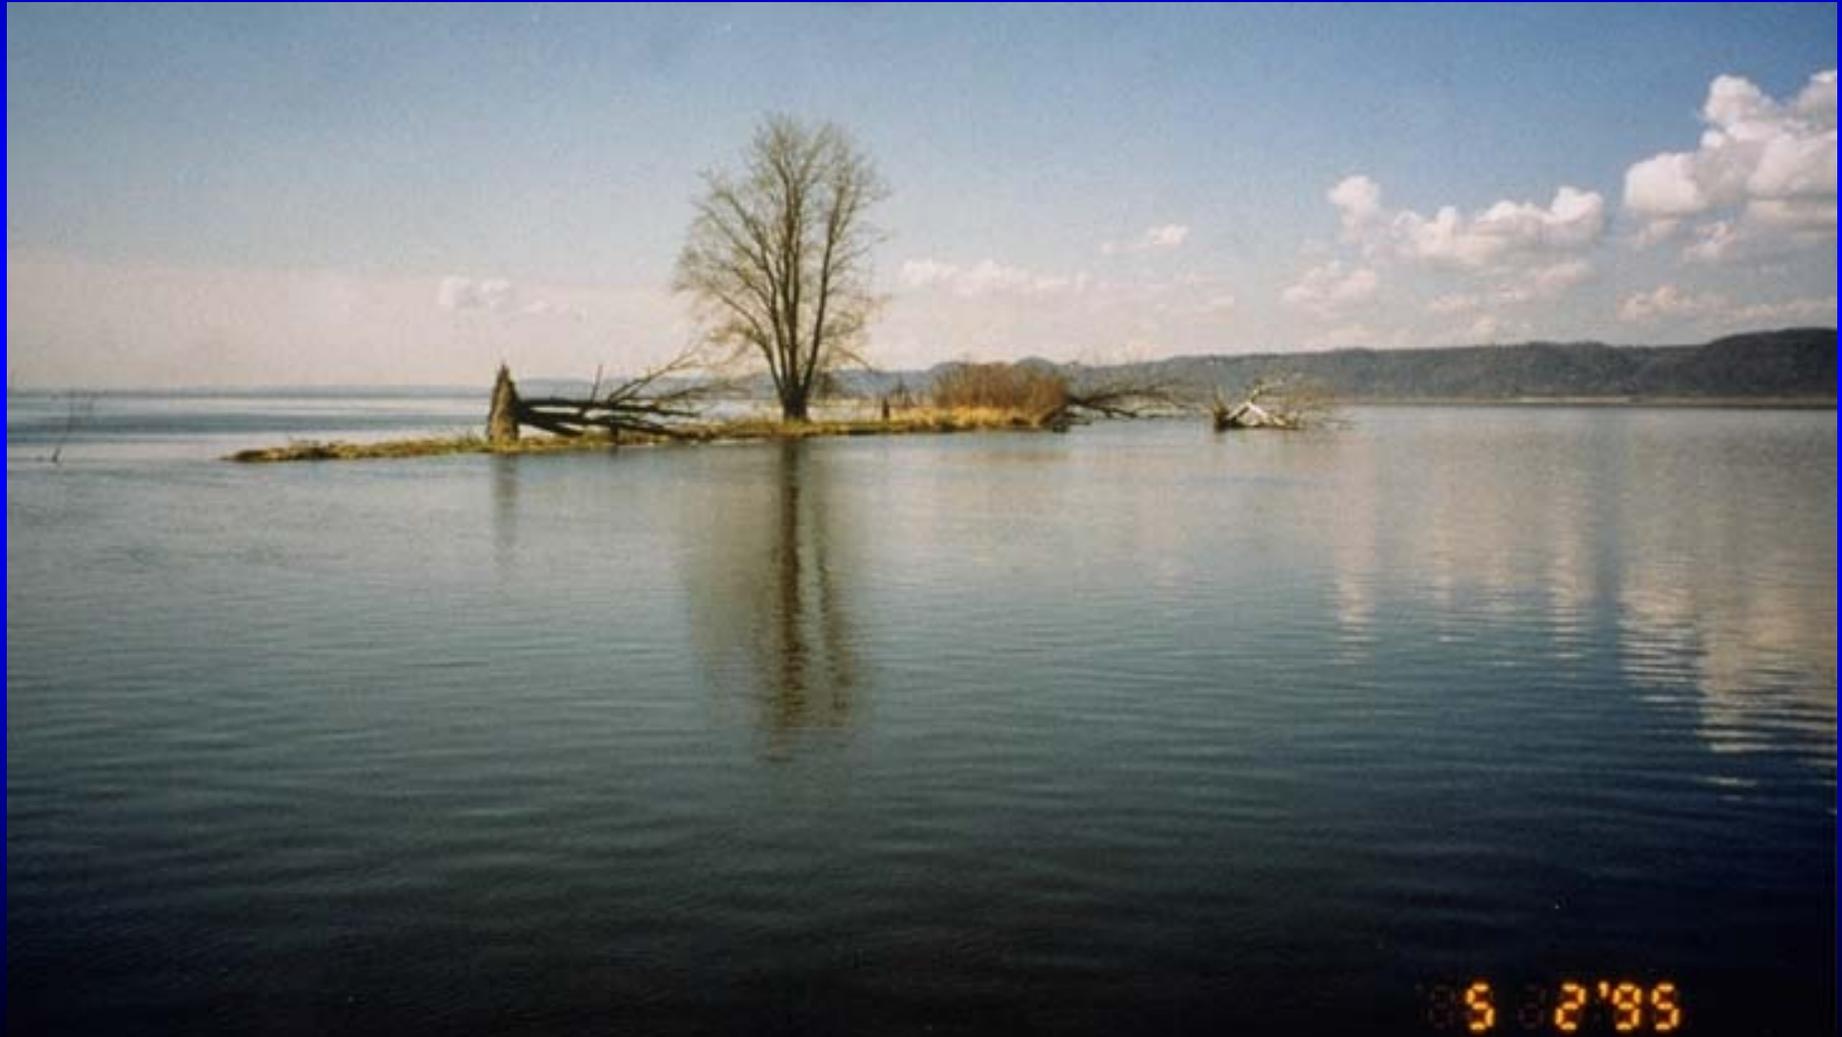
Photo H.13: Remnant island, Stoddard Bay
